* * TECHNICAL INFORMATION NOTICE * *

DATE: October 16, 2020
TO: Mitsubishi Motors US & Puerto Rico Dealer Parts and Service Managers
RE: Seat Slide Sensor Wiring Harness Damage Under Driver's Seat
TIN Number: TIN-20-52A-002

AFFECTED VEHICLES: 2013 – 2020 (ZC) Outlander Sport

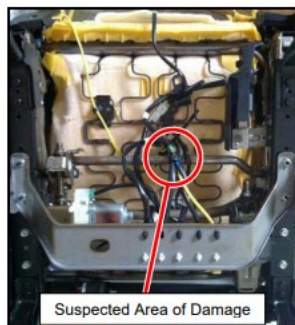
View from under Driver's Seat

During diagnosis for this condition, dealers should check for damage to the driver's seat slide position sensor harness. If a damaged harness is found, **DO NOT replace the front seat adjuster or SRS ECU for this condition.** Please replace the seat harness with the countermeasured part listed in the parts information section below.

Parts information: Harness tube of the seat slide sensor was changed to improve its durability as of May 22nd, 2020 (VIN:JA4AP4AU5LU031440).

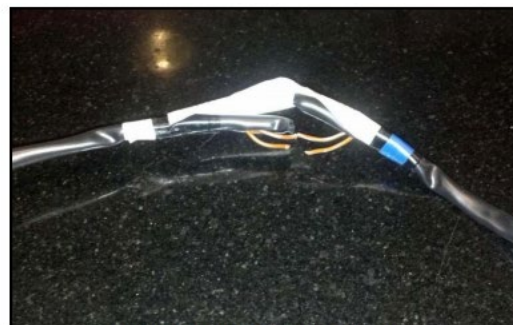
Close-up View of Damaged Harness
