Technical Service Bulletin

GROUP FUEL SYSTEM	NUMBER 20-FL-010H
DATE OCTOBER 2020	MODEL(S) Tucson (TL) 2.0L

SUBJECT: TUCSON 2.0L DTC P0420 - ECM UPDATE AND CATALYST REPLACEMENT

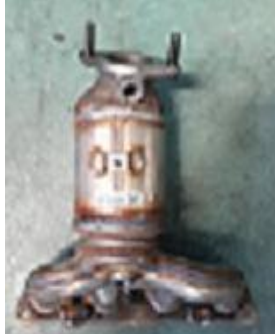
Part Name	Part Number	Diagram
MANIFOLD CATALYTIC ASSY	28510-2EMN0 (2WD) 28510-2EPE0 (4WD)
