Technical Service Bulletin

30 Transmission leak from service opening of the lower bellhousing

30 20 30 2053597/5 November 9, 2020. Supersedes Technical Service Bulletin Group 30 number 20-28 dated August 20, 2020 for reasons listed below.

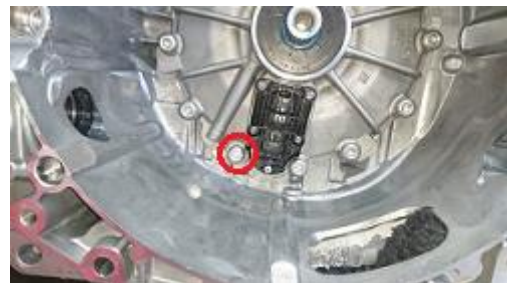
1. Remove the lower bolt of the cover on the passenger's side of the plastic cover (Figure 1 and Figure 2).

Figure 1. Bolt location.

1. Remove all bolts of the clutch cover (*Do not remove the dual clutch only the bolts are being replaced*).
2. Clean the bolt holes.
3. Install 12 new bolts for the clutch cover with the part number WHT 002 459 C:
 - Tightening torque: 12Nm + 90°.
 - The tightening sequence is a diagonal pattern as described in the repair manual.
4. Reinstall the dual mass flywheel into the transmission per the repair manual.
5. Reinstall the transmission into the vehicle per the repair manual.
6. Check and adjust the transmission ATF level.
7. Road test for proper operation.

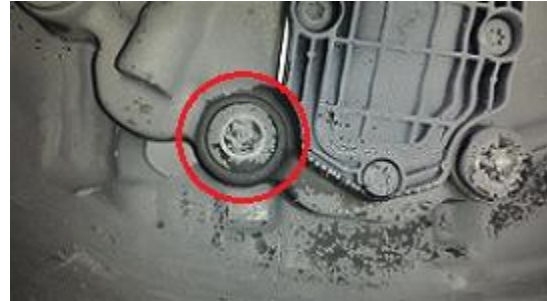
Leaking through the bolt holes of the clutch cover.

Figure 2. Leak location.

2. If there is oil residue in the bolt hole, continue with this TSB repair. If there is no oil residue in the bolt hole, create an Audi Technical Assistance Center contact with pictures of the leak and a diagnosis log attached. Then contact Audi Technical Assistance Center for diagnosis assistance.
