Technical Service Bulletin

91 No diagnostics communication to the telematics control module

91 20 29 2056076/10 November 9, 2020. Supersedes Technical Service Bulletin Group 91 number 20-21 dated October 19, 2020 for reasons listed below.

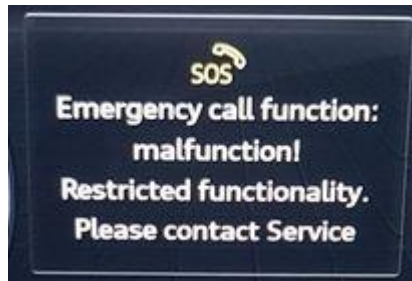
- An SOS Warning might be displayed in the instrument cluster (Figure 1).

Figure 1. Emergency call malfunction warning.

A software bug can cause the control module to freeze during cold start.

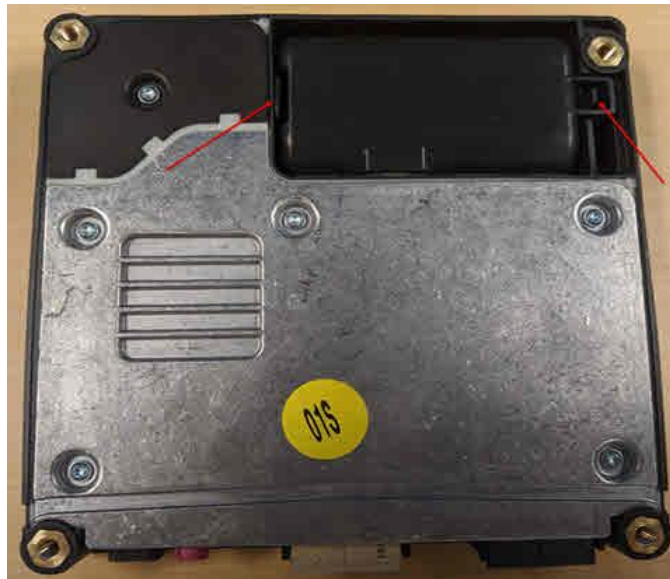
Figure 2. Backup battery compartment location.

1. Remove and unplug the telematics control module, J949 (address word 0075) according to the repair manual in Elsa.
2. Open the battery compartment of the telematics control module, J949 (address word 0075) and disconnect the backup battery (Figures 2 - 3).

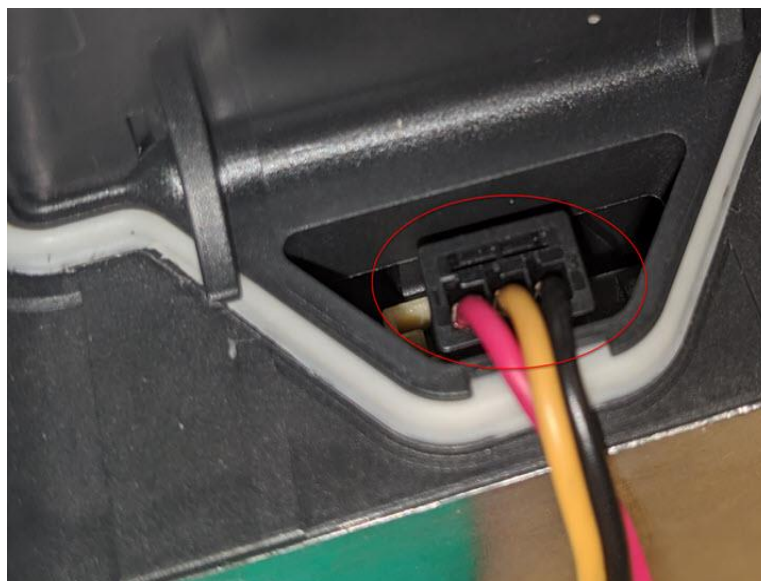
Figure 3. Backup battery connector (no release mechanism).

3. Remove the fuse supplying power to the data bus on board diagnostic interface, J533 (address word 0019). Please consult ElsaPro or the vehicle's manual as to the fuse location for the specific model you are working on.
4. Leave the battery and Gateway fuse disconnected for approximately 20 minutes.
5. Reinstall the backup battery back into the telematics control module, J949 (address word 0075).
6. Reinstall the telematics control module, J949 (address word 0075) back into the vehicle.
7. **If ODIS still cannot connect** to the telematics control module, J949 (address word 0075), follow the ODIS test plan.
