SERVICE BULLETIN

APPLICABILITY: 2014-16MY Forester 2.5L Models

NUMBER: 07-112-16

SUBJECT: New Alternator Assembly to Address DTC P0300

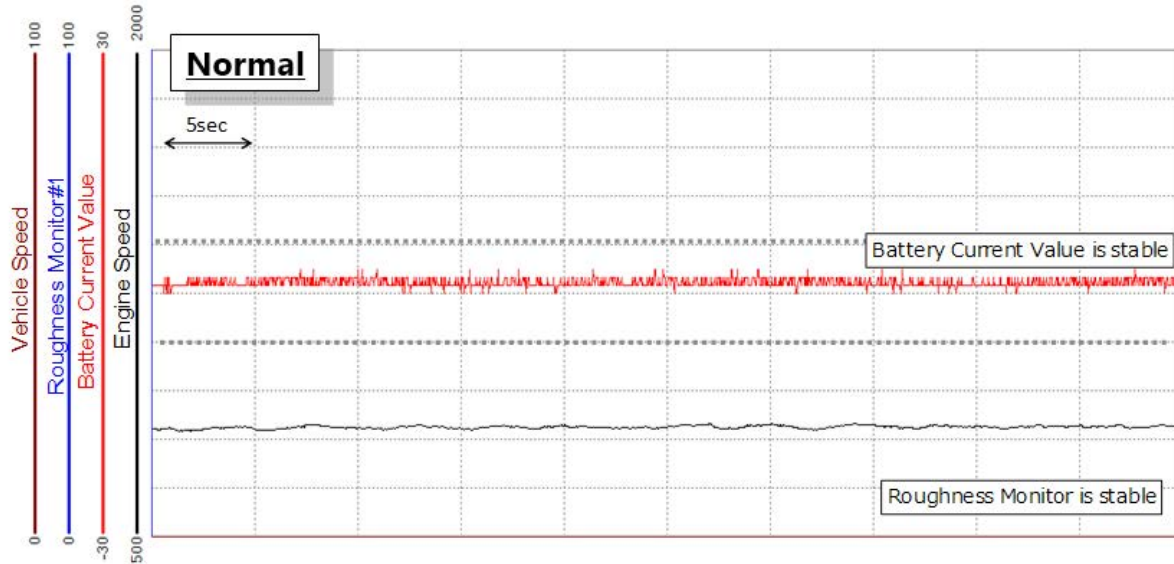
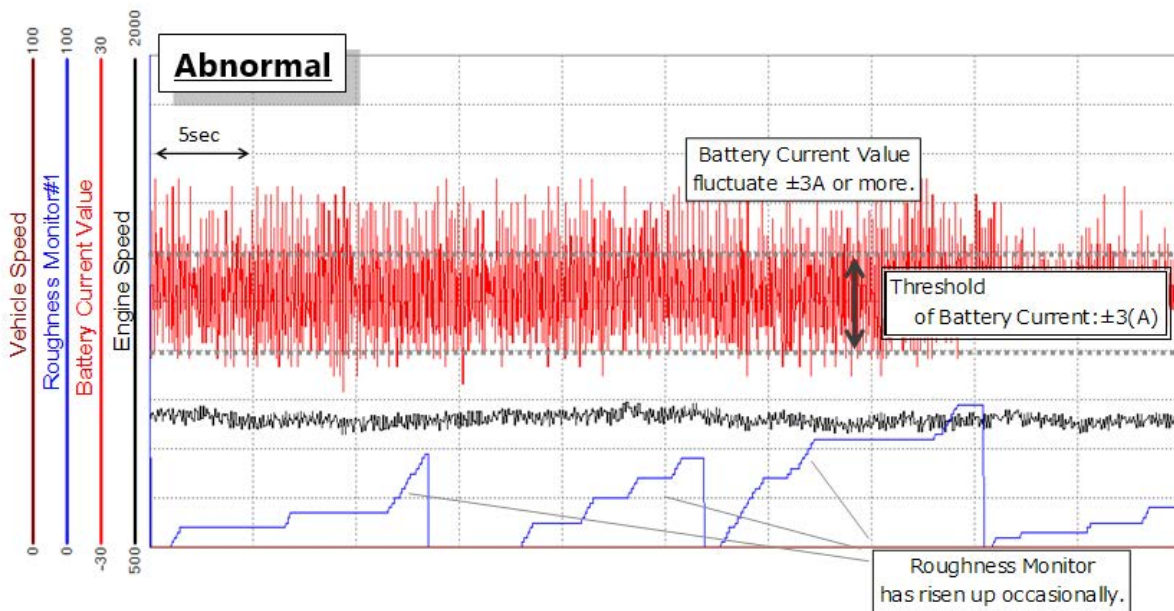
The reference illustrations below show examples of “Normal” and “Abnormal” SSM4 data.

The abnormalities shown above for the Roughness Monitor and Battery Current Value are a result of resonance originating in the alternator pulley assembly. Although a DTC P0300 can also be set, there is not an actual misfire of the engine.

- When determined necessary to replace the alternator and tensioner, follow the service procedures in the applicable Service Manual. Accessory drive belt replacement is **NOT** required as part of this repair.
