Service Bulletin

Bulletin No.: 17-NA-149

Subject: Water Sloshing in Quarter Panel Area When Accelerating or Stopping and/or Long Period of Water Draining from Rear Wheel Well After Vehicle is Parked

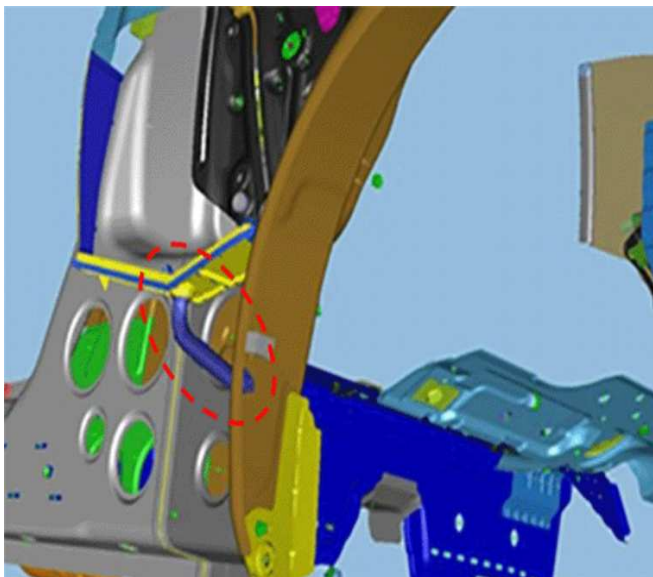
4788754

Note: The drain hose (shown circled above) runs from the quarter window cavity to the wheel well. A blockage or clog could occur at either end of the hose.
