Service Bulletin

Bulletin No.: 18-NA-325

Subject: Infotainment Screen Appears Too Bright at Night

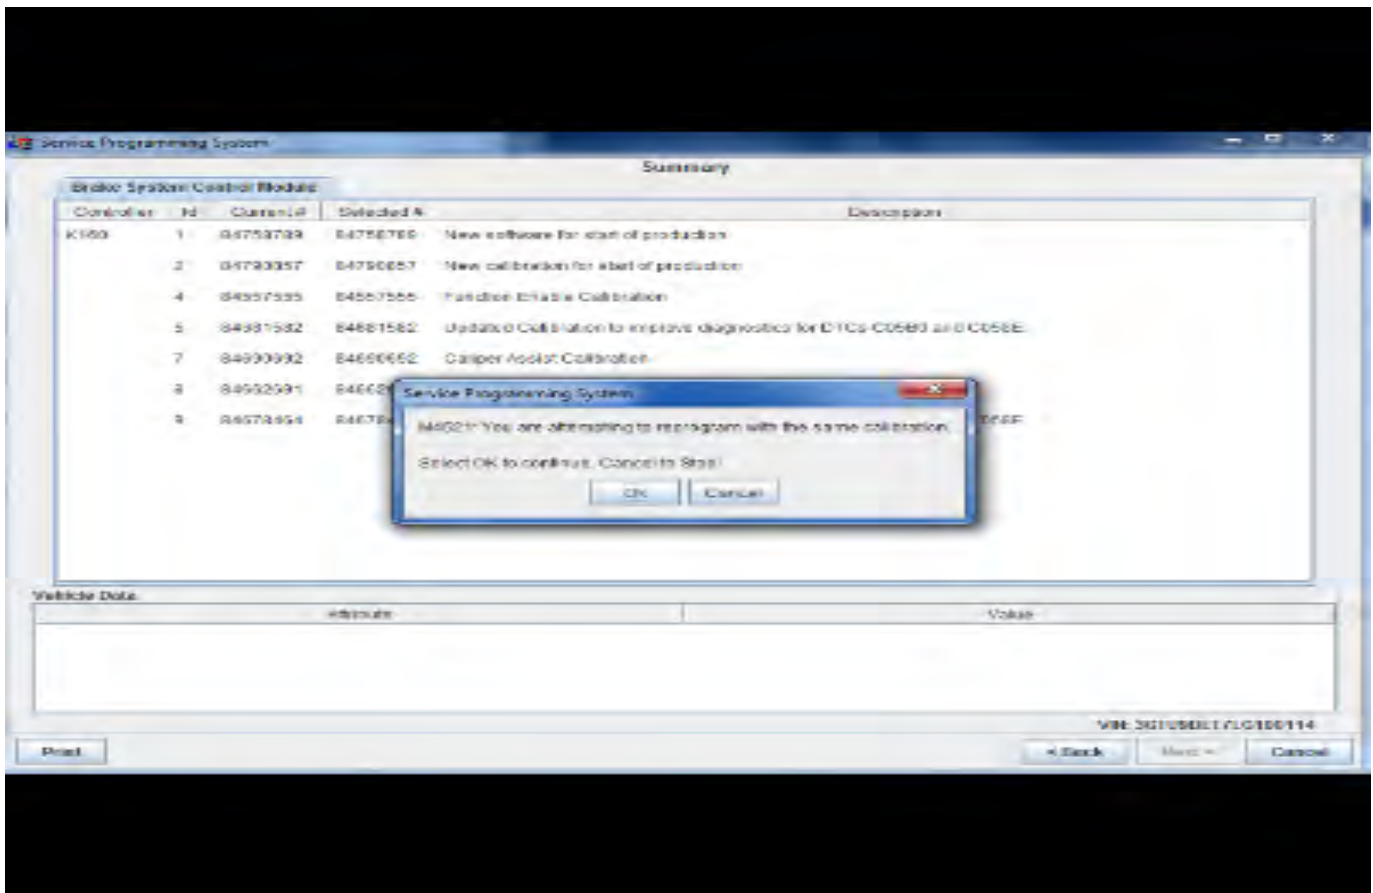
Important: Techline Connect and TIS2WEB screens shown above.

Important: If the Same Calibration/Software Warning is noted on the TLC or SPS Summary screen, select OK and follow on-screen instructions. The system will generate a warranty claim code (WCC) for documentation purposes only. Perform service information (SI) diagnostics to determine the cause of the condition. Use the applicable labor operation code when submitting a warranty claim. Do NOT use the WCC with the warranty claim submission.
