Service Bulletin

Bulletin No.: 20-NA-011

Subject: Voice Recognition Launches or Radio Station Changes to an Adjacent Favorite Without Any Button Press

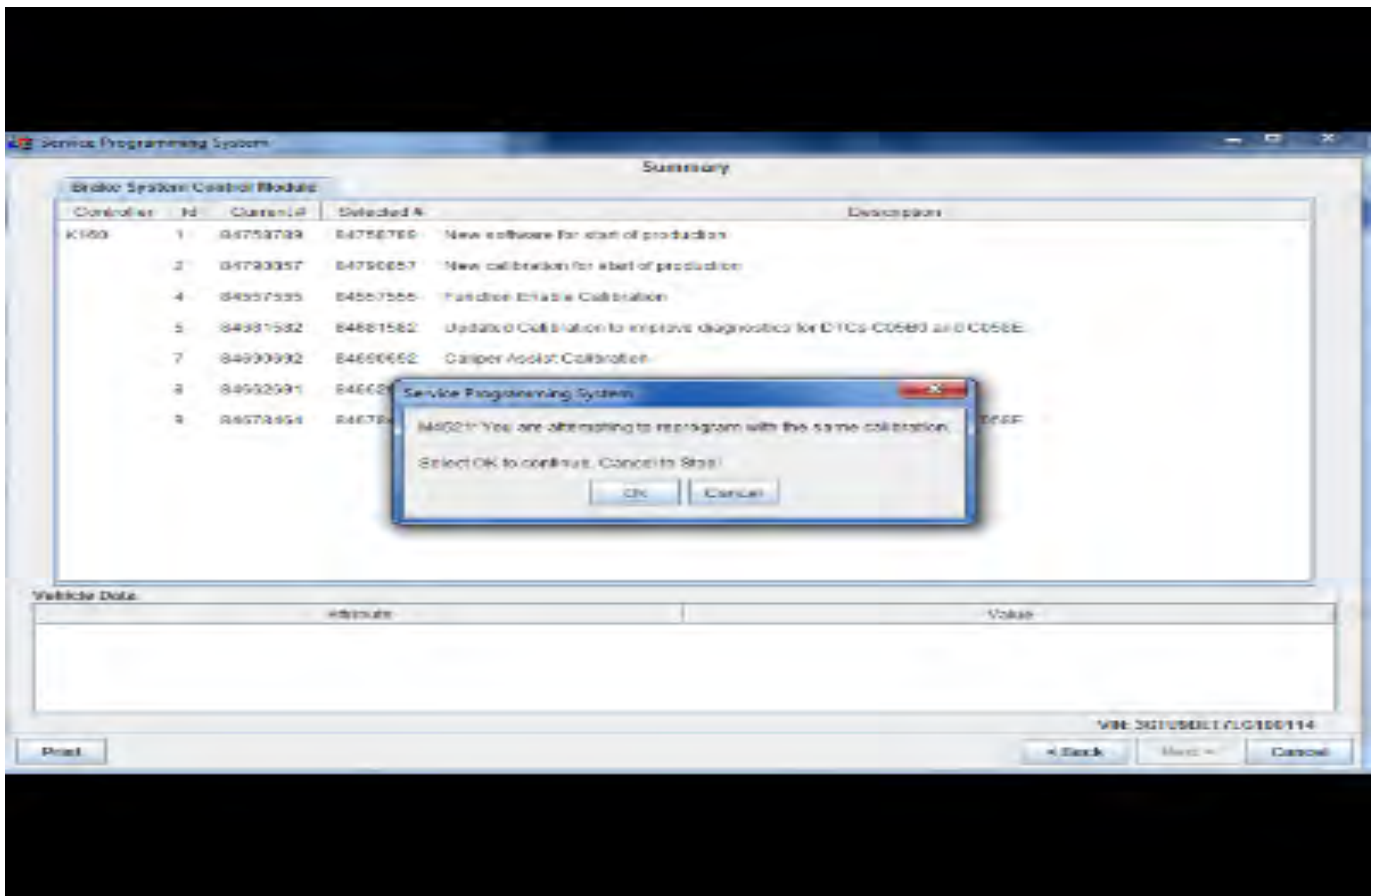
5431207

Important: If the Same Calibration/Software Warning is noted on the TLC or SPS Summary screen, select OK and follow on-screen instructions. The system will generate a warranty claim code (WCC) for documentation purposes only. Perform service information (SI) diagnostics to determine the cause of the condition. Use the applicable labor operation code when submitting a warranty claim. Do NOT use the WCC with the warranty claim submission.
