Service Bulletin

Bulletin No.: 20-NA-209

Subject: Service 4WD Message Illuminated on Driver Information Center (DIC), DTCs C118D, C119B and/or C119C Set

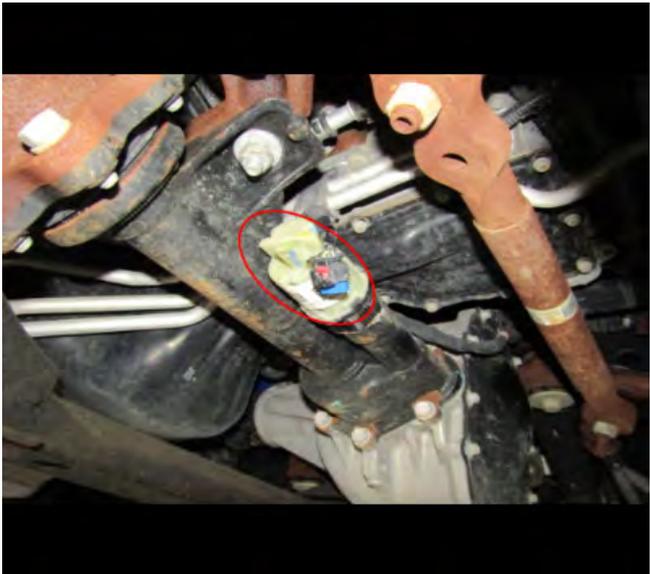
Involved Region or Country	North America, Israel, Saudi Arabia, Chile
Additional Options (RPOs)	
Condition	Some customers may comment on seeing a Service 4WD message illuminated in the DIC, Technicians may find DTCs C118D, C119B and/or C119C Set.
Cause	The cause of the condition may be water intrusion and corrosion within the front differential actuator connector and the electrical harness connector terminals.
Correction	<div style="text-align: right; margin-bottom: 10px;">5660054</div>

<p>Scan for DTCs and verify if C118D, C119B, and / or C119C are present. If any of the listed DTCs are present, inspect the front drive axle actuator electrical connector for signs of moisture, corrosion at the pins, or damage to the actuator housing.</p> <p>Note: Examples of damage to the actuator housing and the harness connector seal, are shown at the start of the Service Procedure below.</p> <p>Also inspect the electrical wire harness connector for any damage to the internal seal or signs of moisture and corrosion. If any of the listed conditions such as moisture, corrosion, or damage are present on either component, replace BOTH the front drive axle actuator and the electrical wiring harness that connects to the actuator.</p>

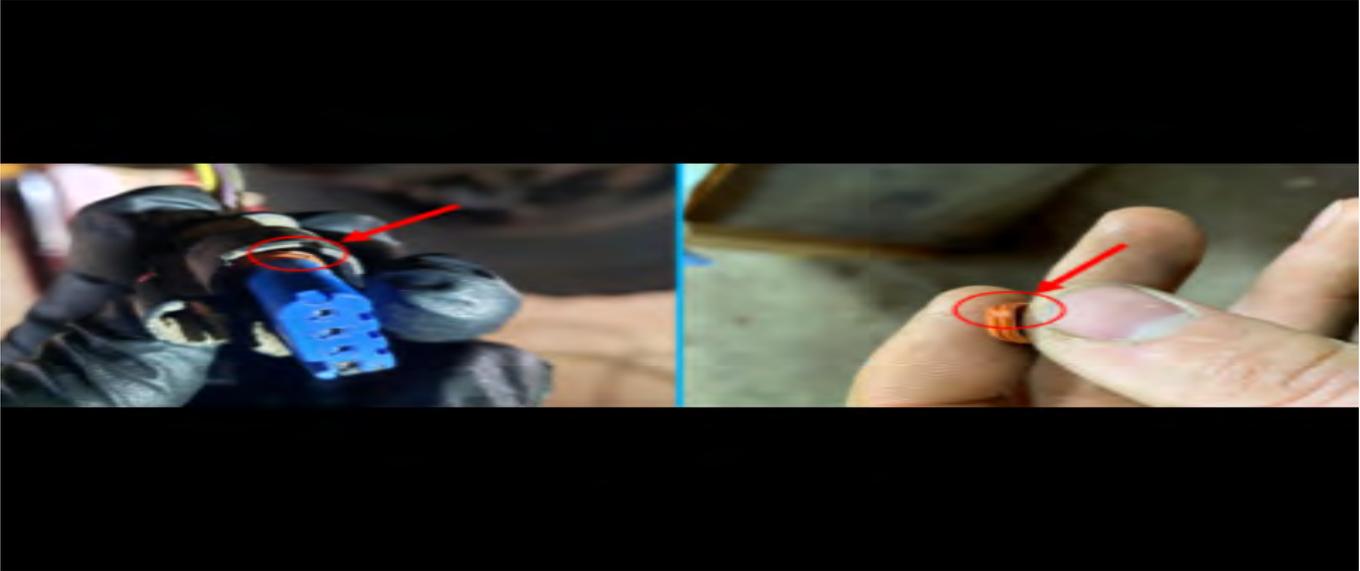
5660055

Electrical Harness Connector Seal Damage

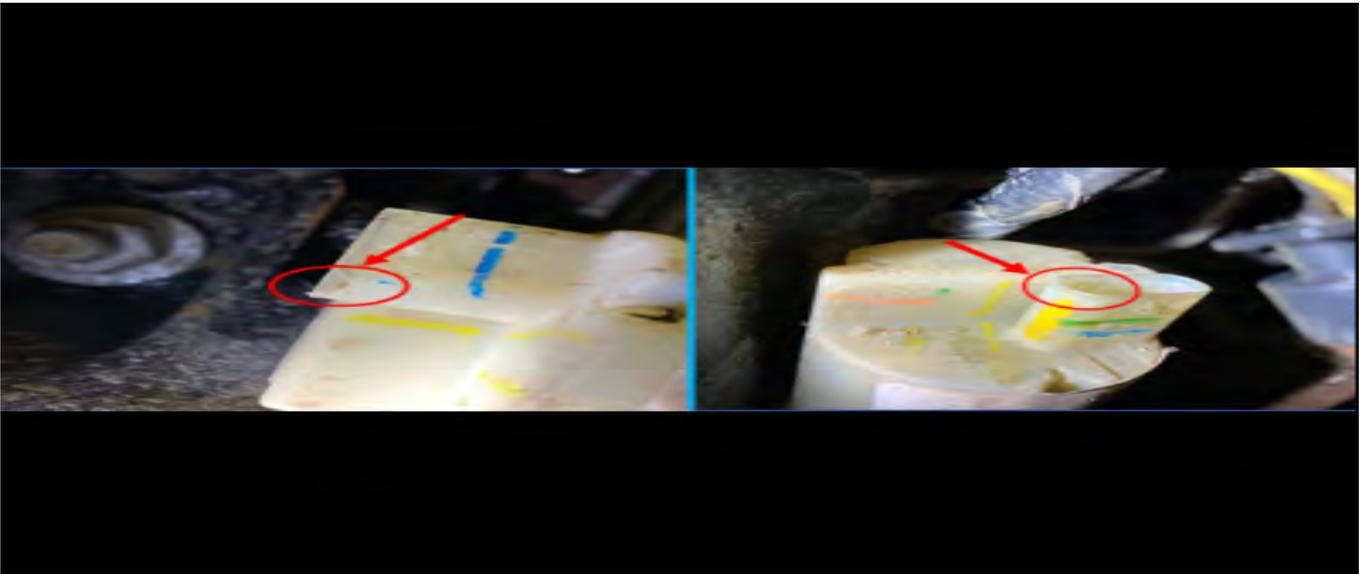
5660056

Front Drive Axle Actuator Housing Damage
