Subject		Market	
<b>MIL on P0AA649 / P1C8049 - Corrosion on MGR Cable</b>		USA	
Service Category		Section	
Engine/Hybrid System		Hybrid/Battery Control System	
Applicability			
2019-2020 RAV4 HV

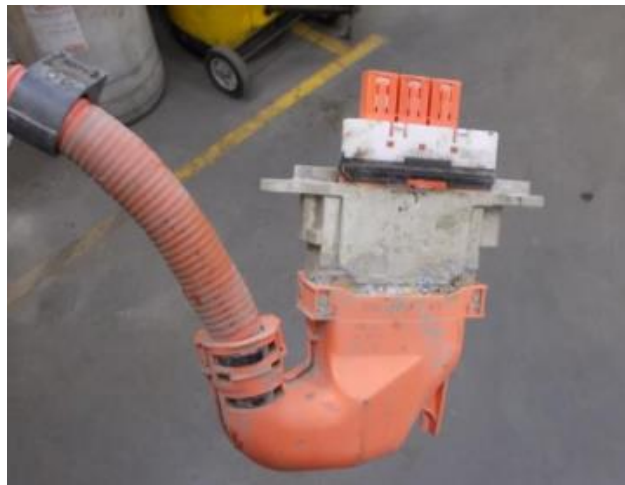
Vehicles exhibiting this condition have been experiencing a short in MGR connector due to corrosion.

Raise the vehicle to visually inspect the high voltage wire harness that connects to the MGR. Unplug and check for corrosion or buildup of dirt and sediment in the connector. See below:

This issue is currently being investigated. Confirm the cable corrosion or dirt build-up at the MGR connector and call TAS for further instruction. If it is a weekend or holiday, continue with diagnosis and repair. Please save all parts and/or details and contact TAS on the next available workday.
