GROUP	MODEL		
	CHA	All Applicable Models with C-MDPS		
	NUMBER	DATE		
	084 (Rev 5, 11/04/2020)	November 2018		
TECHNICAL SERVICE BULLETIN				
SUBJECT: PARTIAL REPAIR OF C-MDPS MOTOR, ECU, WORM GEAR				
AND/OR STEERING COLUMN HOUSING				
		1

This bulletin provides information regarding the partial repair of the Motor Driven Power Steering (MDPS) Motor, Electronic Control Unit (ECU), Worm Gear Assembly or Steering Column Housing on some 2010MY~ Kia models listed on page 8, equipped with a Column Motor Driven Power Steering (C-MDPS) unit. Follow the MDPS Flowchart (page 2) along with the MDPS DTC Table (page 3) procedure outlined in this bulletin before replacing the <u>C-MDPS Motor, ECU, Worm Gear Assembly or Steering Column Housing</u>.

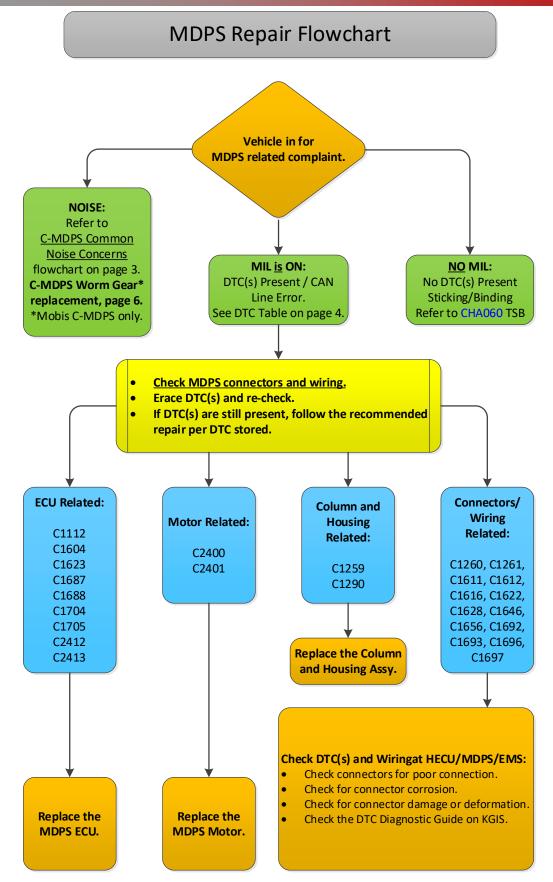
- MDPS Repair Flowchart and Common Noise Flowchart are meant to be used as a reference guide only. See MDPS DTC table for more details.
- Note that some DTC(s) may be found in systems other than Electric Power Steering (EPS) in KDS. They may be found in the Brake/ABS/ESC system. Check all systems for DTC(s).
- Replacing the complete C-MDPS <u>Steering Column Assembly</u> is NOT allowed when the components failure is identified in the flowchart. In addition, replacing the <u>Steering</u> <u>Column Housing</u> is NOT allowed when the problem source is the C-MDPS Worm Gear Assembly (for applicable models).
