TECHNICAL SERVICE BULLETIN

Exterior Rearview Mirror Replacement Wiring Information

20-2386
09 November 2020

Lincoln 2013-2020 MKZ

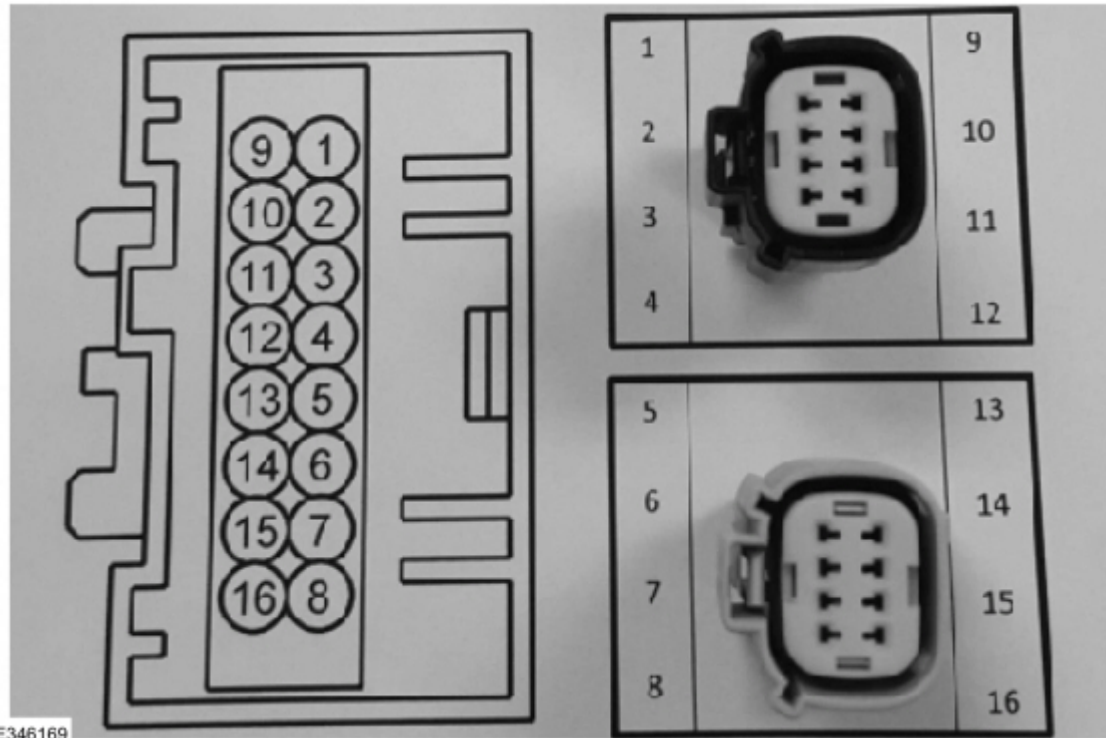
Figure 1

Issue: Some 2013-2020 MKZ vehicles may need the exterior rear view mirror replaced. The replacement exterior mirror will have different wiring than the original exterior rear view mirror. Follow the Service Procedure steps below to modify the vehicle-side wiring harness to accept the replacement exterior rear view mirror wiring.

1. Remove the affected exterior rear view mirror. Refer to Workshop Manual (WSM), Section 501-09.
2. Remove the original 16-pin door harness mirror connector. To remove the connector, follow the wiring repair kit instructions included with the pigtail kit (Figure 1) and cut the wires 13 mm (1/2 inch) from the connector and splice to the 8-pin gray and 8-pin black female connector pigtails.
 - (1). To gain enough access to perform the splices, pull the harness connector through the wire harness grommet hole below the access hole for the mirror bolts.
 - (2). Using a small flat head screwdriver, remove the white christmas tree body-to-connector retainer from the original connector and install it on the replacement gray female connector.
 - (3). Tape the female connectors together using electrical or foam tape.
