2014~2016MY Soul (PS)  
2014~2016MY Sorento (XMa)  
2014~2016MY Optima (TF/QF)  
2014~2016MY Forte (YD)  
2014~2016MY Sportage (SL)

100 (REV 2, 04/21/2016)

## TECHNICAL SERVICE BULLETIN

SUBJECT: COMBINATION TSB / SERVICE ACTION: UVO SYSTEM  
UPGRADE (SA 222)

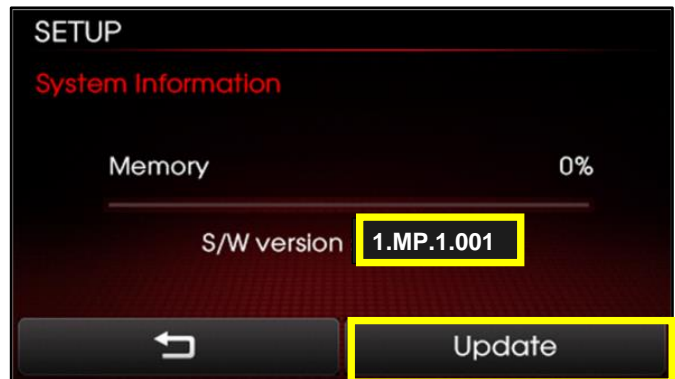
1. Start the vehicle or connect the Midtronics GR8-1299 charger.
2. Record the customer's radio presets before performing the upgrade.
3. Press **SETUP > System > System Information** and check to ensure the software version is at or above the level shown in the table below.

Original Software Version
1.MP.1.001 (or higher)

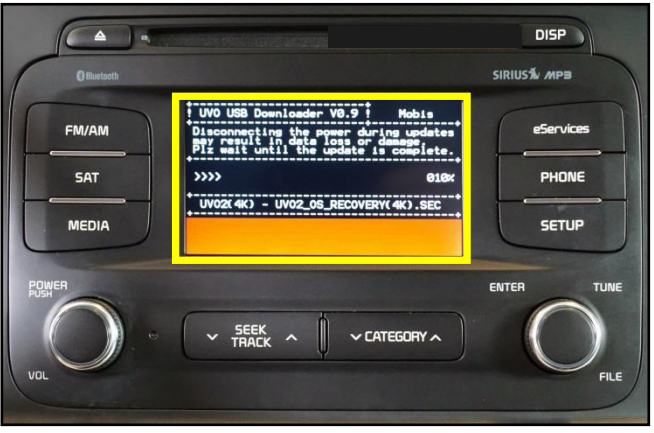
- The head unit will enter the UVO USB Downloader mode and begin downloading the upgrade from the USB stick or AUM.

**\* NOTICE**  
 If the **USB Downloader** fails to download the upgrade, press the **Reset** button and restart the procedure from step 3 or 4. If the upgrade download continues to fail, refer to the **Troubleshooting Matrix** on Page 8.

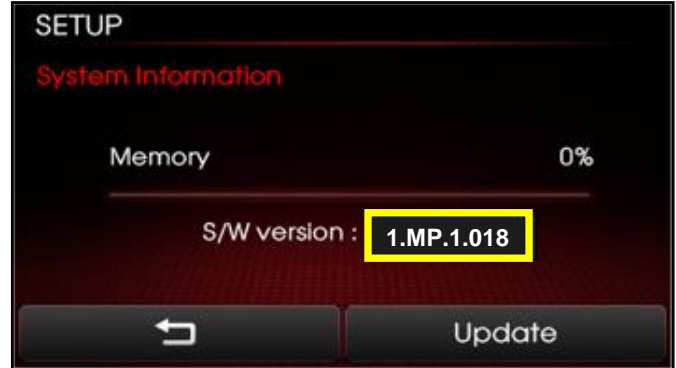
15. Check to ensure the new software version matches the information in the table below.

Original Software Version
1.MP.1.018
