Technical product information

Topic	Rear tail lamp flashes - After opening an exterior door - With the vehicle unlocked
Market area	Bentley: worldwide (2WBE)
Brand	Bentley
Transaction No.	2060895/1
Level	EH
Status	Approval
Release date

Bentayga

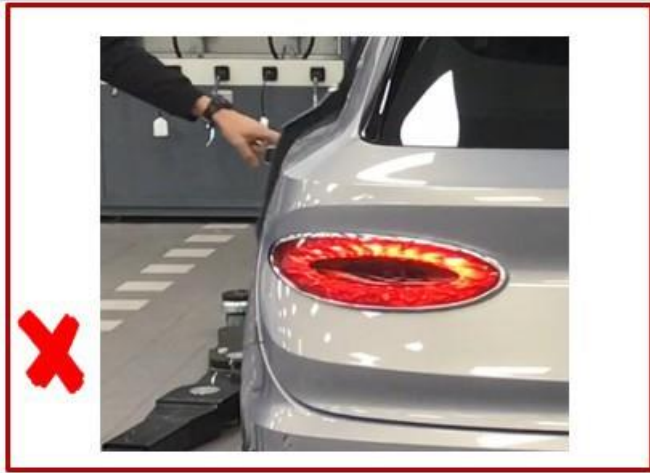
Figure 1

When a door is opened with the vehicle unlocked, the boot lamps flash once (Figure 1)

Should the car go into bus silence with the car unlocked, on door opening, there is a <math><100\text{ms}</math> flash of the rear lamps.

Due to BCM2 supplying power to the rear lamp immediately, there is a delay in establishing communication, which causes the tailgate lamp to activate for <math><100\text{ms}</math>.

A software fix for this issue adds a 1 second delay upon power being supplied to the lamp

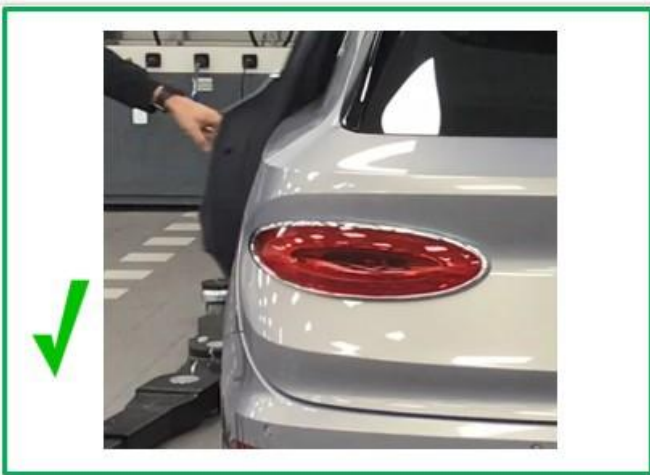
Figure 2 shows the correct operation (No flash)
