48-20-01 - Electromechanical Power Steering - Creaking Noise when Turning

Release date: 11/23/2020

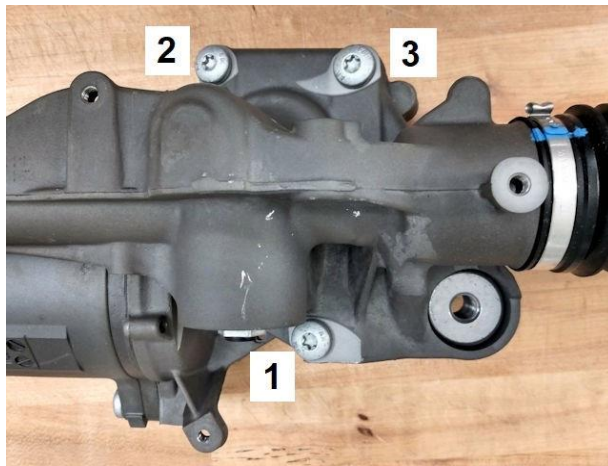
Figure 2

Noise resulting from tension between the servo motor unit and the steering gear housing.

- Remove the T30 Torx screws holding the heat shield in place and remove it from the steering gear.
- Note the position of the servo motor unit within the steering gear housing.
- Following the sequence 1, 2, and 3 shown (Figure 2) loosen the three T40 Torx screws about half a turn to relieve tension in the servo motor unit.

- Return the servo motor unit to its starting position.
- Tighten the three T40 Torx screws in sequence 1, 2 and 3 (Figures 2, 4, 5 and 6) with a torque of **10 Nm**.

- Retighten the three T40 Torx screws in sequence 1, 2 and 3 (Figures 2, 4, 5 and 6) with a turning angle of **65°**.
- Verify the final torque of the three T40 Torx screws in sequence 1, 2, and 3 (Figures 2, 4, 5 and 6) using a torque value of **25 Nm** while checking that no more than **10°** of additional turn is applied.

If a torque of **25 Nm** is not reached with no more than **10°** of additional turn (max. total turn **75°**), then the steering gear must be replaced! Worn or damaged threads are non-repairable.
