SERVICE BULLETIN

APPLICABILITY: 2020MY Legacy and Outback Models **NUMBER:** 15-261-20R
SUBJECT: Reprogramming File Availability for Optimization of Gen 4 Denso CP1 Infotainment Systems **DATE:** 03/10/20
REVISED: 11/20/20

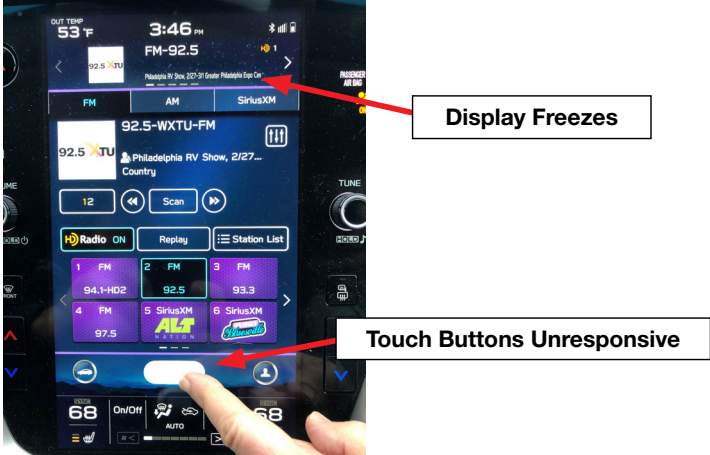
Symptom #	Description of Symptom:
1	<p>The CP1 display and/or center Combination Meter display freezes. No response from touch screen or voice guidance. After switching the ignition off and opening the driver’s door, the system does not recover**.</p> <div style="text-align: center;">

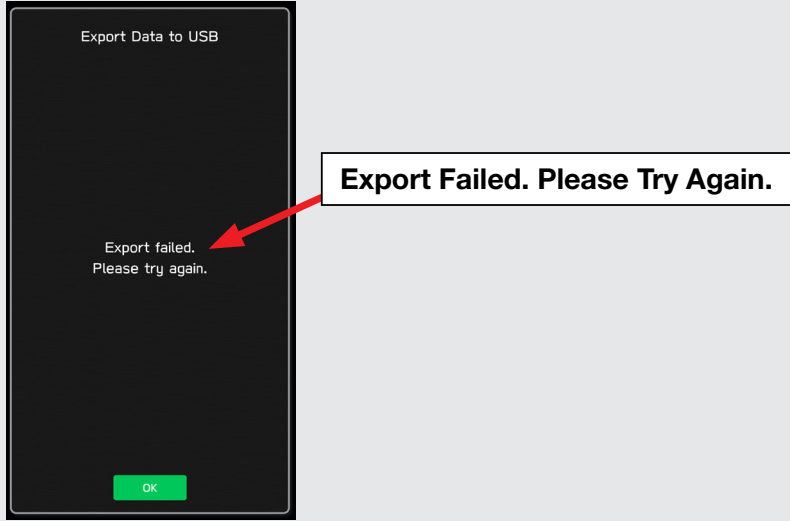
Symptom #	Description of Symptom:
4	<p>Diagnostics Recorder Data cannot be exported to the USB memory device. When the diagnostic log data is being downloaded (by selecting: Dealership Menu > Diagnostics Recorder > Export Data to USB), it fails after the progress bar reaches almost 90% with an error message of Export failed. Please try again.</p>

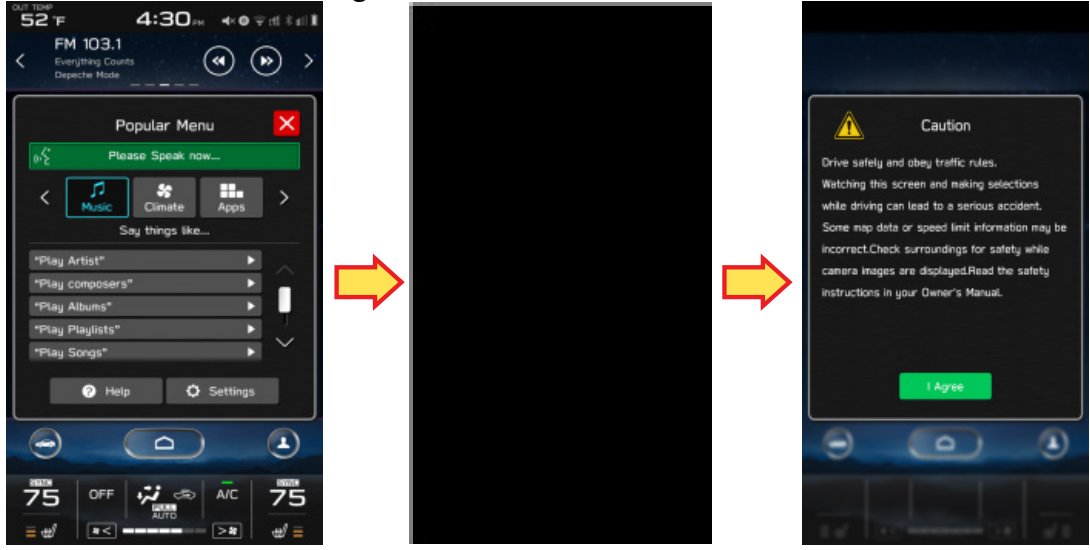
5	<p>When using Voice Recognition to search for a 'Nearby POI' (Point of Interest) in Canada with FRENCH language selected, the CP1 display turns black and displays a Caution / disclaimer message.</p>

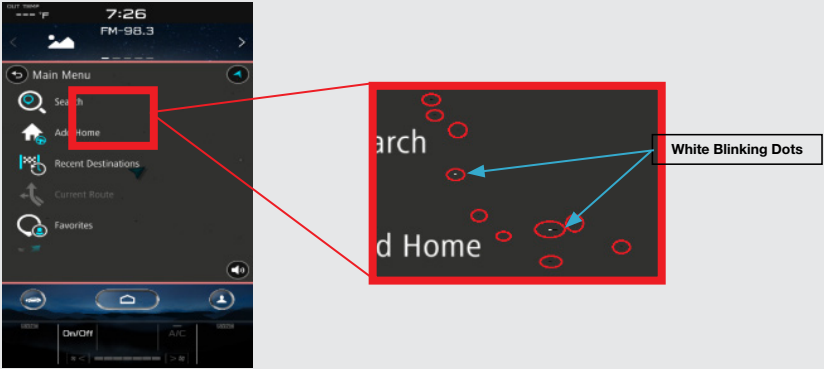
Symptom #	Description of Symptom:
1	Several minutes after Engine start, the Center Information Display (CID) reboots.
2	<p>After an extended period of usage, some white blinking dots appear on the display.</p>

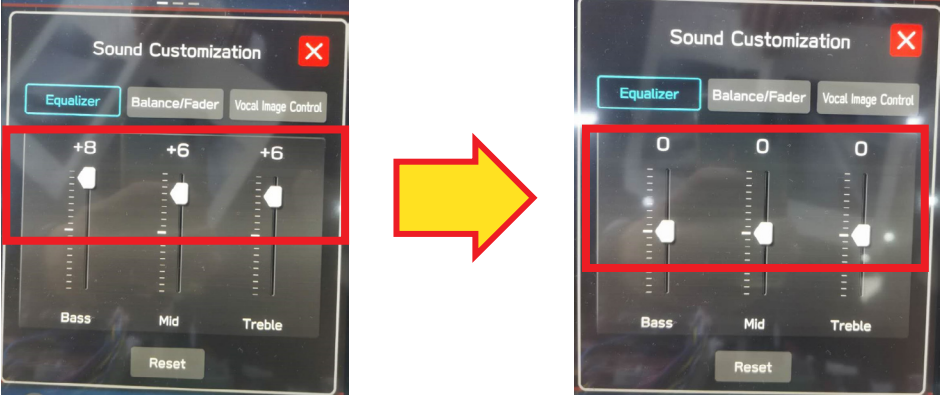
7	<p>Customer-selected Equalizer settings are lost. Equalizer returns to the default settings after ignition switch is turned OFF and back ON.</p>

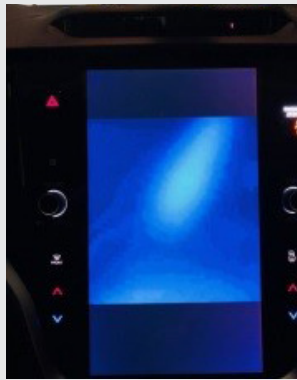
Symptom #	Description of Symptom:
9	In a case where the system was shut down while the Navigation map screen was being displayed, the display goes blank (black screen) soon after the Disclaimer screen is displayed after restarting.
10	CID reboots repeatedly after setting a destination using the Navigation system.
11	CID reboots while using the Pandora application via CarPlay.
12	Bluetooth connection cannot be reestablished when using certain smart phones. When using Android Auto on certain smartphones, a Bluetooth connection cannot be reestablished automatically once it has been disconnected.
13	CarPlay connection cannot be established. When connecting an iPhone via USB, "CarPlay Unavailable" is displayed and CarPlay does work.
14	The HOME screen goes blank. When the screen is switched from Camera mode to HOME, no icons are displayed as shown below.
