QUALITY ACTION

CAMPAIGN BULLETIN

Final All Wheel Drive Clutch Break-In

Reference: POA33
Date: November 24, 2020

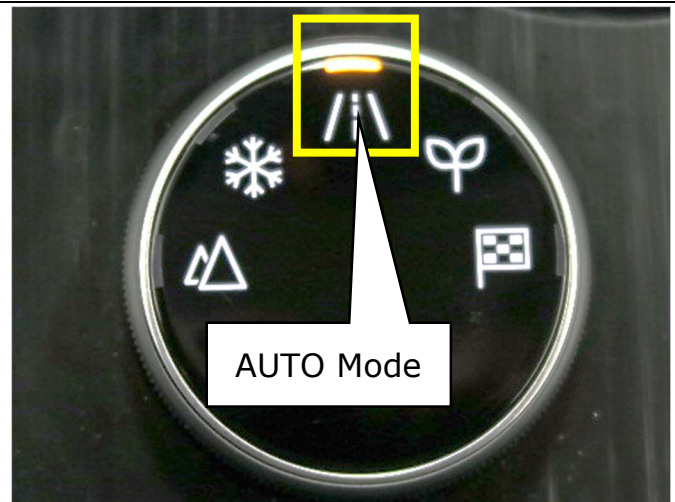
Figure 1

3. Verify the AWD selector is in AUTO mode. (Figure 1)
