December 4, 2020

Version 5

## MIL Comes On with DTC P0716

Supersedes 19-003, dated October 15, 2020; to revise the information highlighted in **yellow**.

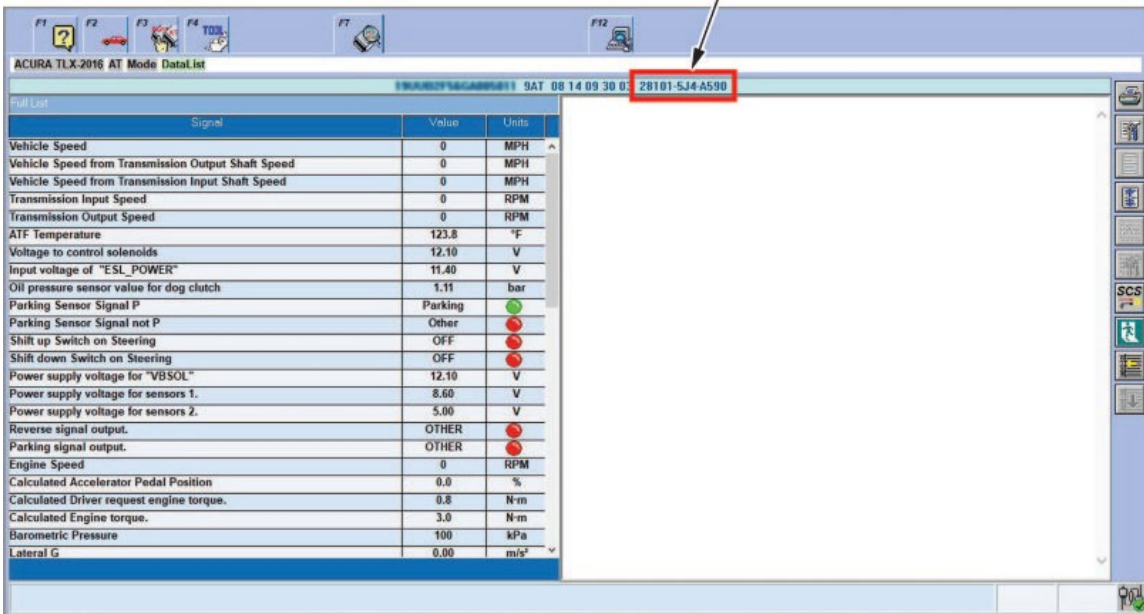
PROGRAM ID

1. Turn the ignition to ON.
2. Connect the i-HDS, and go to the **A/T Data List**. Check if the software has been updated by comparing the Program ID with the table in SOFTWARE INFORMATION.

- If the Program ID shown matches the table, the vehicle has been updated and this service bulletin does not apply. Continue with normal system troubleshooting.
- If the Program ID shown does not match the table, the vehicle has not been updated. Go to step 3.

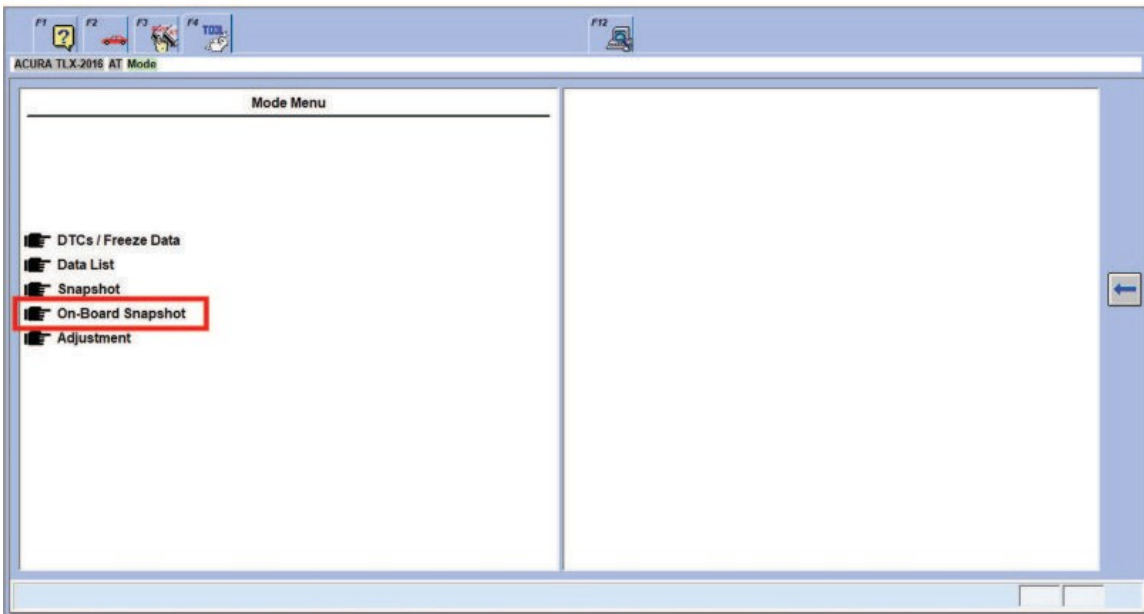
3. Select **Mode Menu**, then **On-Board Snapshot**.

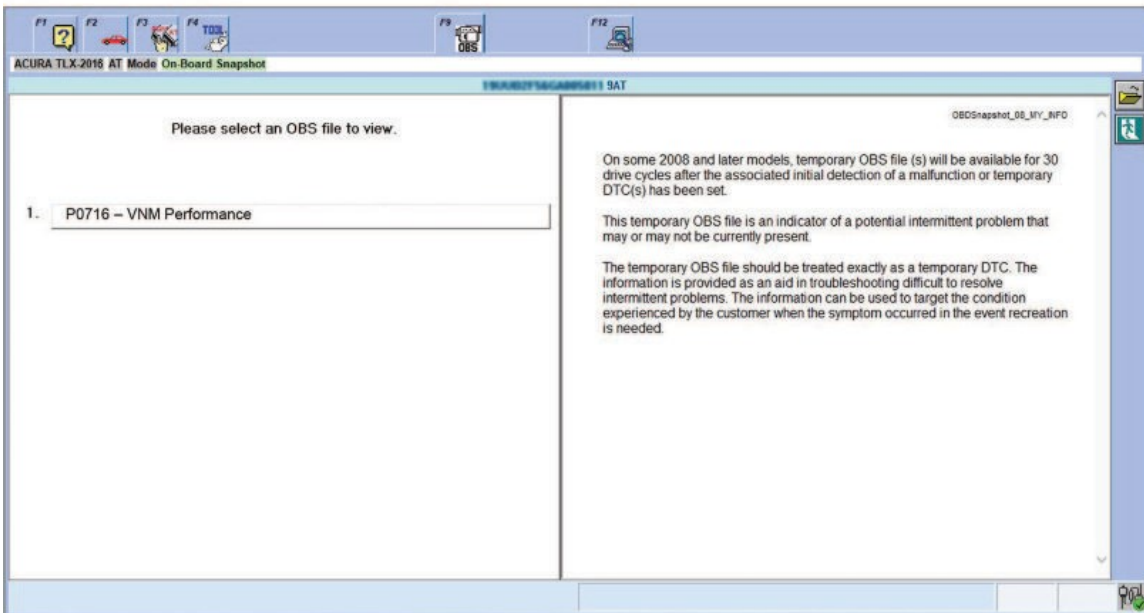
4. Select and view all available on-board snapshots for Automatic Transmission (EAT).

- If no on-board snapshots show P0716, this service bulletin does not apply. Continue with normal system troubleshooting.

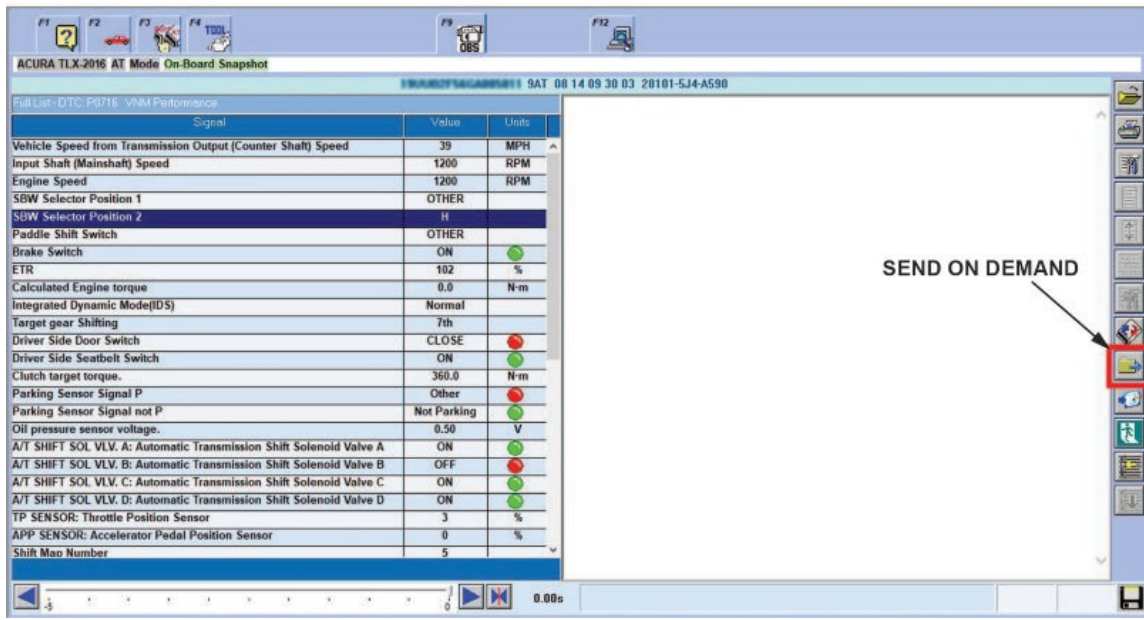
- If an on-board snapshot shows P0716, select **Send On Demand** to e-mail it to Tech Line, then go to step 5.

5. Update the TCM software using the i-HDS J2534 Rewrite software with the MVCI or DST-i. Refer to service bulletin 01-026, *Updating Control Units/Modules*.
