REQUIRED SPECIAL TOOL

SERVICE PROCEDURE

Update AV Control Unit

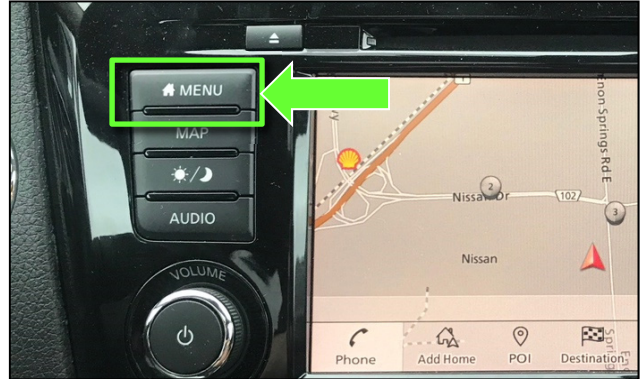
Figure 2

1. Push the **MENU** button.

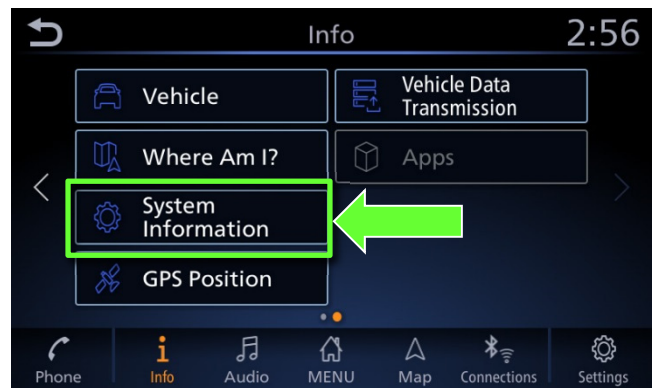
Figure 4

3. Select **System Information** to access the vehicle update menu.

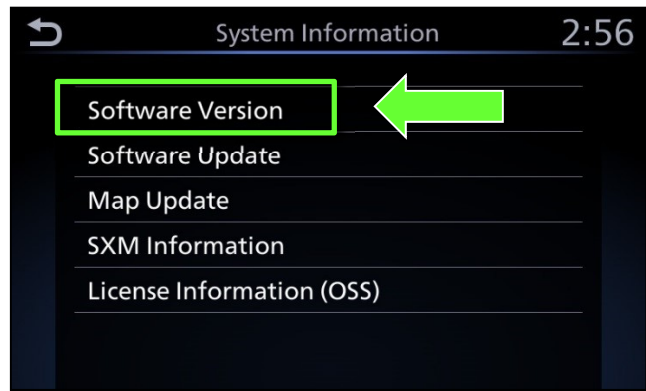
Figure 5

4. Select **Software Version**.

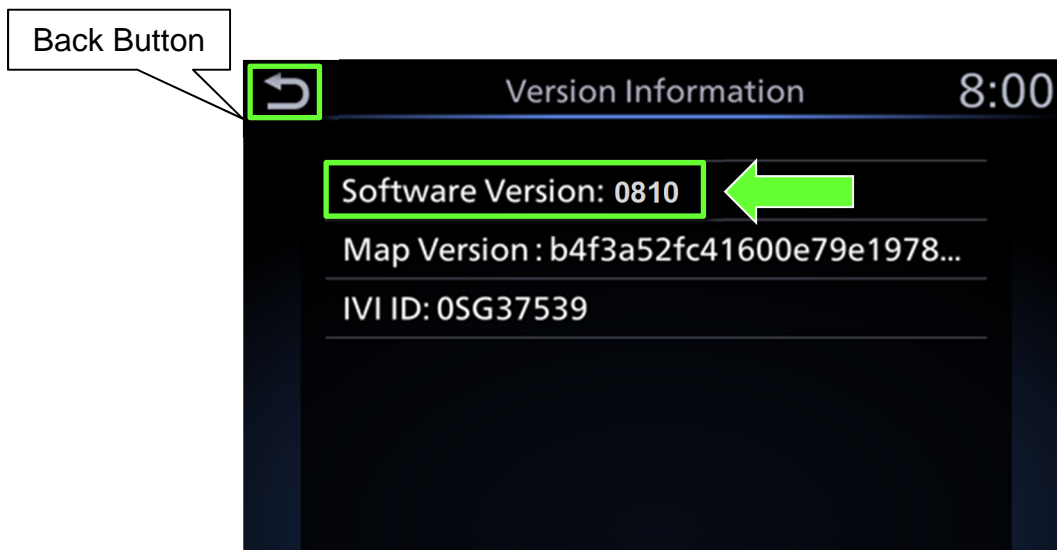
Figure 6

- If the Software version is NOT **0810** or higher, select the back button and continue to step 5 on the next page.
- If the Software version is **0810** or higher, select the back button, this bulletin does not apply.

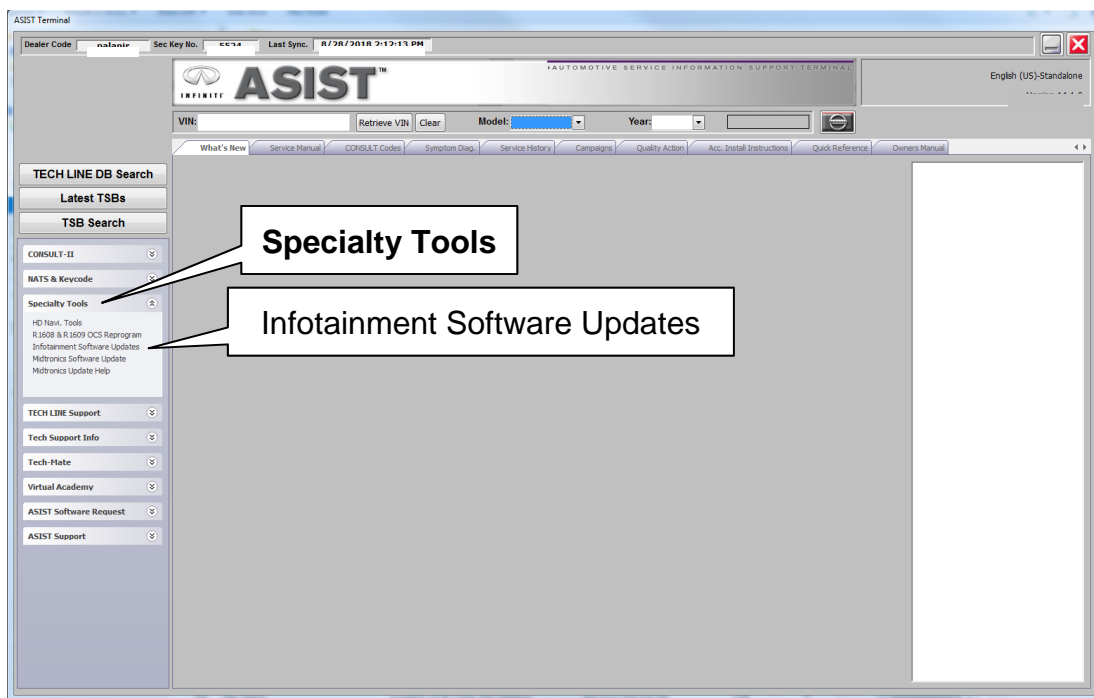
Figure 7

7. Select **Specialty Tools**, and then select **Infotainment Software Updates**.

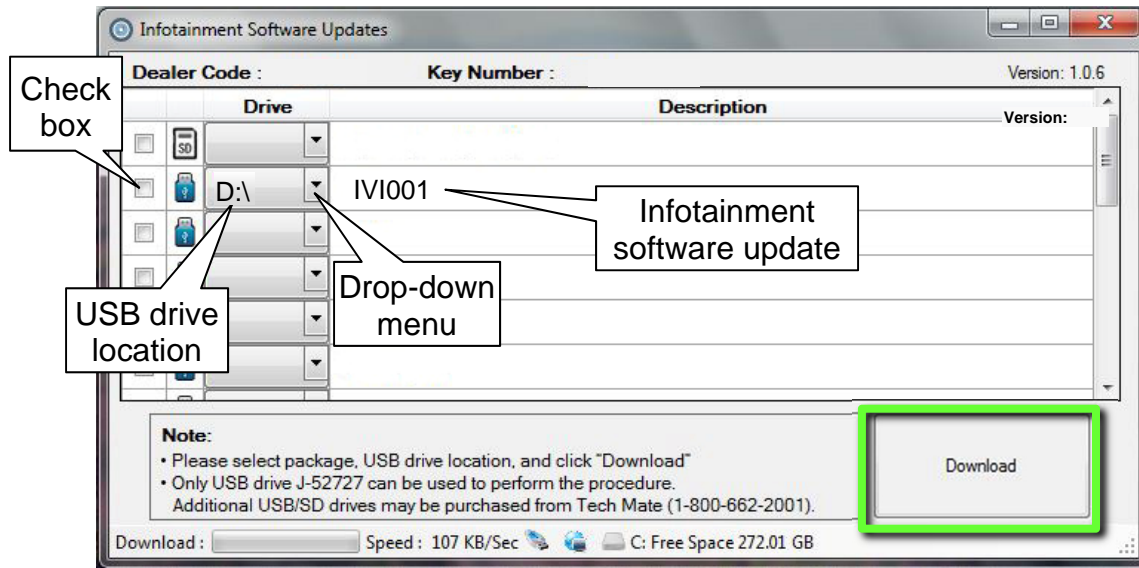
Figure 8

8. Select the check box next to the **IVI001** infotainment update-software (Figure 8).
9. Use the drop-down menu and select the location of the USB drive that was inserted into the ASIST Station in step 5.

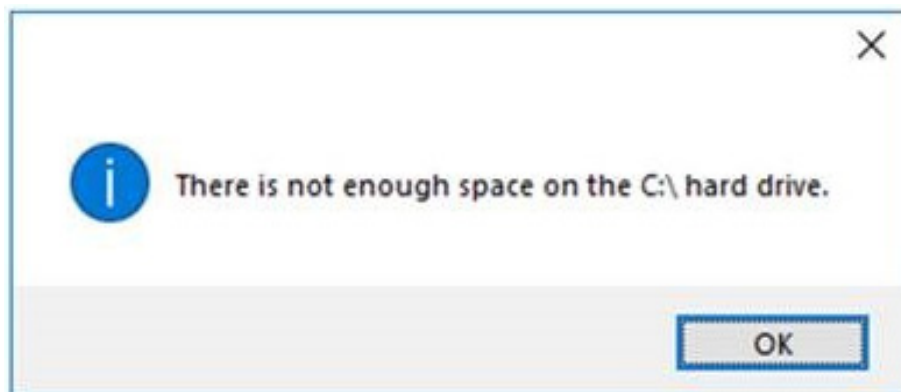
Figure 9

- The update-software is estimated to take **4 hours** to download to the USB drive.
 - If, while attempting to download the software to the ASIST Station, you receive the message show in Figure 9:
 - a. First, attempt to clear space on the ASIST Station hard drive.
 - b. If space on the hard drive cannot be cleared, email Bosch at nissan.dealers@us.bosch.com for additional options.

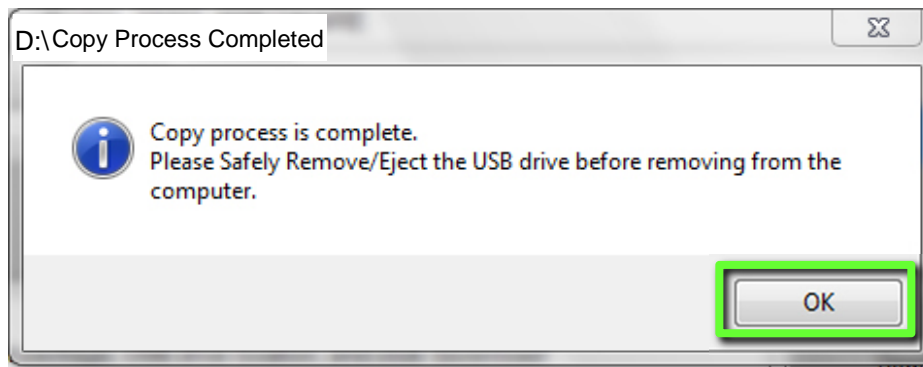
Figure 10

11. Select **OK**.

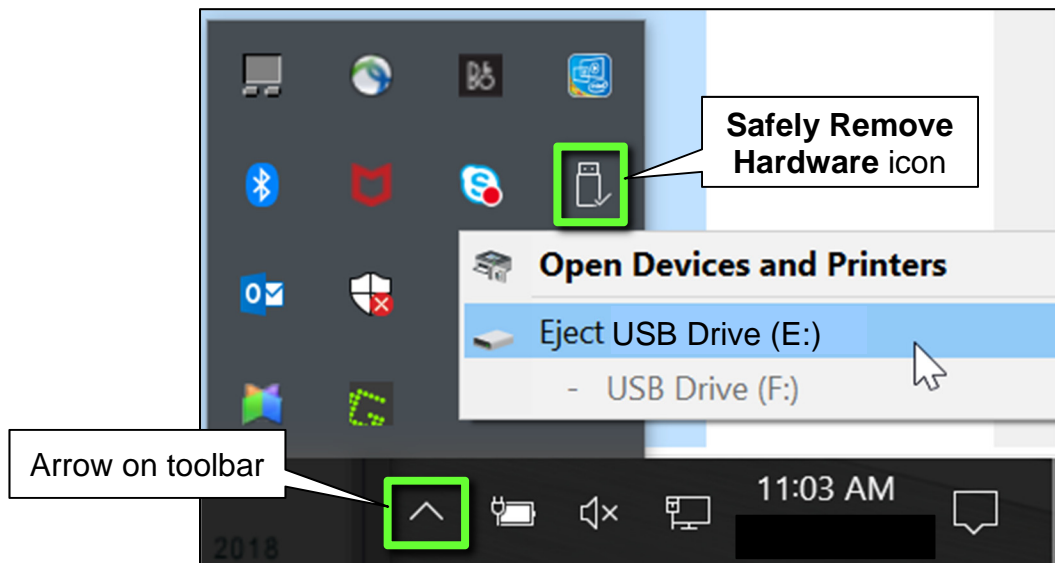
Figure 11

- a. From the PC toolbar, select the **Safely Remove Hardware** icon.
 - The icon is on the toolbar, or can be found after selecting the arrow.
- b. Select the USB drive to be removed, and then remove the USB drive from the ASIST Station.

NOTICE Follow the steps to safely remove the USB drive. If not followed, the USB drive may corrupt the infotainment update-software.

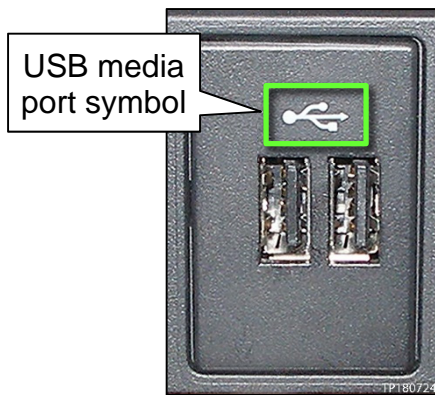
Figure 12

16. Insert the USB drive with infotainment update-software into the vehicle's USB media port (see Figure 12).

NOTICE Do not insert the USB drive into a charging port. If used, the update-software and/or USB drive may become damaged. Only insert the USB drive in a USB media port.

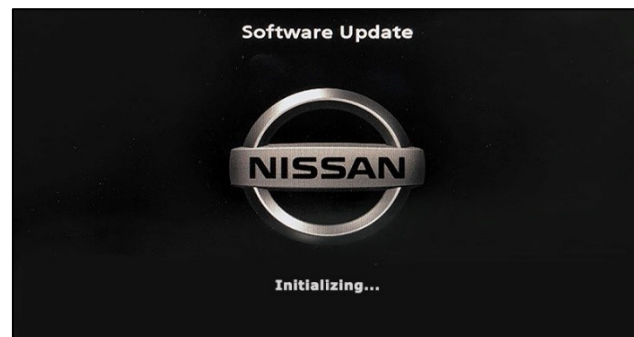
17. Wait approximately 10-30 seconds for the screen in Figure 14 to appear.

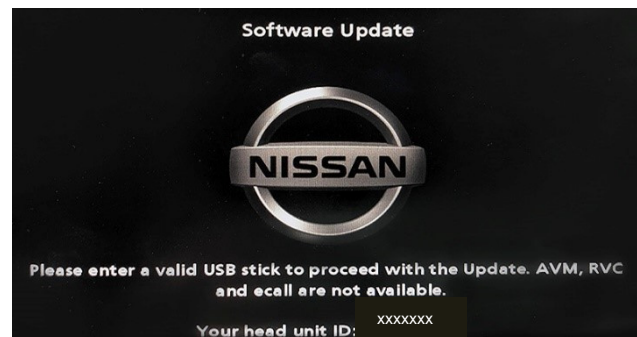
- The screen in Figure 15 may briefly appear. **Do not remove the USB drive.** The audio system will detect the USB drive and continue the update.

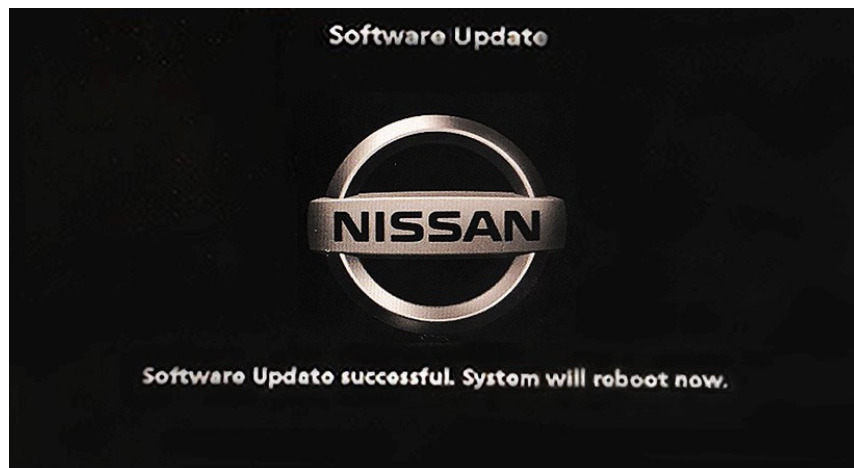
Figure 17

19. Once the update is complete (Figure 17), remove the USB drive; the system will reboot (restart).

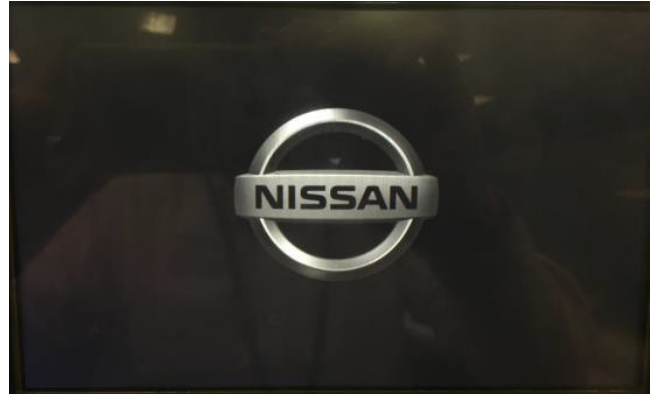
Figure 18

20. Allow the reboot to complete (approximately 30 seconds).
 - The Nissan logo will be displayed during the reboot.

24. Turn the ignition ON (engine OFF) and wait for the Nissan logo to appear (Figure 18).
 - If the Nissan logo does not appear (this might take up to 30 seconds), start over from Step 21.

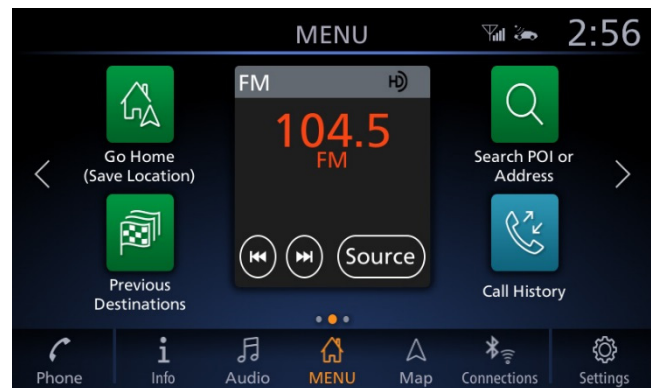
25. After the Nissan logo appears, wait about one (1) minute.
 - The MENU (Home) screen in Figure 19 will be displayed.
