# Maserati Technical Bulletin

Date: July 12th, 2016  
Bulletin No. MAS000883 – Service Campaign  
#268 Dome Reinforcement Plates Installation  
Supersedes: NA  
Section: Suspension

**MODEL: Maserati Quattroporte (M156) and Ghibli (M157)**

**SUBJECT: Dome Reinforcement Plates Installation (Service Campaign 268)**

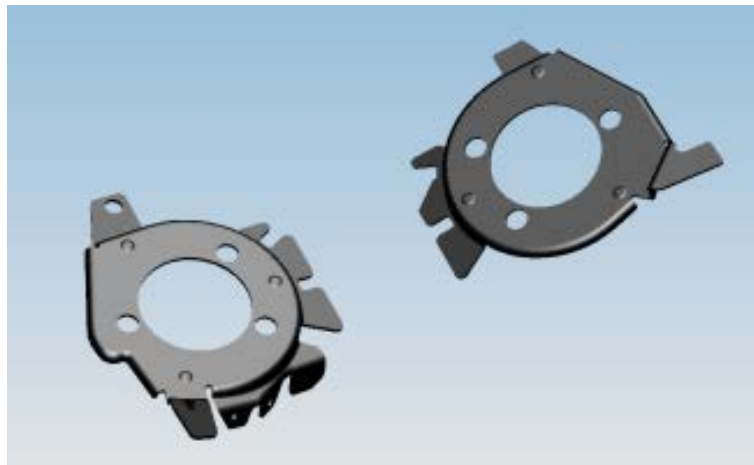
Some Maserati Quattroporte (M156) and Ghibli (M157) vehicles are involved in a Service Campaign to install Dome (strut tower) Reinforcement Plates (see figure below) because of possible deformation to the dome. Aggressive and extreme driving on rough roads, pot holes and speed bumps can lead to a degree of fatigue on the strut towers. This may cause the front end wheel alignment to shift out of the desired specification. Continued driving under these conditions may cause the strut towers to deform.

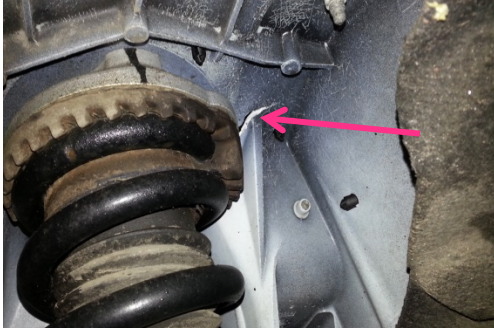
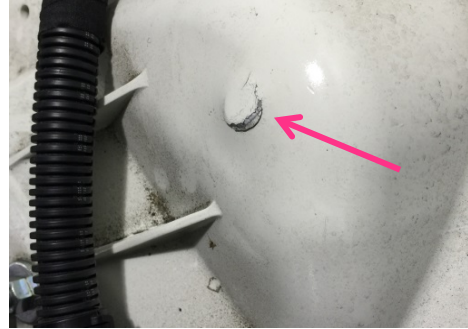
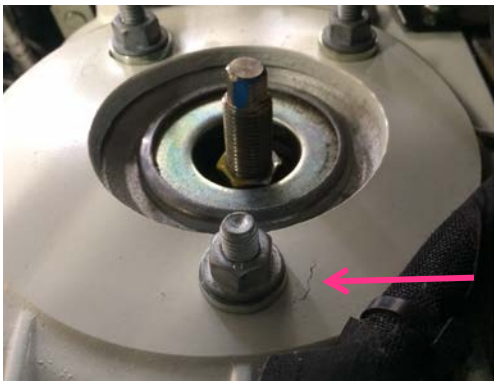
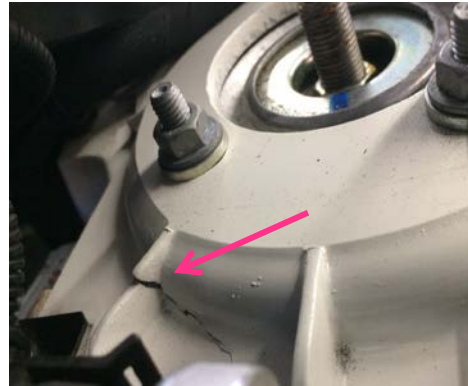
2. Open the hood and visually inspect the strut tower (dome) on both sides of the car for any cracks or denting. If no cracks or denting is found, continue with step 3. If any cracks or denting of the strut tower dome is found (Fig's. 2, 3, 4 and 5 as examples) open a BOL, attach clear pictures then follow the instructions you will receive in response to the BOL.

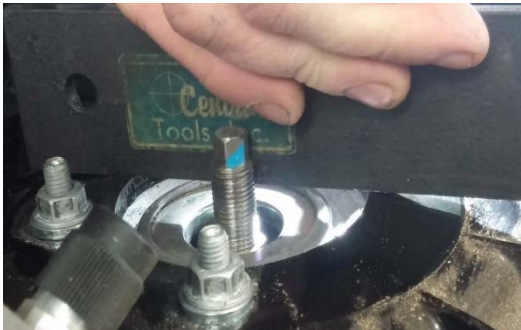
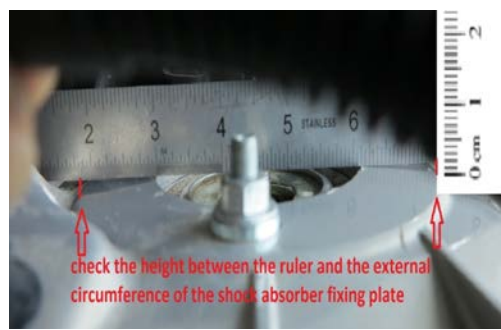
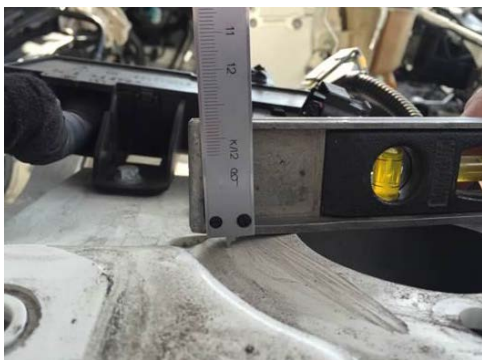
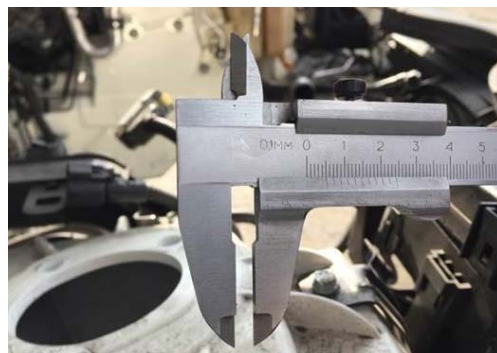
3. Inspect the strut tower dome to see if it's deformed by placing a straight edge across the top as shown in Figs. 6 tru 9.

4. If any deformation of the dome can be seen using the straight edge, measure it by checking the gap on the outer portion of the dome as shown in Fig.6 and Fig.7.
5. Check for the gap at several different points along the radius of both domes.
  - If no gap is present or it is less than 1mm, proceed with the reinforcement plate installation Procedure "A".
  - If a gap is more than 1mm but less than 5 mm's is measured, proceed with re-shaping of the dome Procedure "B1" if only one dome is affected or "B2" if both domes are affected.
  - If at any point a gap of 5 mm's or larger is measured in any dome, open a BOL, attach clear pictures then follow the instructions you will receive in response to the BOL.

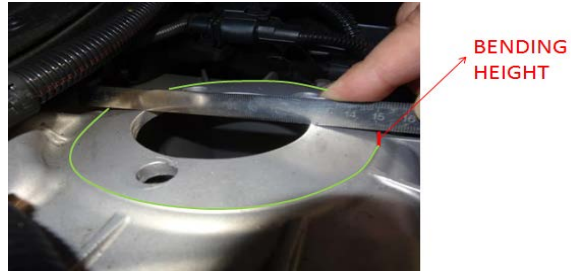
Fig.4

4. Check the bending height of the dome (Fig.4). The maximum should be **1mm** or less.
- If it's **1mm** or less, perform Procedure "A".
  - If the bending height is still more than 1mm, repeat step 3 above a maximum of 3 times. If the bending height is more than 1 mm after 3 attempts at step 3 above, open a BOL, attach clear pictures then follow the instructions you will receive in response to the BOL.
