**NUMBER:** 08-074-20 REV. E

Improved Steering Feel

2018 - 2020	(JL)	Jeep Wrangler
2020	(JT)	Jeep Gladiator

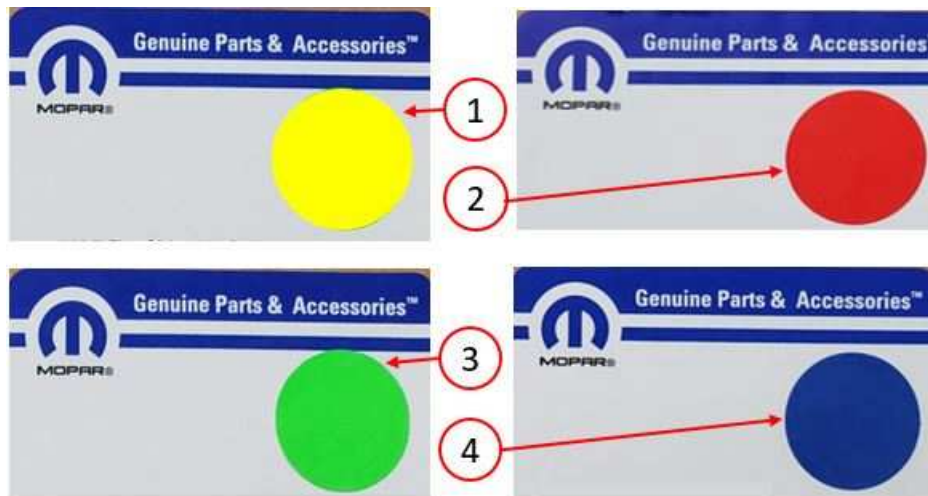
Fig. 1

**\*\*The Steering Gear Parts Label Has A Color Dot On It To Help Confirm The Correct Steering Gear Was Order**

- 1 - Yellow Dot, 68507576AA (JT)
- 2 - Red Dot, 68507569AA (JL 4 Door, **W/O EXJ 3.0 Diesel**)
- 3 - Green Dot, 68507574AA (JL 4 Door, **With EXJ 3.0 Diesel**)
- 4 - Blue Dot, 68507571AA (JL 2 Door)\*\*
