## **Service Bulletin**

## Subject: Diagnostic Tip for Coolant Leak, Coolant Consumption and/or Low Coolant Message Being Displayed On the Driver Information Center (DIC)

Brand:	Model:	Model Year:		VIN:		Engine	Transmission:
		from	to	from	to	- Engine:	
Chevrolet	Silverado	2017	2018				
	Silverado 2500/3500	2019	2021			Equipped	
	Silverado 4500HD, 5500HD and 6500HD	2019	2021			with 6.6L Diesel Engine (RPO	
GMC	Sierra	2017	2018			L5P, L5D)	
	Sierra 2500/3500	2019	2021

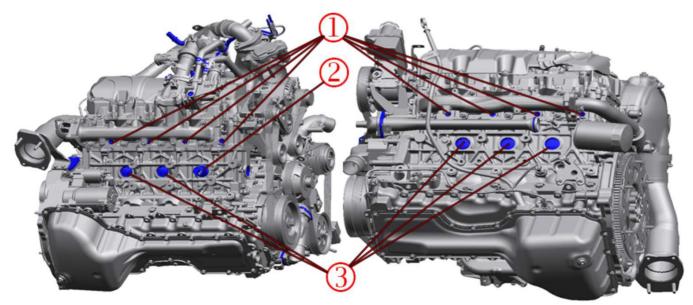
- 1. Plugs in Cylinder Head (PLUG, CYL HD CORE HOLE) (Qty 8)
- 2. Block Heater (HEATER, ENG COOL)
- 3. Cup Plugs in Block (PLUG, ENG BLK COOL DRN HOLE (OD=40MM) (Qty 5)

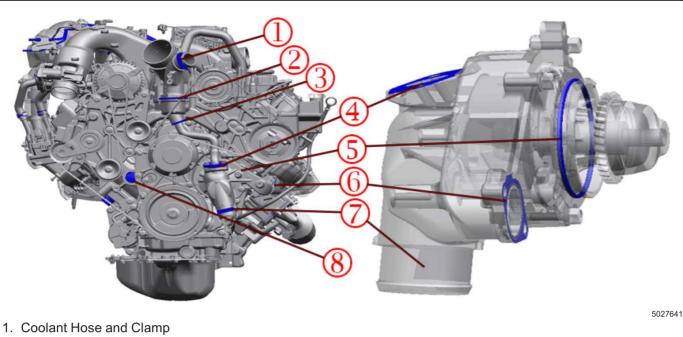
5027608

- 2. Thermostat Housing (SEAL, ENG COOL THERM (O RING)
- 3. O-Ring for Bypass Pipe (SEAL, THERM BYPASS PIPE (O RING))
- 4. Flange with Gasket for Bypass Pipe (GASKET, THERM BYPASS PIPE)
- 5. O-Ring Seal (Front Cover to Water Pump) (SEAL, W/PMP CVR)
- 6. Seal-Water Pump to Pipe (GASKET, W/PMP OTLT PIPE)
- 7. Coolant Hose and Clamp
- 8. Cup Plug on Block (PLUG, ENG BLK COOL DRN HOLE)

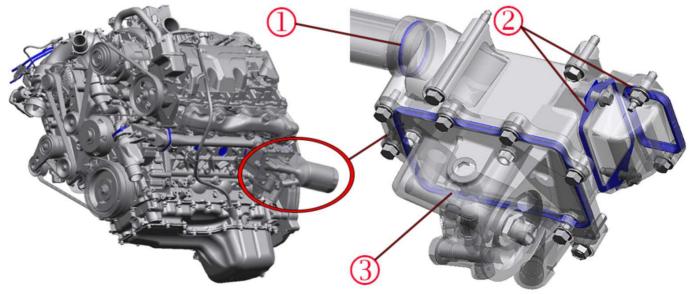
5028324

- 1. O-Ring (Water Pipe to Oil Cooler) (SEAL, W/PMP OTLT PORT)
- 2. Either end of the Oil Cooler Adapter (Elbow) (GASKET, ENG OIL CLR ADAP)
- 3. Seal in the Oil Coolet (GASKET, ENG OIL CLR)

**Note:** Ghost view of the Oil Cooler to reveal O-ring and cover gasket and 2 adapter gaskets (Oil Filter not shown).

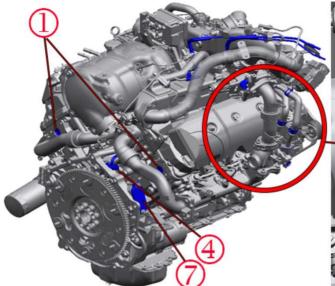
- 1. Cup Plugs (Qty 2)(One per side in rear of Cylinder Head) (PLUG, CYL HD CORE HOLE)
- Gaskets under Flange, 1 location on EGR Bypass Valve (Serviced with VALVE, EGR VLV CLR BYPASS)
- 3. Hose Clamps, 5 locations
- Turbo Coolant Feed Pipe (GASKET, TURBO COOL FEED & RTN PIPE)
- 5. Gaskets under Flange, 2 locations on EGR Valve (Service with VALVE, EGR)
- 6. Cup Plug in Bypass Valve (Service with VALVE, EGR)
- 7. Cover on Flywheel Housing (GASKET, FLYWHL HSG CVR)

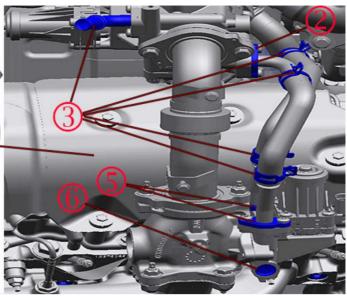
- 1. Gasket for Turbo coolant pipes (GASKET, TURBO COOL FEED & RTN PIPE) (Qty 2)
- Ghost view of Upper Intake Manifold and ERG Coolant Pipe. Inlet Adapter removed to reveal EGR Coolant Return Pipe.
- Hose Clamps for Turbo Coolant Pipes and DEF Coolant Pipe (Qty6)

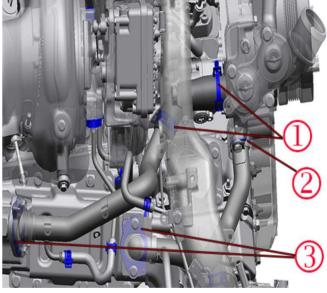
5028604

**Note:** A leak on the top of the engine will trail down the back of the engine and appear as a rear cover leak.

- 1. Hose Clamps on the EGR Coolant Return Hose (Qty 2)
- 2. O-Ring for EGR Coolant Return Pipe (SEAL, EGR COOL FEED PIPE) (Qty 2)
- Gaskets under Flanges for EGR Coolant Feed and Return Pipes (SEAL, EGR COOL FEED PIPE) (Qty 2)

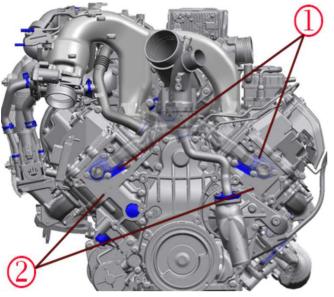
5028676

- Gaskets between Cylinder, Heads and Water Crossover Housing (GASKET, ENG COOL THERM HSG) (Qty 2)
- 2. Head Gaskets (GASKET, CYL HD)
