Service Bulletin

Bulletin No.: 20-NA-199

Subject: Radio Software Version U150 Update

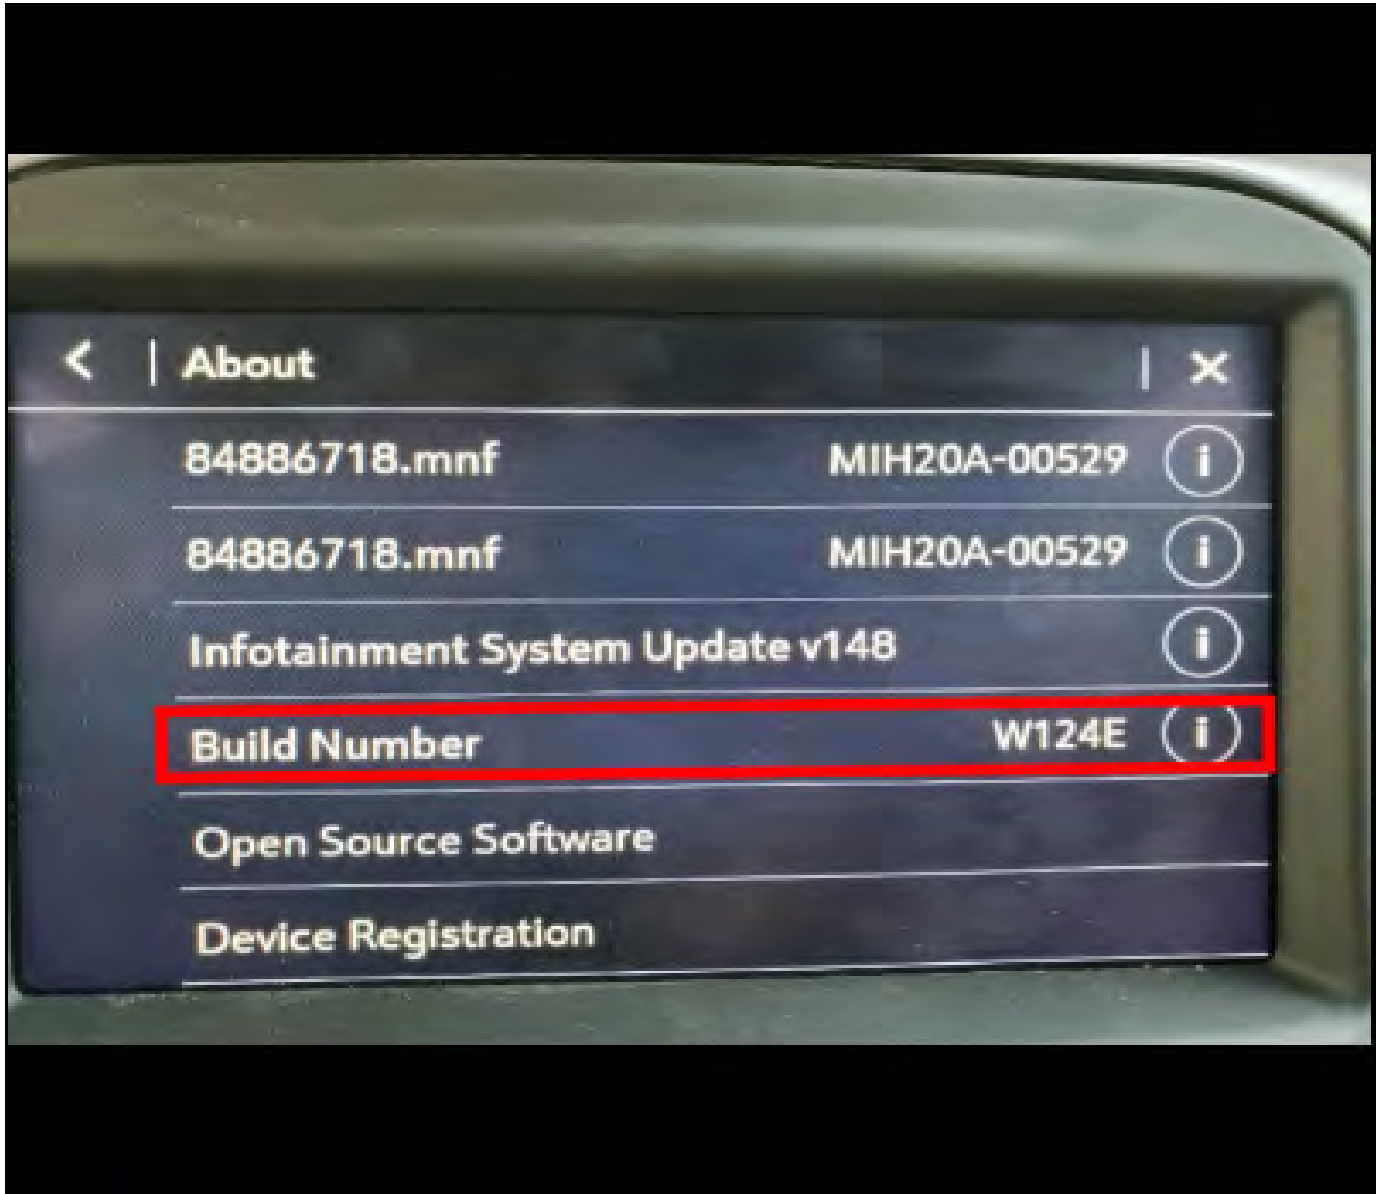
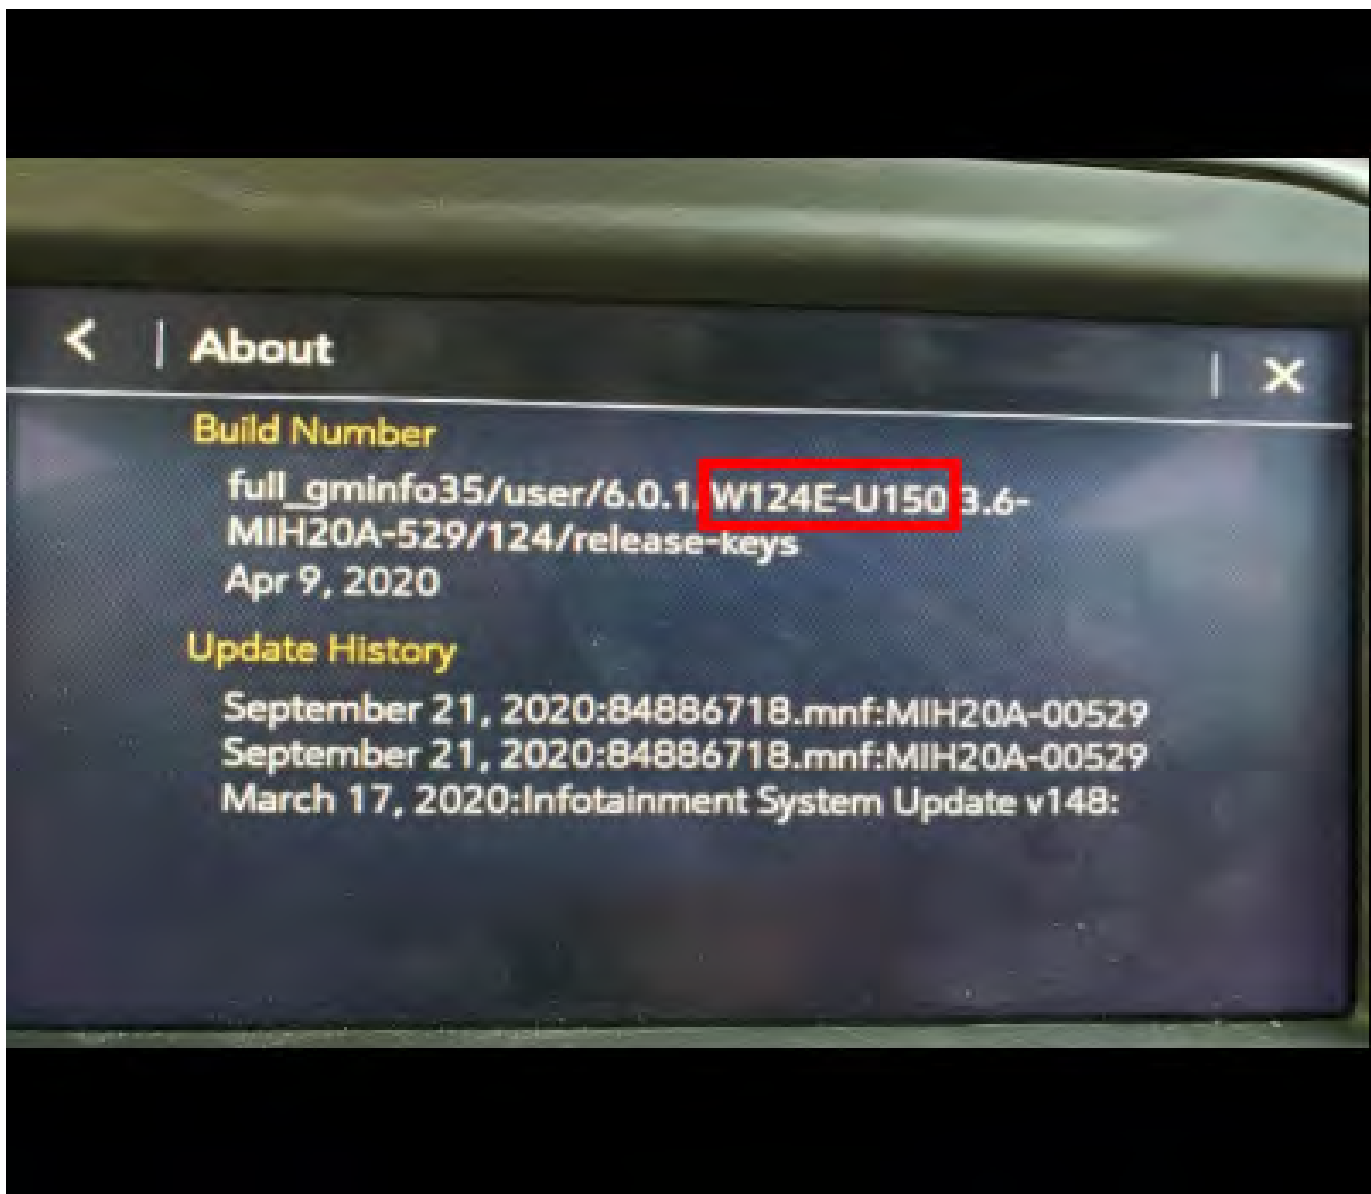
5662665

Important: Some technicians are reporting that the radio remains on v148 after the radio displays the software update completed successfully. It is important to ensure that the technician is inspecting the **Build Number** and not other rows of information on the same screen. This requires the user to locate the Build Number, and then select the Information icon (circled

lower-case i) to see the full software version file name. In these radios, the build number could be W124E after installing U150. This W124E is NOT the software version and is not unique to the U150 software release.

Important: After pressing the information icon, review the full software version file name. In the middle of this long file name you see the U150.3.

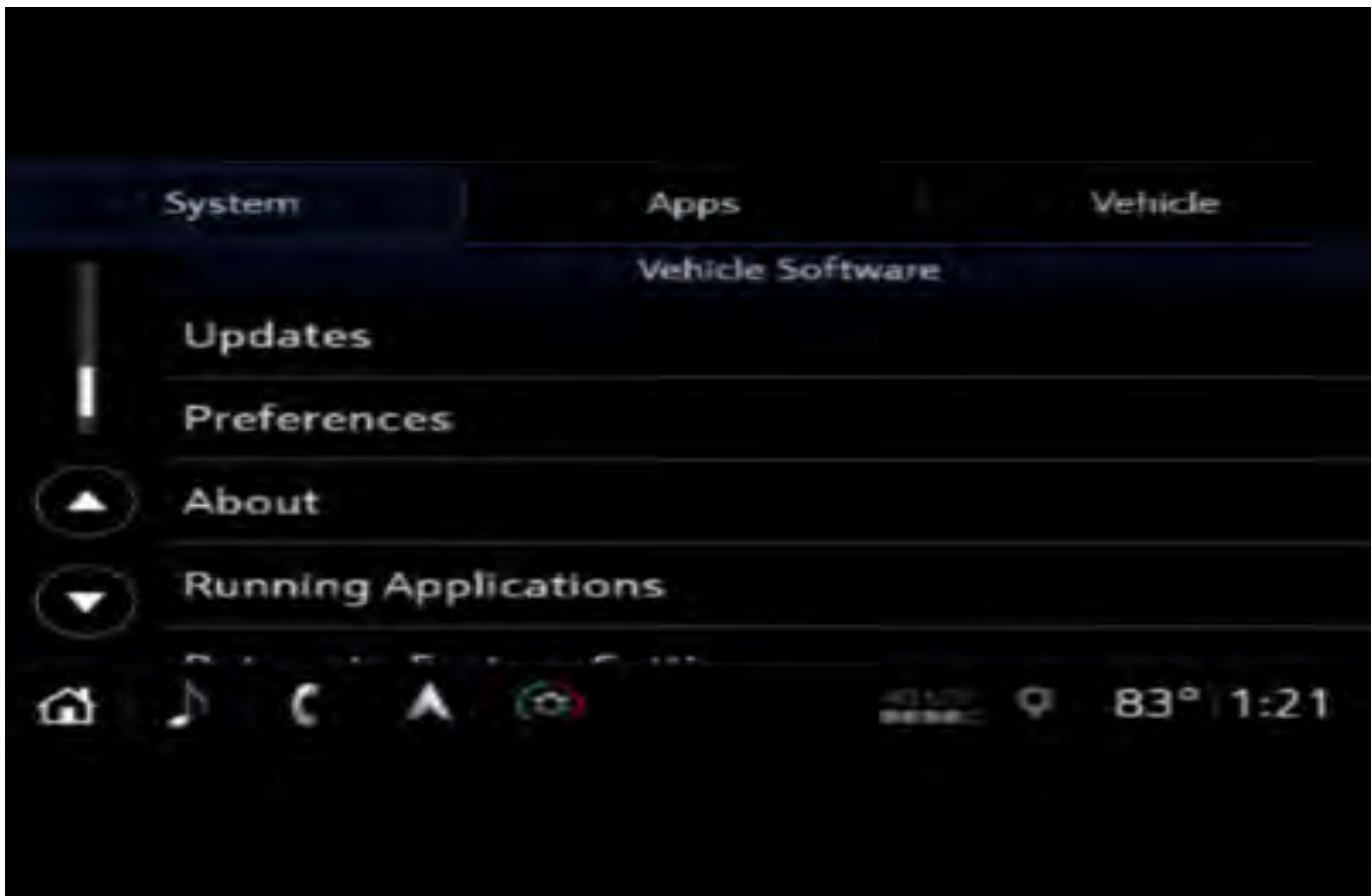
5651942

- If an update is shown under the “Updates” screen, proceed to the **Update Procedure Using Remote Vehicle Update** section of this document.

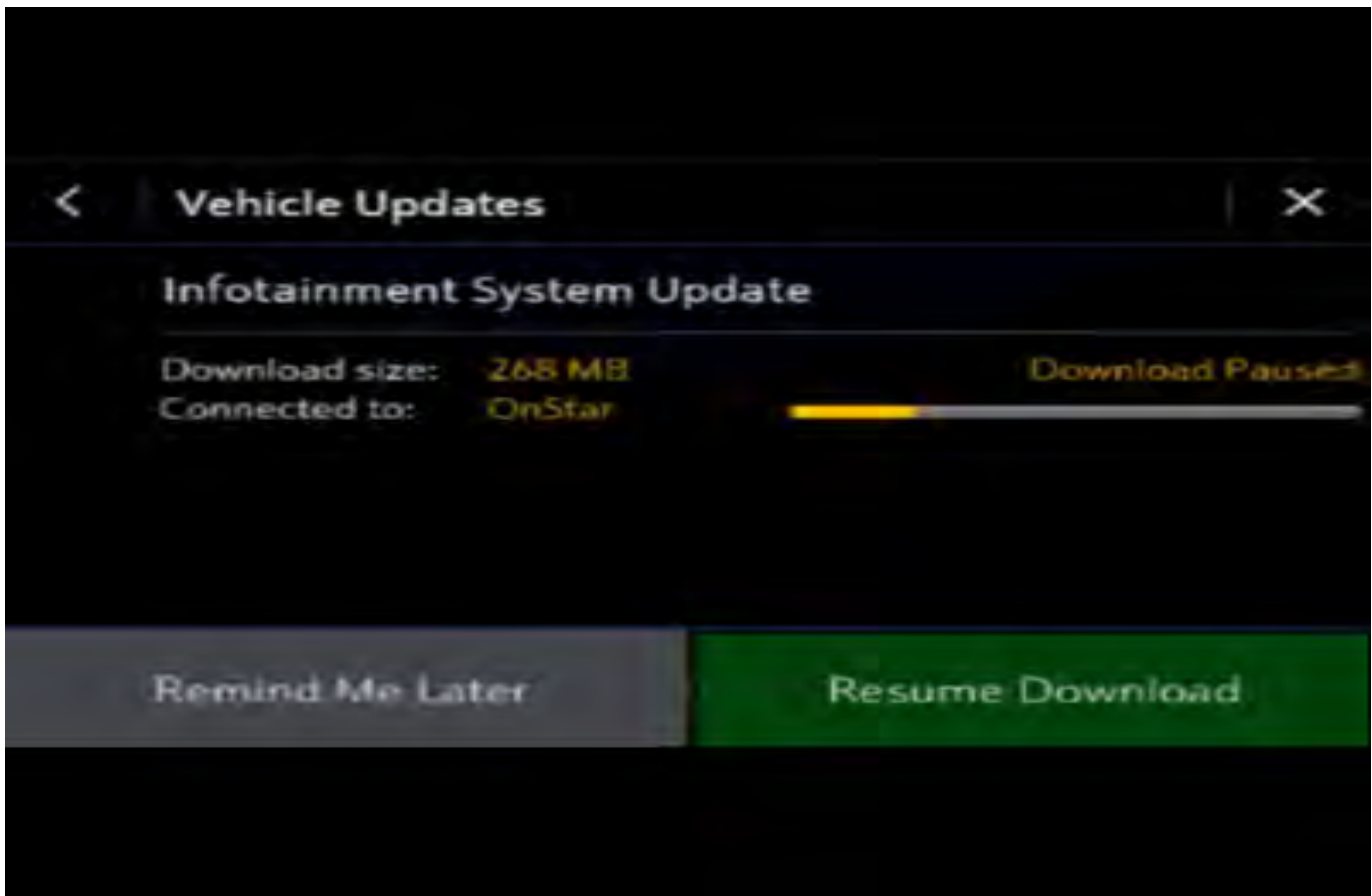
5651943

Caution: If Vehicle Update screen shows “Infotainment System Update” (such as the screen above), do not use TIS2WEB or insert a USB stick. Use of the USB stick when the Remote Update has already been downloaded, installed, or paused during installation could result in program failures or module lockup condition. The update should be completed using the Remote Vehicle Update procedure, following prompts on the infotainment screen. Refer to Update Procedure Using Remote Vehicle Update after reading the remaining information in this section if the Remote Update has already been downloaded to the radio.

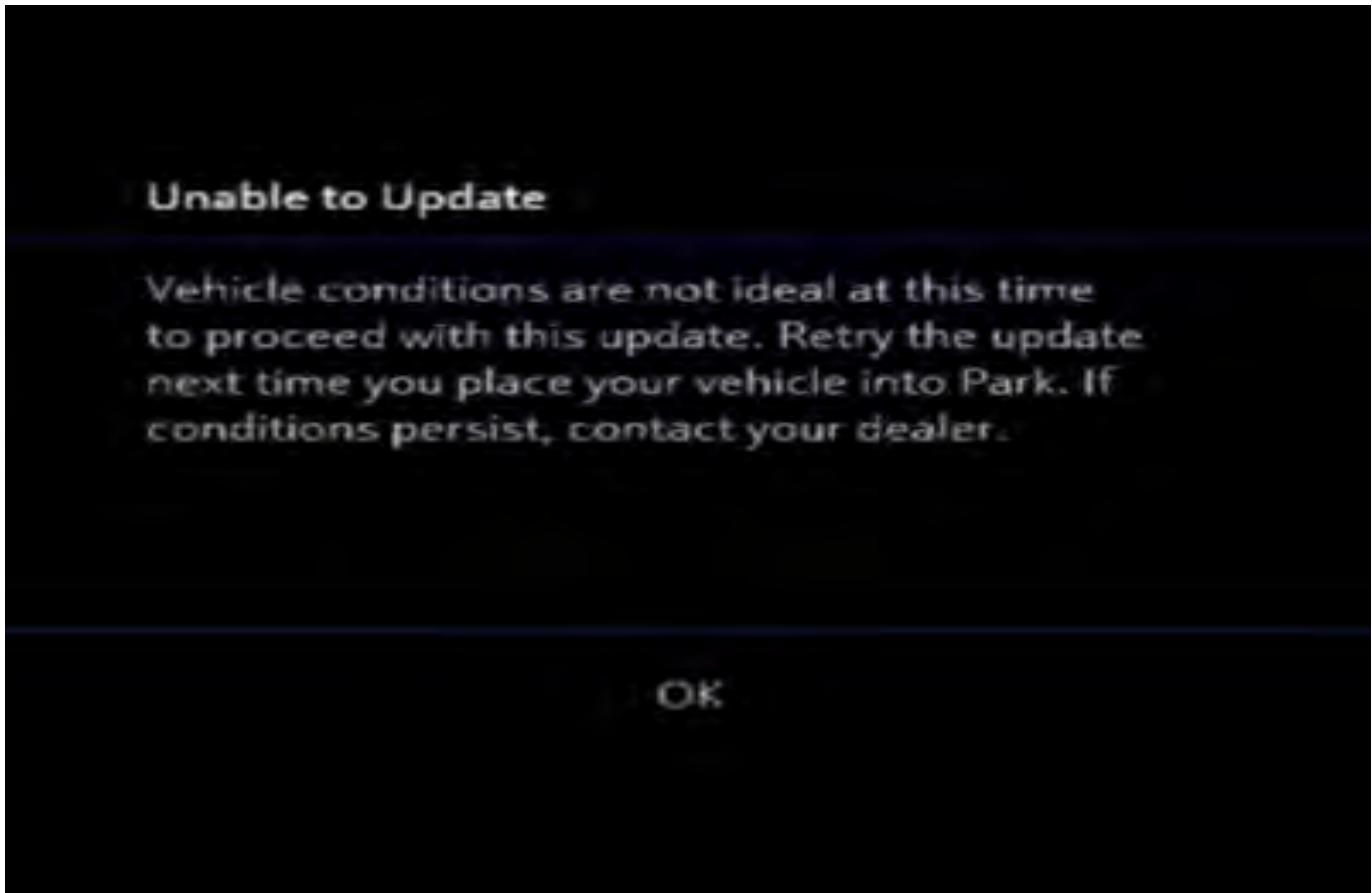
5651949

Scenario 1: Vehicle conditions are not ideal.

If the above screen is shown, download the update through TIS2Web and perform USB update. Upon USB insertion while vehicle is running, the "Install Now" pop up will be presented. Ensure the vehicle battery is being maintained (using EL-49642 or battery maintainer) while performing this update.

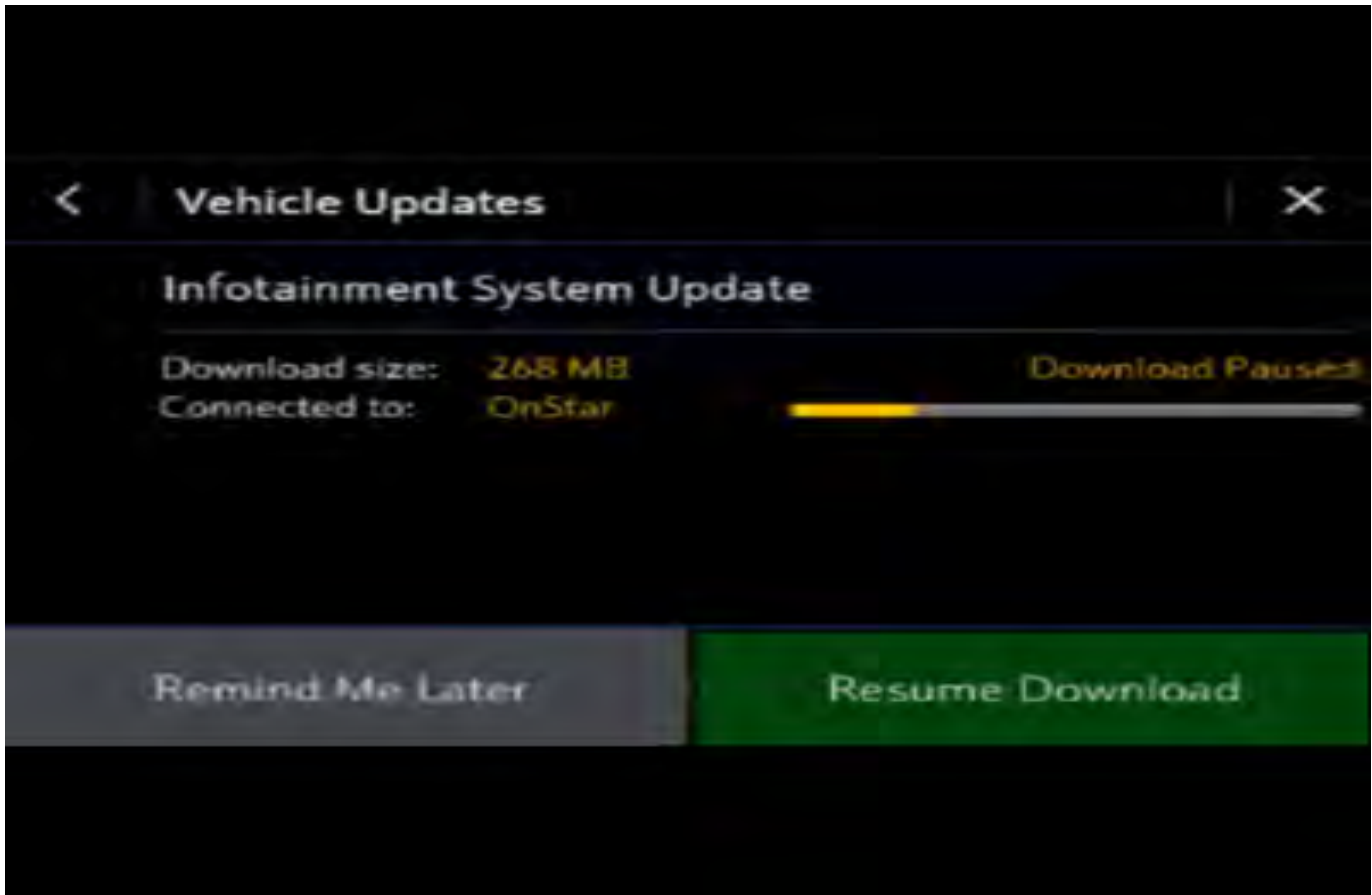
5651943

Scenario 2: Consistently Paused Download

If the above screen is shown and resuming the download repeatedly fails, a USB update will need to be performed. Turn the vehicle on, return to the home screen, and insert USB stick (see previous section). A pop up should be shown to "Install Now." Click "Install Now", verify the part number is correct and follow on screen prompts.

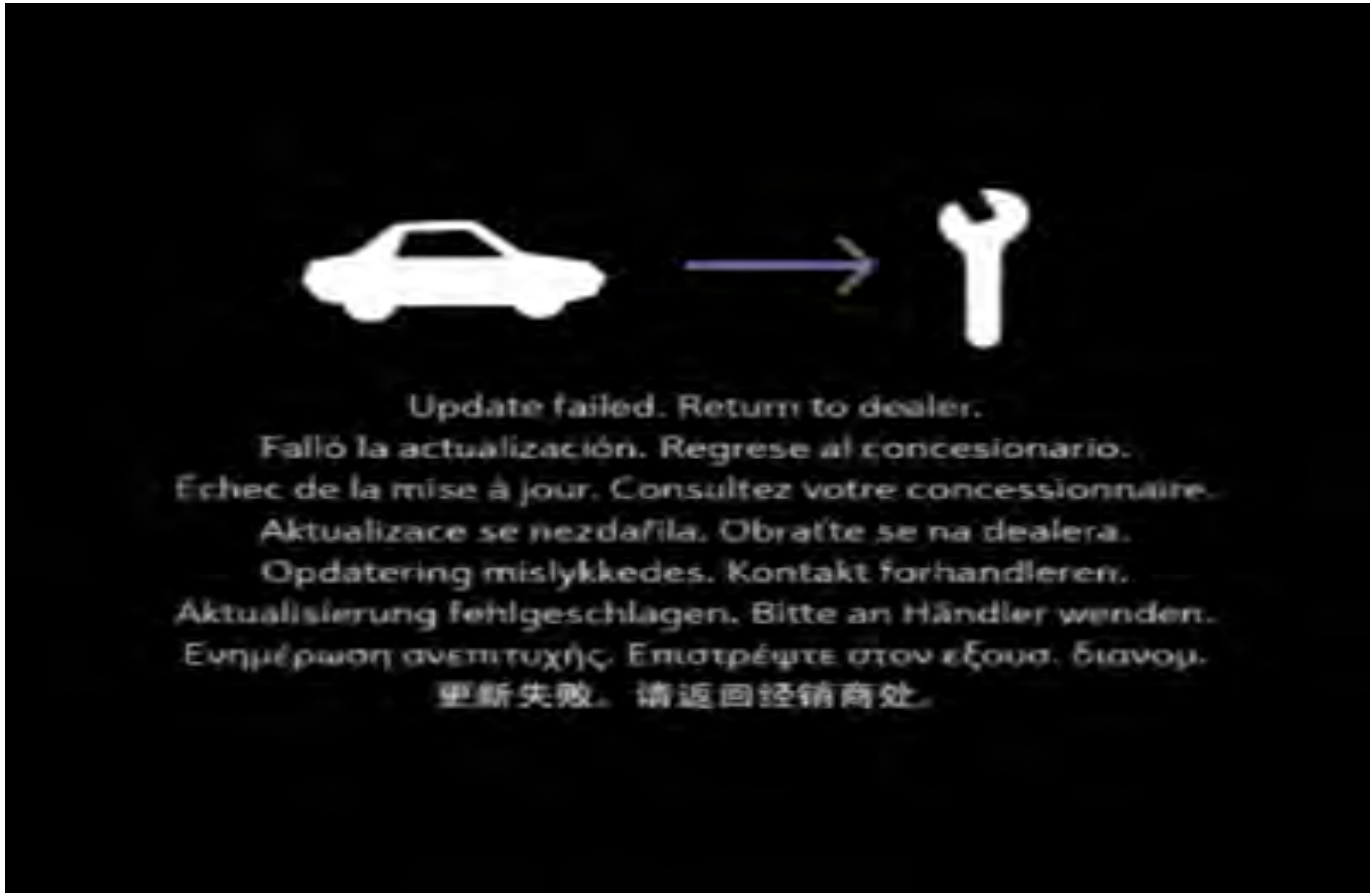
5651950

Scenario 3: Update failed. Return to dealer screen.

1. If the above screen is shown, download the update through TIS2Web and insert USB stick into the radio *twice* (USB stick is not recognized on first insertion). A blue progress bar should come on the screen and update will proceed. If this screen above is shown when trying to update the radio through USB, reformat to FAT32 on your PC, and then try to download the update through TIS2WEB again.

2. After selecting USB File Transfer, if you are prompted by TIS2Web to select a software P/N, then follow the on-screen instruction to attempt to gather the software P/N from the A11 Radio using GDS2 scan tool. If GDS2 indicates the radio is not communicating, go back to TIS2Web, select A11 Radio, and select when radio displays "*Update failed. Return to dealer.*" to complete the USB File Transfer programming event.

3. If the screen above is shown again, contact Technical Assistance (TAC) for further assistance.
