SIB 65 18 20

2020-11-30

SERVICE ACTION: HEAD AIR BAG HOLDER RETROFIT

E-Series	Model Description	Production Date
E46	323i, 328i 3 Series Sedan	September 1998 thru October 1998

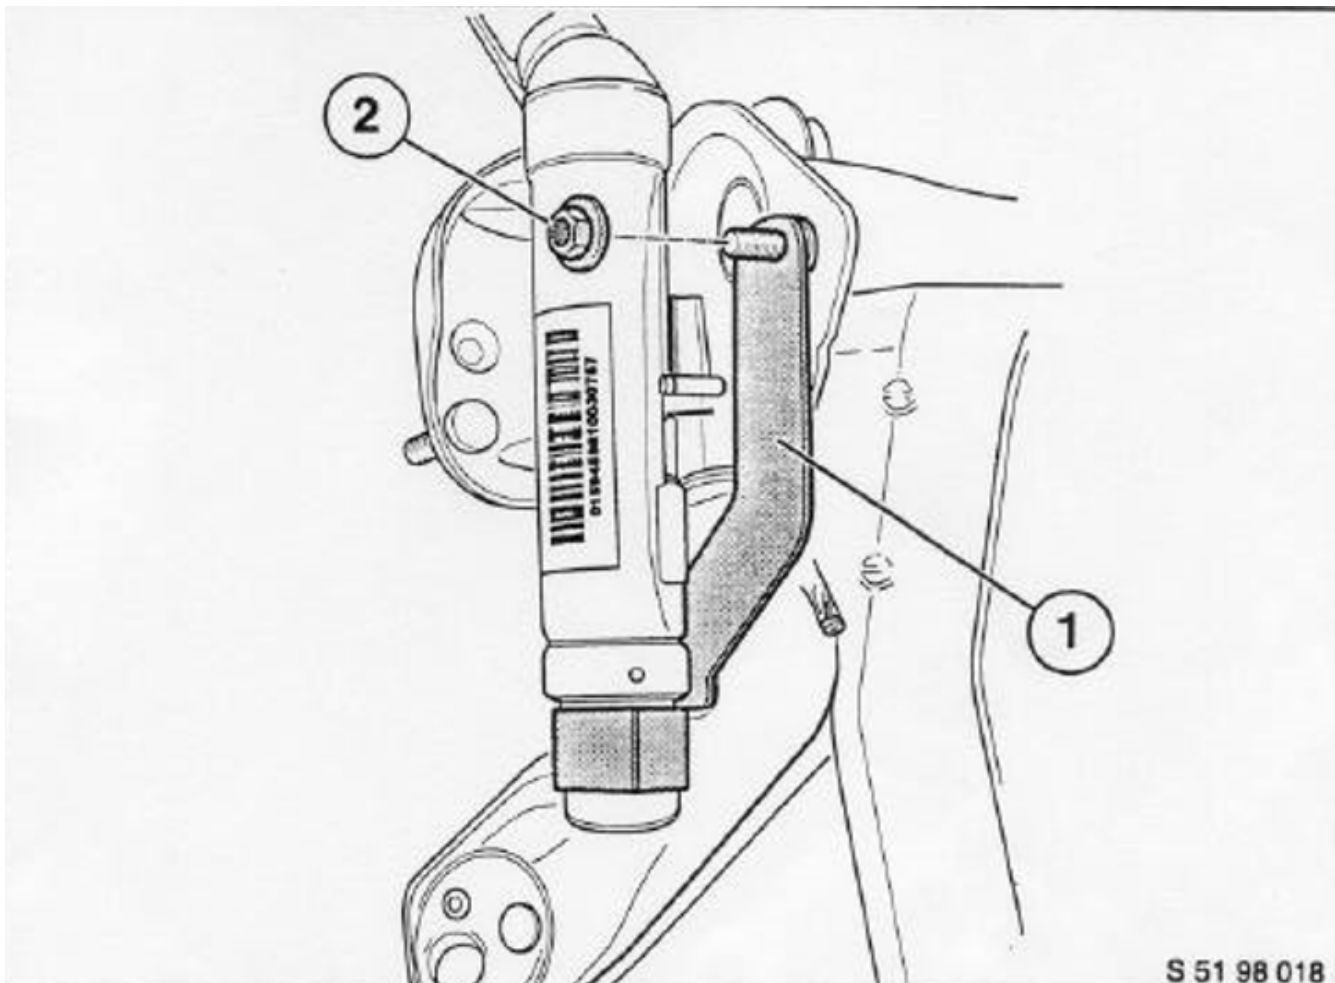
An additional retrofit bracket (1) has been created to be installed on both ITS head air bags.

A new locking nut (2) will be used to retain the retrofitted bracket.
