## P20EE (diagnostic troubleshooting code) SOLUTION - NOX CONVERSION EFFICIENCY

Prevost vehicles

B13R (9700 us/can)

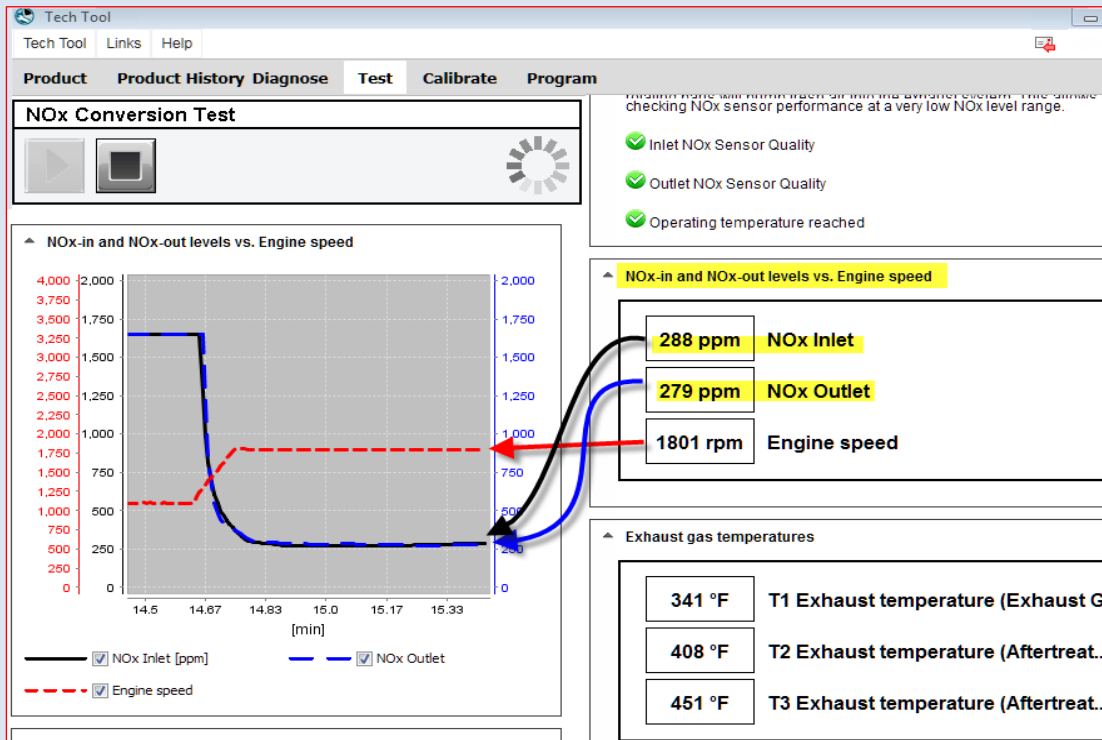
Use this test to compare the inlet and outlet NOx sensor ppm levels. Usually we monitor the last part of the test, just before shutdown, when the engine runs at high rpm (1800 rpm). Both levels should be close to each other at that point. See the example below (image). **Take screen captures.**

If both NOx sensor ppm levels are **close to each other** during the last part, as shown in the example above (image), then both NOx sensors are good.

If ppm levels difference **exceeds 10%**, then the sensor reading higher should be considered as defective.

Replace the defective sensor<sup>1</sup> if applicable and then perform a new NOx sensor test once again to make sure that the replacement sensor is good.

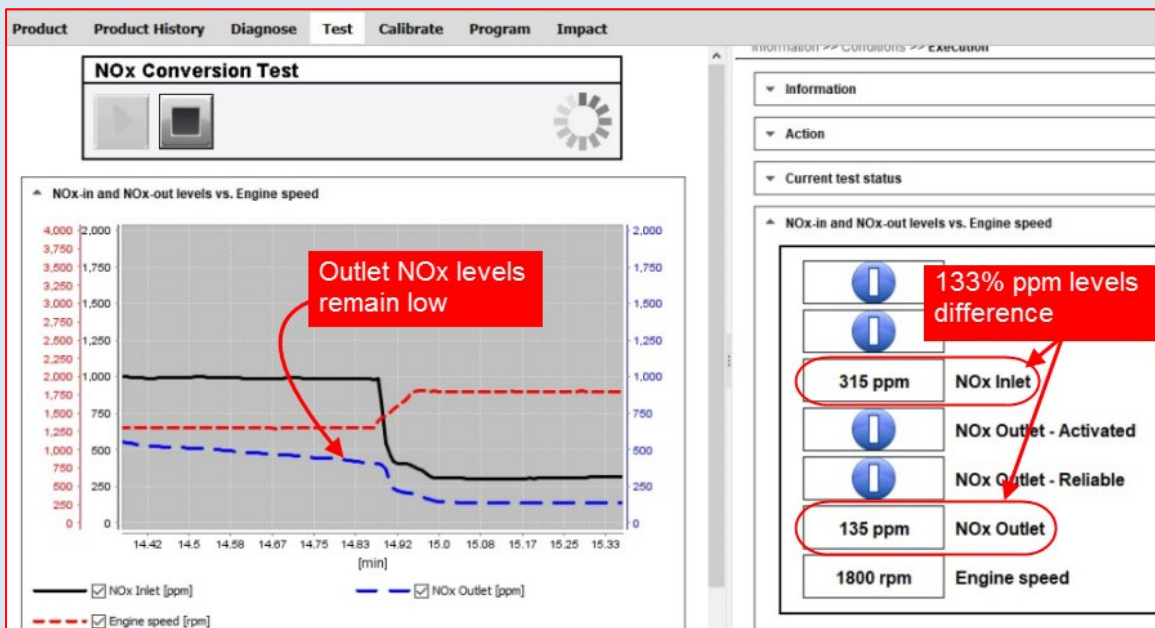
### NOx Conversion Test With engine ECU software number 23470183

Engine ECU software number 23470183 allows DEF dosing to continue during the last part of the NOx conversion test (just before shutdown). This causes continued low outlet NOx sensor ppm levels, as seen in the example below. **Take screen captures.**

**DIFFERENT BEHAVIOR.** In this example, the NOx sensors ppm levels are not close to each other because DEF is still injected during the last part of the test. **In this instance, review earlier sections of the test** to ensure that both sensors are responding to changes in the same manner. Examples of different stages to review are shown below.

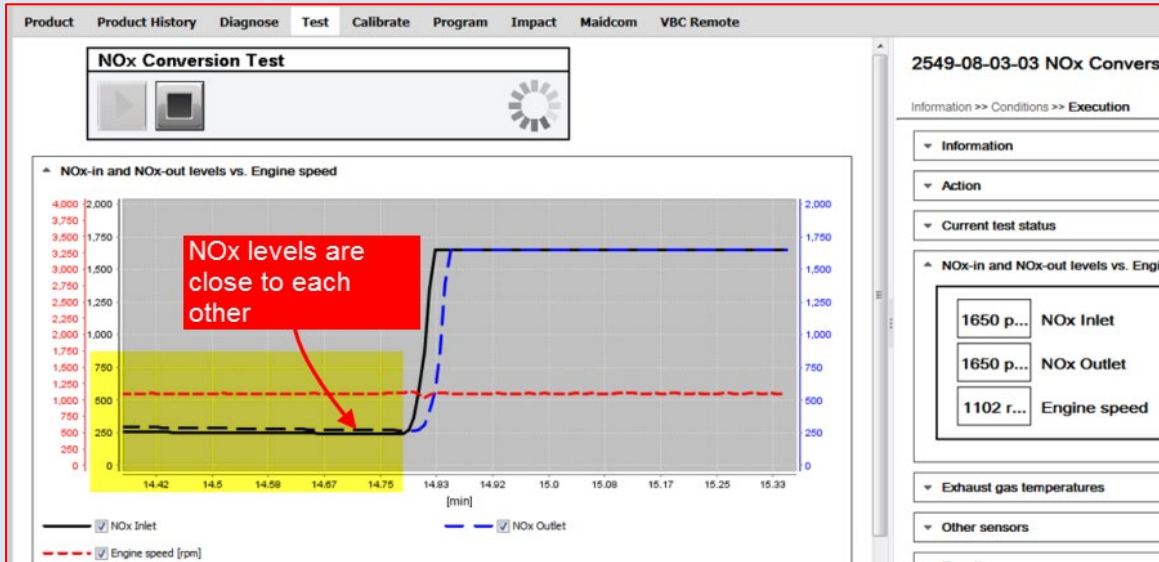
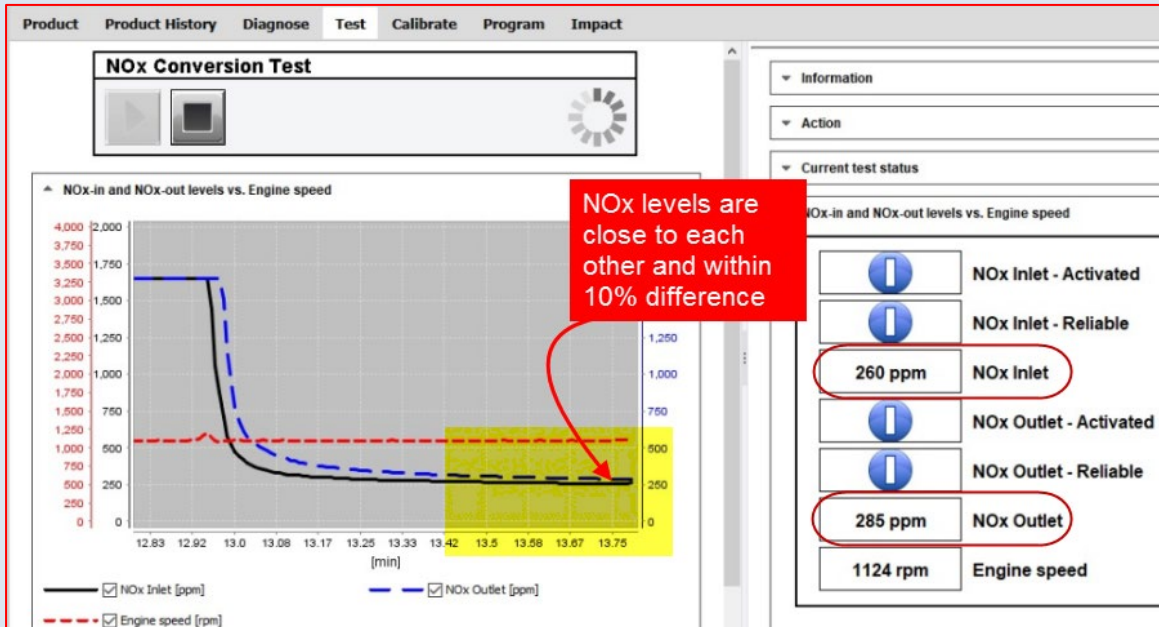
The NOx sensors levels are close to each but earlier during the test (images above & below).

If both NOx sensor ppm levels are **close to each other** at a point during the test as shown in the examples (image) above, then both NOx sensors are good.  
 If ppm levels difference is **greater than 10%**, then the sensor reading higher should be considered as defective.
