**SERVICE BULLETIN**

**APPLICABILITY:** 2020-21MY Legacy and Outback Models      **NUMBER:** 15-261-20R  
**SUBJECT:** Reprogramming File Availability for Optimization of Gen 4 Denso CP1 Infotainment Systems      **DATE:** 03/10/20  
**REVISED:** 12/18/20

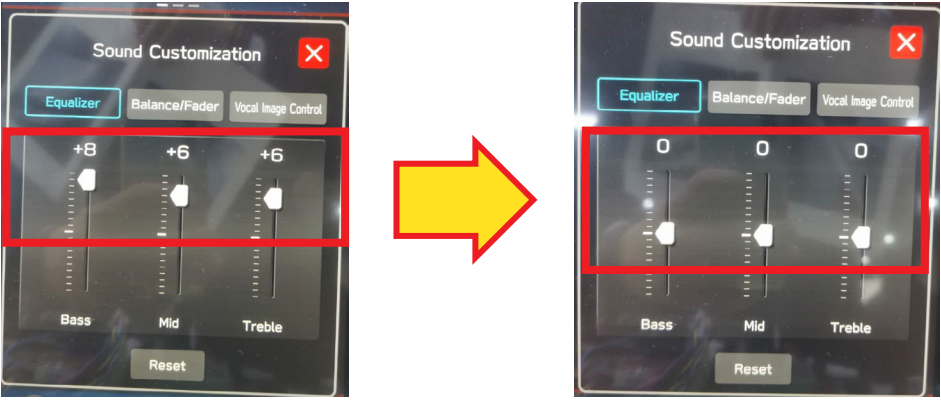
7	Customer-selected Equalizer settings are lost. Equalizer returns to the default settings after ignition switch is turned OFF and back ON.

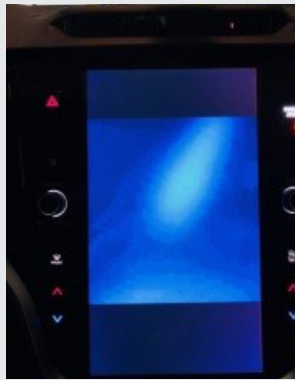
Symptom #	Description of Symptom:
9	In a case where the system was shut down while the Navigation map screen was being displayed, the display goes blank (black screen) soon after the Disclaimer screen is displayed after restarting.
10	CID reboots repeatedly after setting a destination using the Navigation system.
11	CID reboots while using the Pandora application via CarPlay.
12	Bluetooth connection cannot be reestablished when using certain smart phones. When using Android Auto on certain smartphones, a Bluetooth connection cannot be reestablished automatically once it has been disconnected.
13	CarPlay connection cannot be established. When connecting an iPhone via USB, "CarPlay Unavailable" is displayed and CarPlay does work.
14	The HOME screen goes blank. When the screen is switched from Camera mode to HOME, no icons are displayed as shown below.

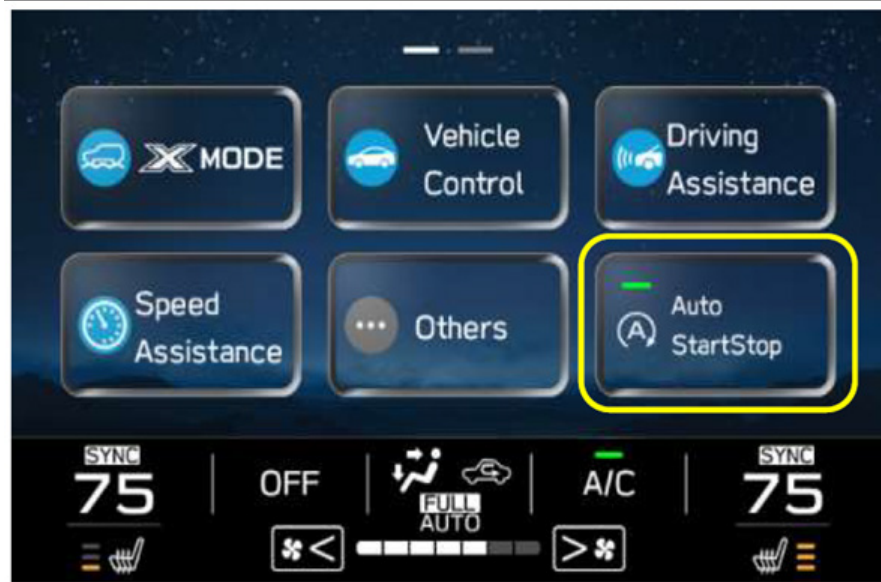
**The Auto Stop-Start On/Off function is difficult to use (find) in SUBARU STARLINK® Multimedia. The function button has been moved from the bottom to top layer of the system for easier use.**
