SERVICE PROGRAM BULLETIN

APPLICABILITY: 2020-2021MY Legacy and Outback **NUMBER:** WRI-20R
SUBJECT: Reprogramming of Denso CP1 Infotainment Units to Optimize System Performance **DATE:** 12/11/20
REVISED: 12/31/20

In the interest of customer satisfaction, Subaru of America, Inc. (Subaru) is initiating a Service Program for certain 2020-2021 model year Legacy and Outback vehicles to update the Cockpit Control Module (CCM) software to the latest version.

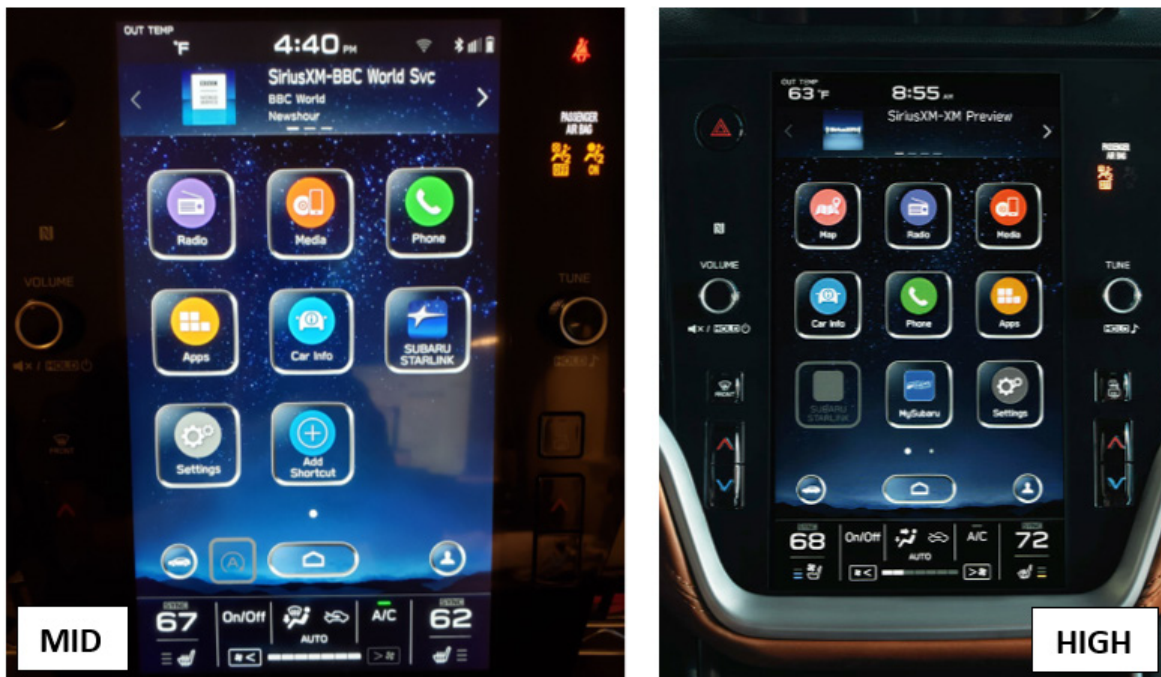
This Campaign affects certain “Mid” and “High” (w/ Navigation) -level CP1 Head Units with 11.6-inch display ONLY as pictured below. The “Base” model (2- 7.0-inch display screen unit) is NOT affected.

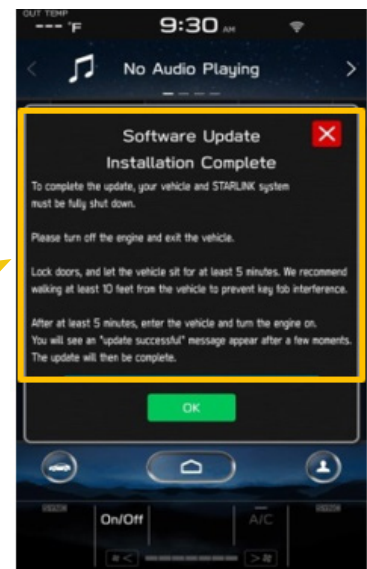
- Clarification of the post-FOTA procedure instructions required to complete the update. The screenshot below will appear and explain what must be done to complete the update installation.

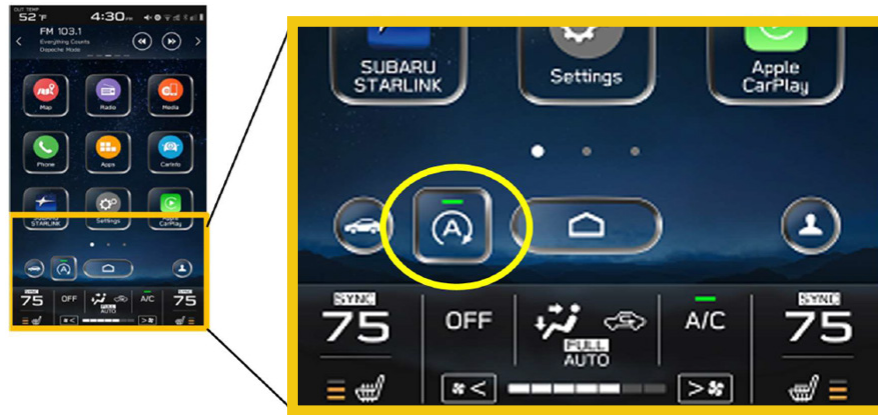
The Auto Stop-Start On/Off function button has been moved from the bottom to top layer of the system for easier use. A screenshot of how the button will appear is shown below.

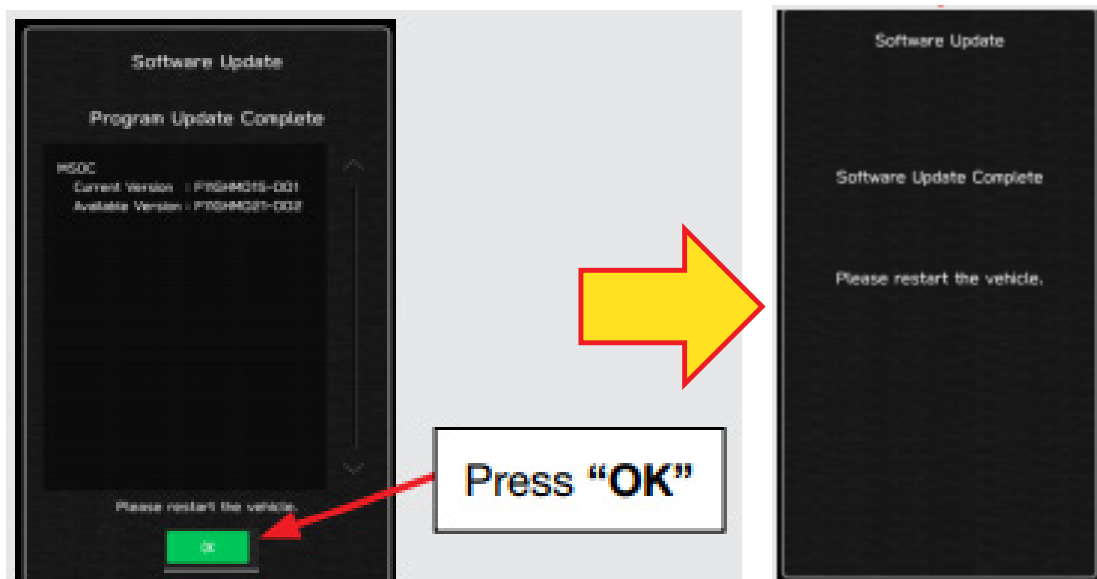
5h) When the update is complete, the screen below will be displayed (the actual software version number will be different).

IMPORTANT NOTE: On rare occasions a “Software Update Incomplete” message may appear in this step which occurs due to a bug in the software update procedure. DO NOT attempt to install the update again, proceed to **5i)** below to confirm the software version has been updated to the latest version.

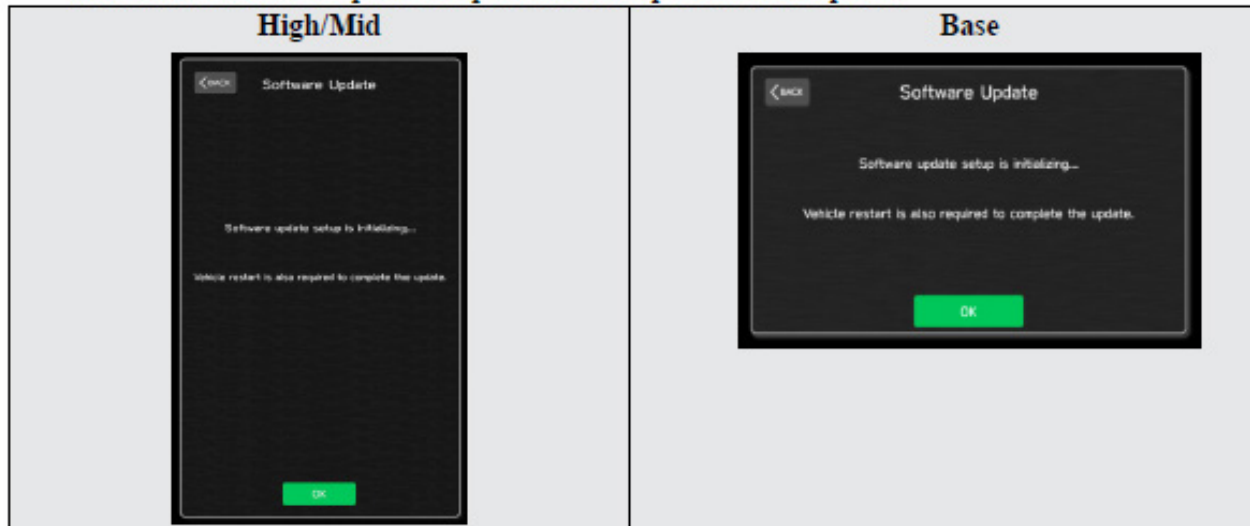
Follow this procedure in the RARE case of “Software update setup is initializing...” message is displayed:

- If the screen shown below appears, **WAIT** for approximately 15 minutes or as long as necessary to allow the Software update setup initialization process to complete.

1. Turn the ignition OFF, open the driver's door, close the driver's door and **WAIT** for 3 or more minutes before proceeding further.
2. Open the driver's door again and either turn the ignition ON (if a charger is connected) or start the engine.
3. Go to Dealership Mode menu again (PRESS and HOLD the RIGHT-side temperature control buttons (both up and down) and press the Tune / Scroll knob 6 times then release all to display the Dealership Mode) and select Software Update as in STEP 3 beginning on pg. 8.

IMPORTANT NOTE: If this procedure is required, contact Techline as additional action may be necessary.
