**PRODUCT CAMPAIGN BULLETIN**

**APPLICABILITY:** 2020MY Legacy and Outback

**NUMBER:** WRH-20R

**SUBJECT:** Rear Visibility FMVSS 111 Non-Compliance

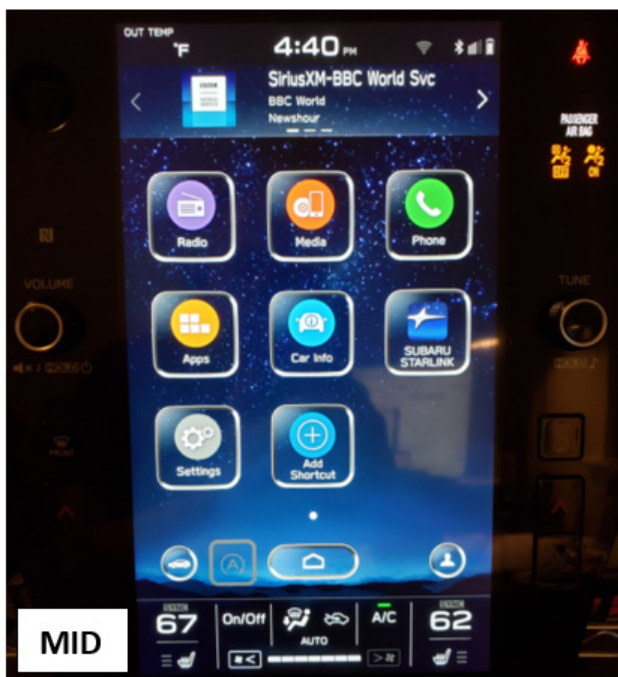
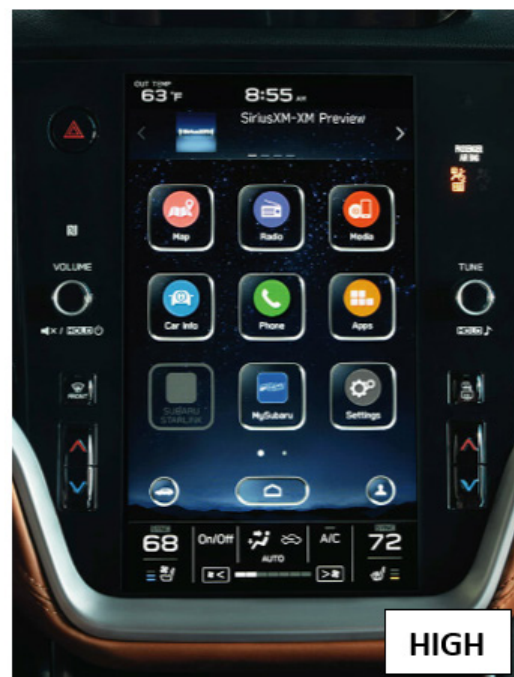
This Campaign affects certain “Mid” and “High” (w/ Navigation) -level CP1 Head Units with 11.6-inch display ONLY as pictured below. The “Base” model (2- 7.0-inch display screen unit) is NOT affected.

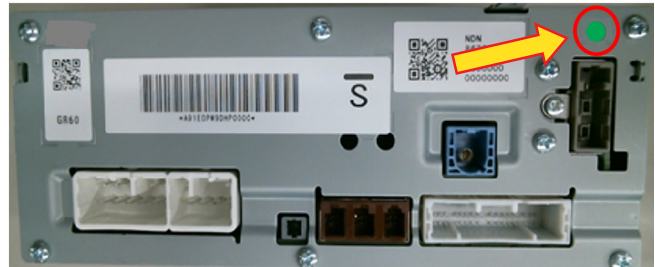
**STEP 2a:** When receiving the exchange CCM, inspect the back of the module for a GREEN dot as shown here. This **GREEN** dot signifies the module has already been updated with the latest Version 4.0 software. **NOTE:** All related CCMs shipped to retailers after 12/3/2020 have this dot. The **GREEN** dot will be applied to related exchange modules for six months. After that time, the dot will be discontinued but the modules will be OK for use. Proceed with CCM R&R following the procedure in the applicable Service Manual.
