Technical Service Bulletin

39 Four-wheel drive malfunction message, DTC C05ED00 is stored in the all-wheel drive control module

39 20 39 2051558/5 December 10, 2020. Supersedes Technical Service Bulletin Group 39 number 20-35 dated August 21, 2020 for reasons listed below.

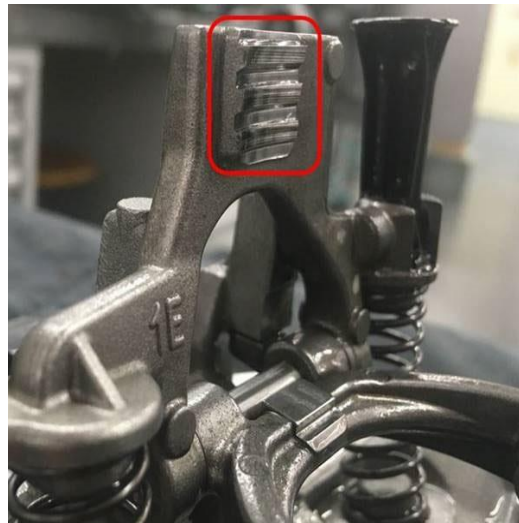
Quattro Ultra shift fork inside the rear differential is worn/faulty (Figure 1).

Figure 1. Worn/faulty shift fork.

Improved material in production.
