Technical Service Bulletin

50 Creaking noises heard when body twists during braking or steering maneuvers

50 20 03 2061672/1 December 16, 2020.

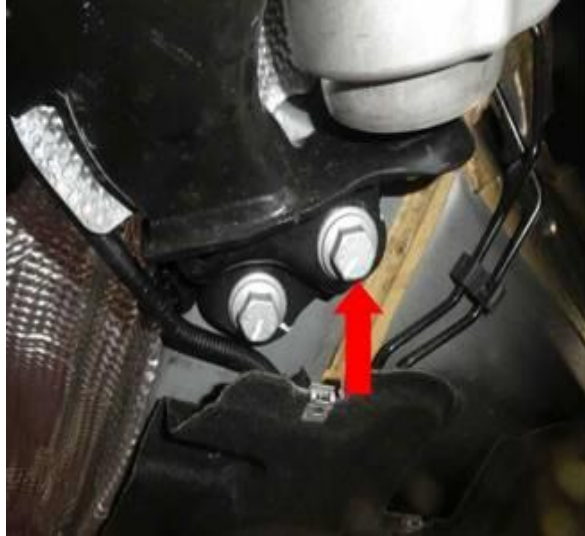
Figure 1. Front most bolt on subframe to be loosened.

2. Begin your diagnosis by loosening the front most bolt on the subframe mounting as indicated in Figure 1. The bolt only needs to be loosened several turns but not removed.

As specified in the repair manual, it is necessary to replace all loosened subframe bolts at the conclusion of the entire repair.

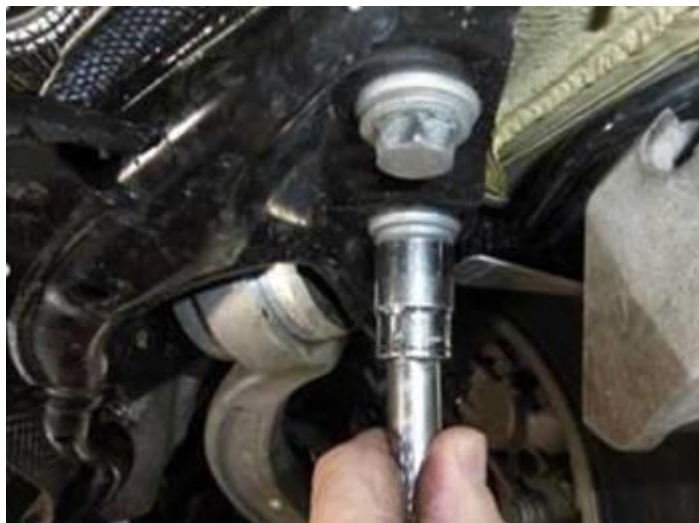
3. In many cases an audible ‘cracking’ noise can be heard in the course of loosening and tightening the subframe bolt (Figure 2).

Figure 2. Loosening the front most subframe bolt.

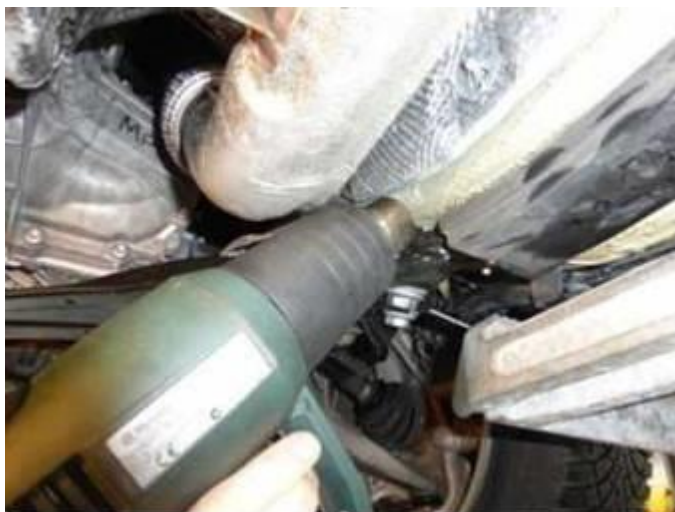
Figure 3. Warming the area of the body near the rear transverse link.

5. Duplication of this noise is difficult when the vehicle is cold. If you suspect that the cold is preventing duplication of this symptom warm up the longitudinal member/body in the area of the rear transverse link bolted connection with a hot air blower set for an outlet temp of approximately 550°C (1022 °F) (Figure 3).

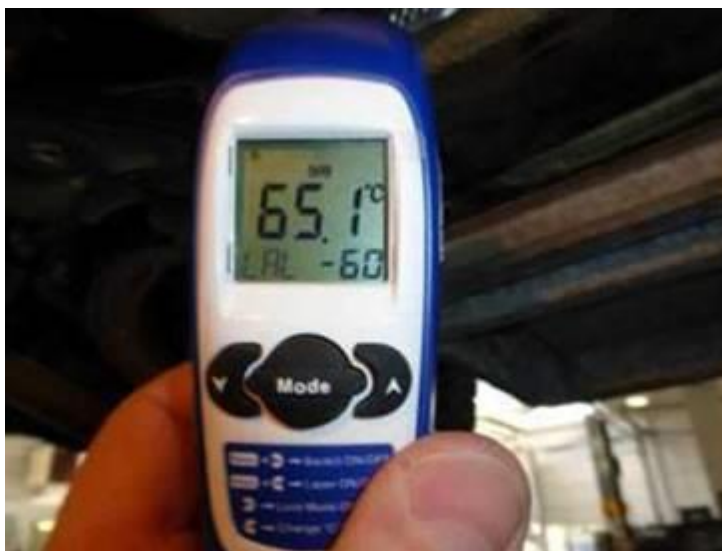
Figure 4. Surface temperature warmed to 65° C (149°F).

6. Warm the surface to approximately 65 °C (149°F) (Figure 4).

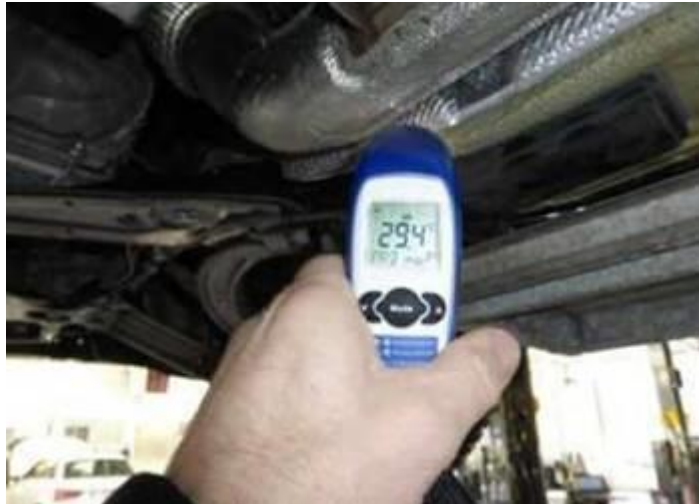
Figure 5. Surface temperature cooled to approximately 30° C (86°F).

7. Allow the surface temperature to cool to approximately 30 °C (86°F) then test drive the vehicle again.

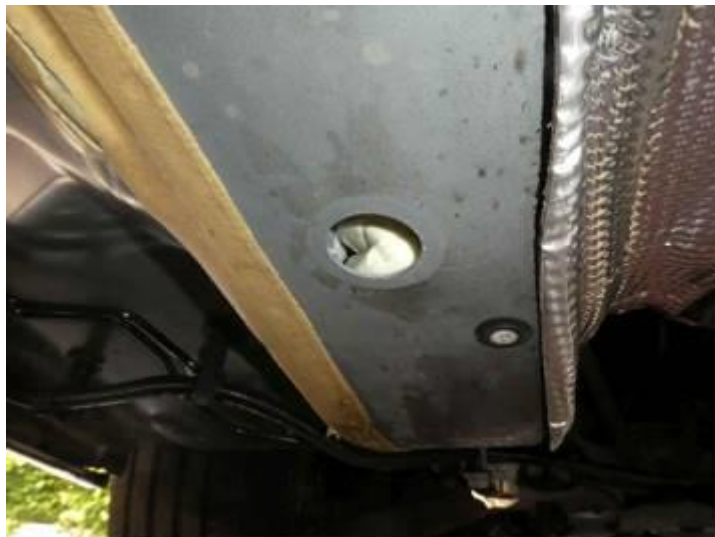
Figure 6. Body plug removed.

8. Merely lowering the vehicle from the hoist can immediately elicit the noise symptom after this warming process.
9. With the symptom confirmed, lower the center cover plate on the affected side. Remove the first body plug aft of the bolted connection for the transverse link (Figure 6).

Replace the body plug removed in this step with 8K0 805 267.

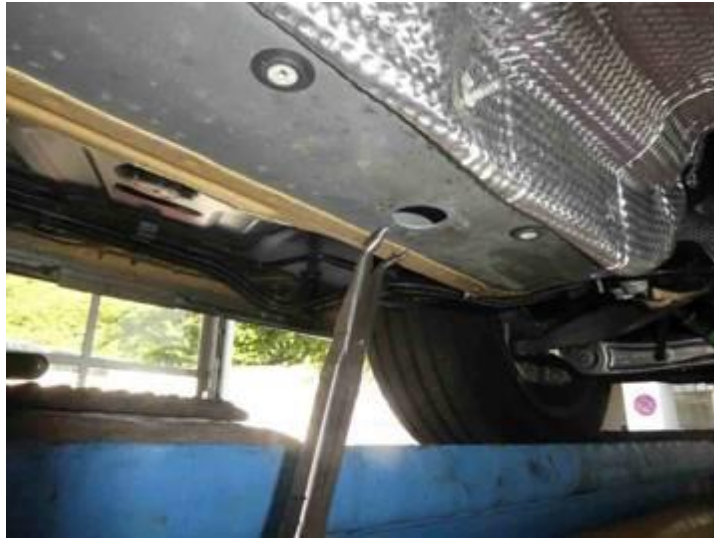
Figure 7. Remove a portion of the acoustic foam.

10. In order to provide appropriate access to the affected area inside the longitudinal member remove sections of the acoustic foam in the longitudinal member area with long needle nosed pliers. It is not necessary to remove all of the acoustic foam and the small amount removed for this procedure will not need to be replaced (Figure 7).

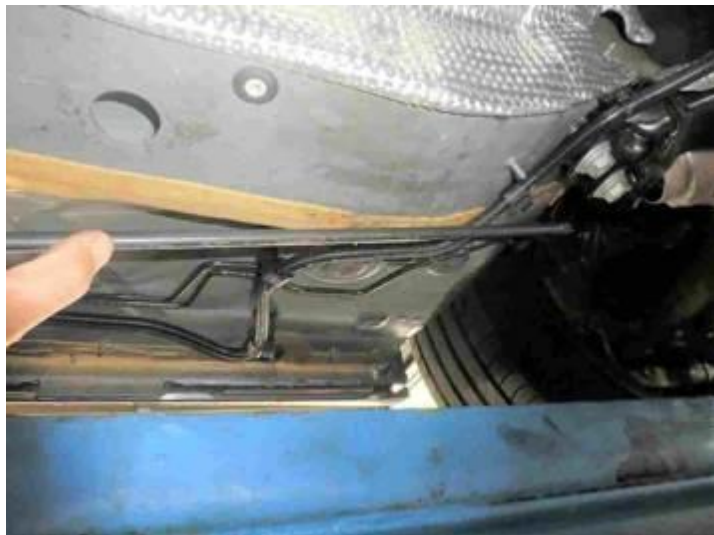
Figure 8. Tool to be fabricated.

11. An improvised tool for this modification will be fabricated. Obtain a steel rod 60 cm long (Figure 8).
