Technical Service Bulletin

50 Creaking noises heard when body twists during braking or steering maneuvers - A6 and A7

50 20 04 2061716/1 December 17, 2020.

Model(s)	Year	VIN Range	Vehicle-Specific Equipment
A6, A7, S6, and S7	2014 - 2018	All	Not Applicable
RS 7	2016 - 2018	All	Not Applicable

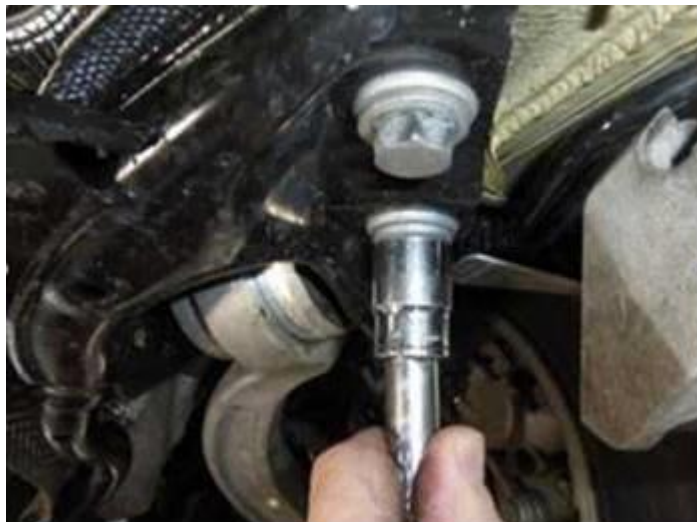
Figure 2. Loosening the front most subframe bolt

3. In many cases an audible 'cracking' noise can be heard in the course of loosening and tightening the subframe bolt (Figure 2).

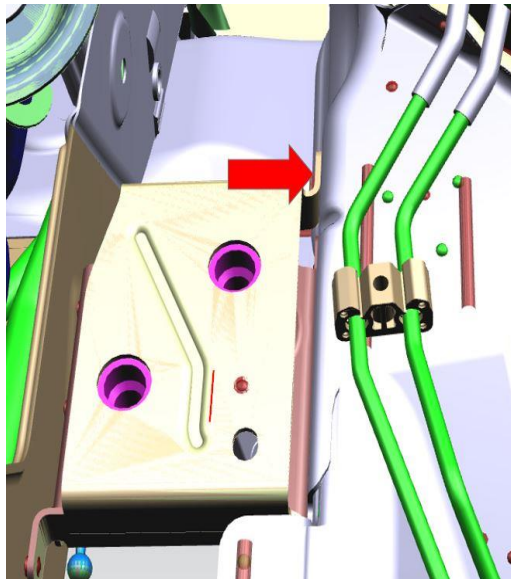
Figure 12. Cut-away drawing showing longitudinal member structure.

During a cornering or hard braking maneuver the longitudinal members can make contact with their internal support plates.

14. The arrow in Figure 12 shows a lip that will need to be bent with a punch in order to achieve a gap between this lip and the nut plate.
