# Technical Service Bulletin

## 20 Fuel gauge is not showing the correct fuel level, sender is stuck in the upper position

20 20 31 2061661/1 December 18, 2020.

Model(s)	Year	VIN Range	Vehicle-Specific Equipment
Q3	2021	All	Four-wheel drive

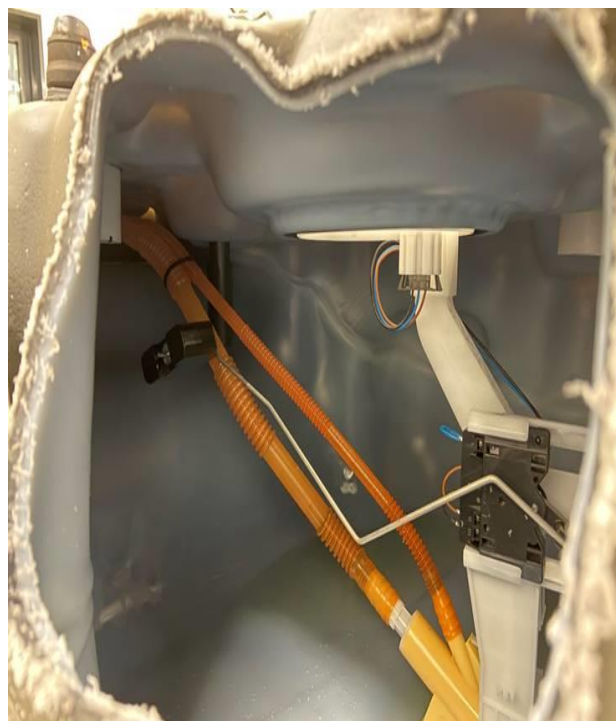
- The instrument cluster is not showing the correct fuel level, indicating that there is more fuel than in tank.

- The float of the G169 gets stuck on the hoses of the suction-jet pump.

Fuel sender in the tank gets stuck on internal fuel line (Figure 1).

*Figure 1. Fuel sender is stuck.*

1. Remove fuel module assembly. Secure an additional cable tie, preventing the sender from getting stuck (it is recommended to put the cable tie around 17cm next to the suction-jet pump). If this is not enough clearance, remove original cable ties and add new ones in a way providing sufficient clearance (Figure 2).

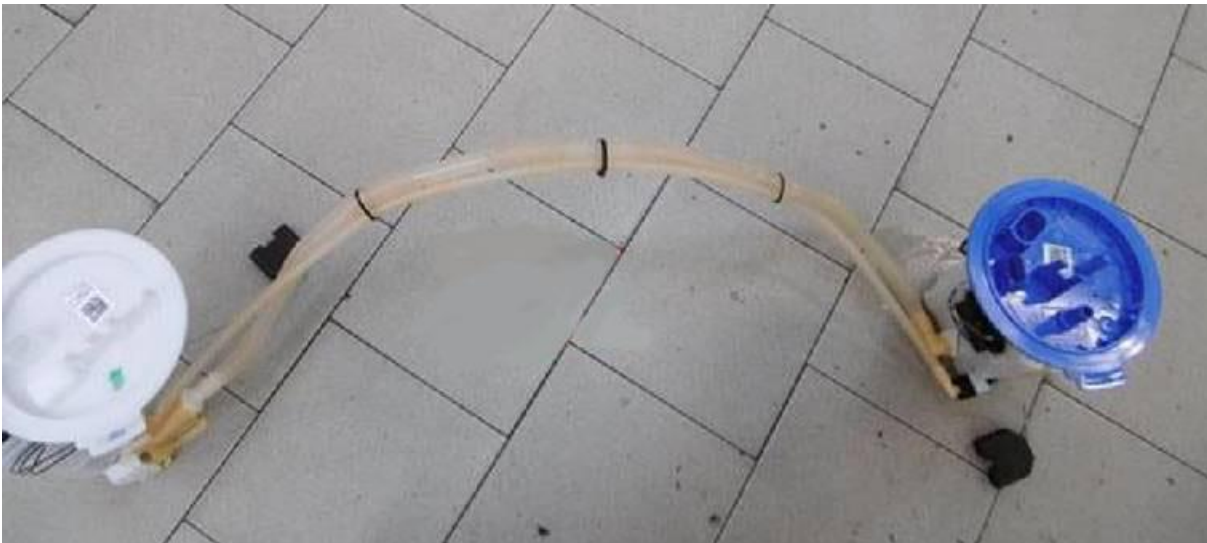
**Figure 2.** Fuel module assembly.

2. Please take photos of the customer concern and upload them into DOC-IT with the repair order. Photos should:
  - Have a date stamp and VIN reference.
  - Be taken in focus and with sufficient light.
3. Then reassemble the fuel module assembly into the tank and ensure the sender can move unobstructed. Finally, perform a battery (Kl.30) reset.
