Technical Service Bulletin

34 Oil is found leaking from the transmission case side bolts

34 20 50 2061714/1 December 17, 2020.

Model(s)	Year	VIN Range	Vehicle-Specific Equipment
A4, A5, A6, and Q5	2021	All	DL382 Transmission

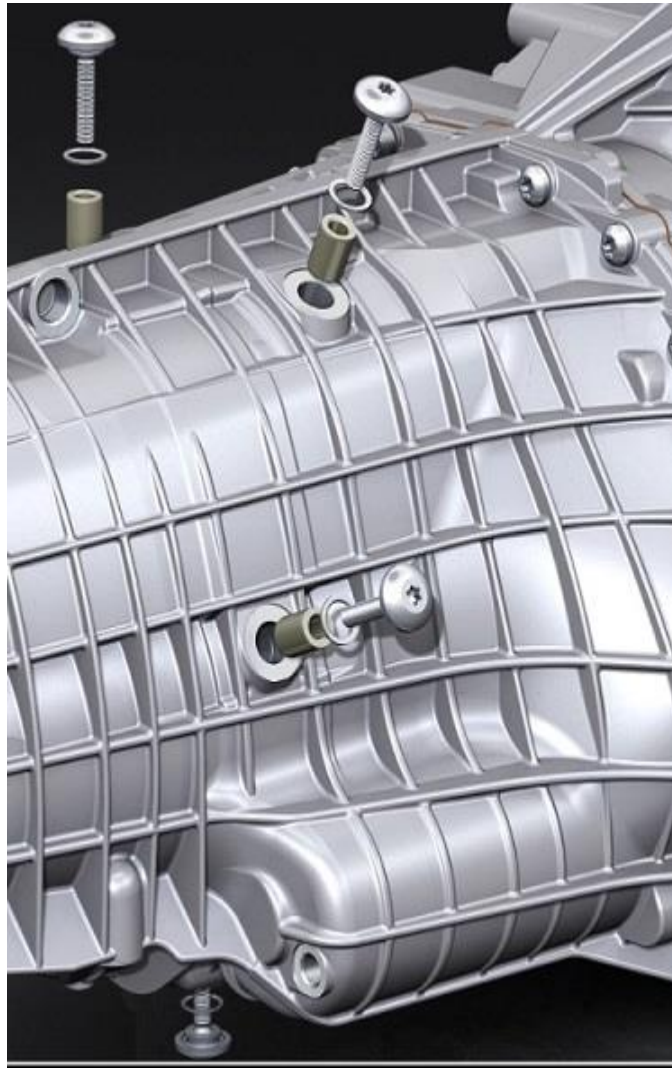
Leaks on the transmission case. The oil loss is caused by missing seals from bearing plate bolts.

Figure 1. Bearing plate bolts.

4. If the oil leak is from one or more of the bearing plate bolts proceed to Step 6 and perform the repair in this TSB.
5. If the oil is leaking from anywhere else on transmission, this TSB does not apply and you should continue with your diagnosis and repair according to warranty policies and procedures.
6. Replace the bolt or several bolts (Only replace the bolts that are leaking) according to the repair manual. You may have to remove the transmission to access some of the bolts.
7. Check and top up the MTF oil level.
8. Test drive the vehicle and recheck for leaks

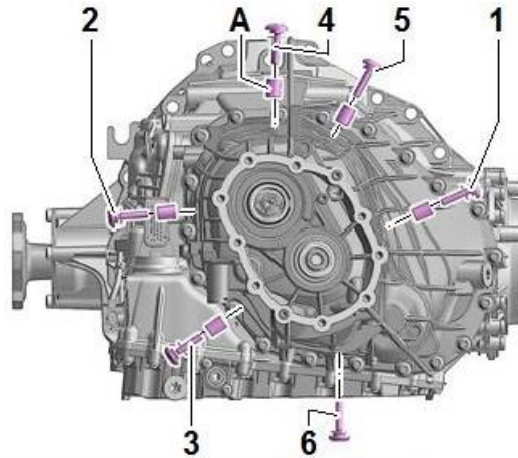
Figure 2. Location of all 6 bolts for the bearing plate.
