Technical product information

Topic	During PDI - Steering wheel vibration and/or steering wheel out of alignment is evident
Market area	Russische Föderation (5RU),Australia E04 Bentley rest Asia and Australia (6E04),China 796 VW Import Comp. Ltd (Vico), Beijing (6796),Germany E02 Bentley rest Europe (6E02),Japan E03 Bentley Japan (6E03),Korea, (South) E08 Bentley South Korea (6E08),United Arab Emirates E06 Bentley Middle East and Africa (6E06),United Kingdom E01 Bentley UK (6E01),United States E05 Bentley USA and rest America (6E05)
Brand	Bentley
Transaction No.	2060223/3
Level	EH
Status	Approval
Release date

New Continental GT/C - New Flying Spur - Bentayga

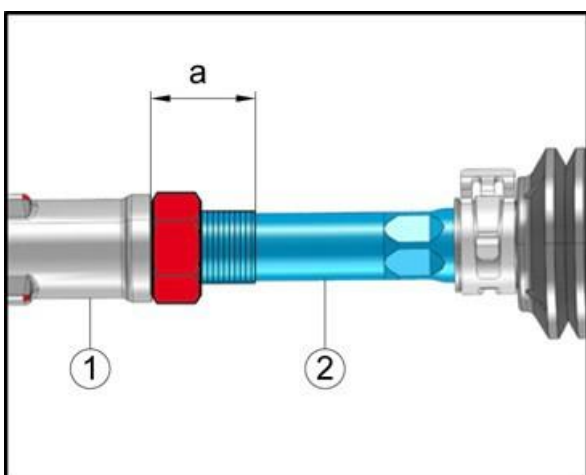
In the event that during the Pre Delivery Inspection procedure (PDI) the steering wheel is shaking/vibrating or out of alignment, please refer to the instructions within the Measure section

- Tyre Pressures to be recorded and checked against the correct specification – Actual results should be requested and attached to the DISS query
- Referring to Figure 1 - Images of the track rod end threads before and after alignment from both sides should be requested and attached to the open DISS query
- *Measure and note down dimension -a- between the track rod ball joint -1- and the track rod -2- on both sides.*
