JTB00640NAS2

TECHNICAL BULLETIN

Water Trapped In Front And/Or Rear Door(s)

MODEL:	MODEL YEAR:	VIN:	ASSEMBLY PLANT:
XF (X260)	2016-2017	Y00124-Y33470	Castle Bromwich

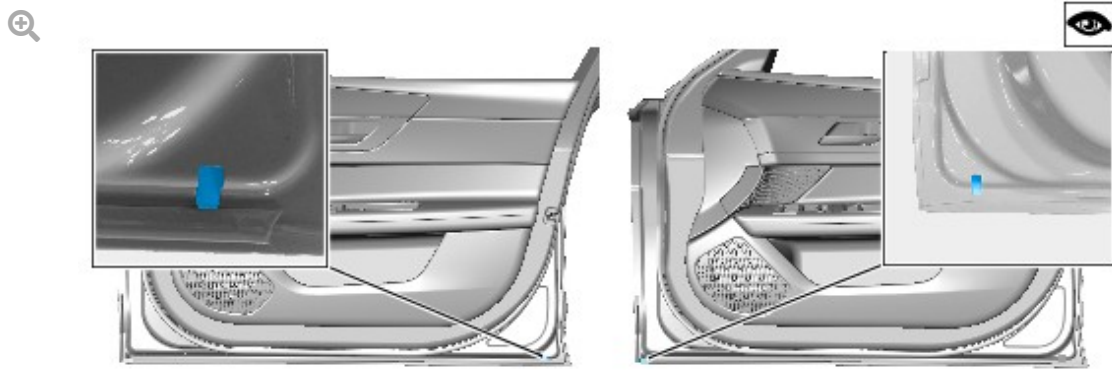
**E225568**

Inspect the front door(s) inner and outer drainage aperture(s) for any excess sealant obstructing the drainage aperture(s).

Use a suitable tool to remove the excess sealant from the drainage aperture(s) and apply paint to the reworked area(s).

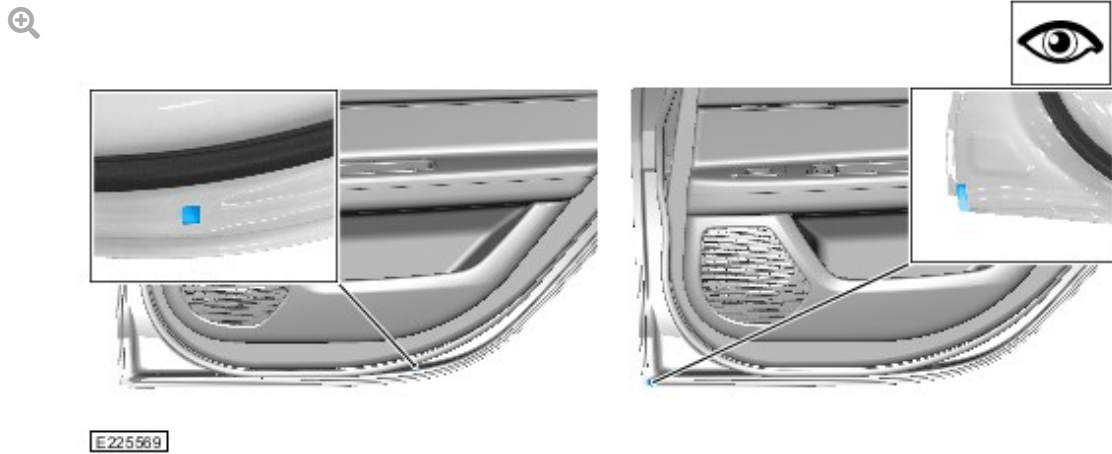
Inspect the rear door(s) inner and outer drainage aperture(s) for any excess sealant obstructing the drainage aperture(s).

Use a suitable tool to remove the excess sealant from the drainage aperture(s) and apply paint to the reworked area(s).
