## Technical product information

<b>Topic</b>	Rear tail lamp flashes - After opening an exterior door - With the vehicle unlocked
<b>Market area</b>	Russische Föderation (5RU),Australia E04 Bentley rest Asia and Australia (6E04),China 796 VW Import Comp. Ltd (Vico), Beijing (6796),Germany E02 Bentley rest Europe (6E02),Korea, (South) E08 Bentley South Korea (6E08),United Arab Emirates E06 Bentley Middle East and Africa (6E06),United Kingdom E01 Bentley UK (6E01),United States E05 Bentley USA and rest America (6E05)
<b>Brand</b>	Bentley
<b>Transaction No.</b>	2060895/2
<b>Level</b>	EH
<b>Status</b>	Approval
<b>Release date</b>

### Bentayga

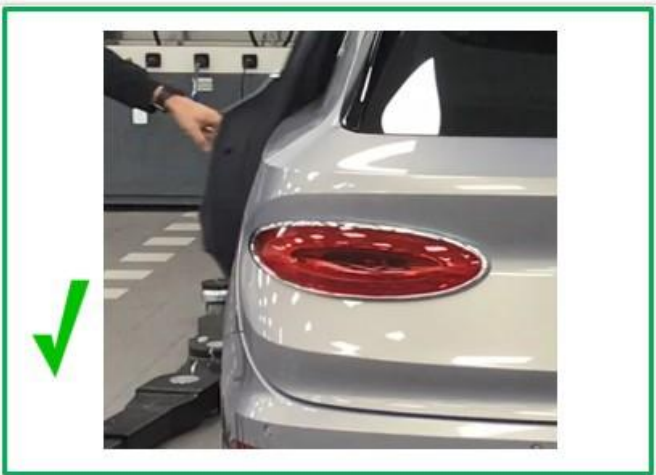
Figure 2 shows the correct operation (No flash)
