ST20-003

ITB20-029

2017-2020 Q50; STEERING FEELS LIGHT OR SENSITIVE

APPLIED VEHICLES: 2017-2020 Q50 (V37)**APPLIED SYSTEM:** Steering - Vehicles without Direct Adaptive Steering (DAS)

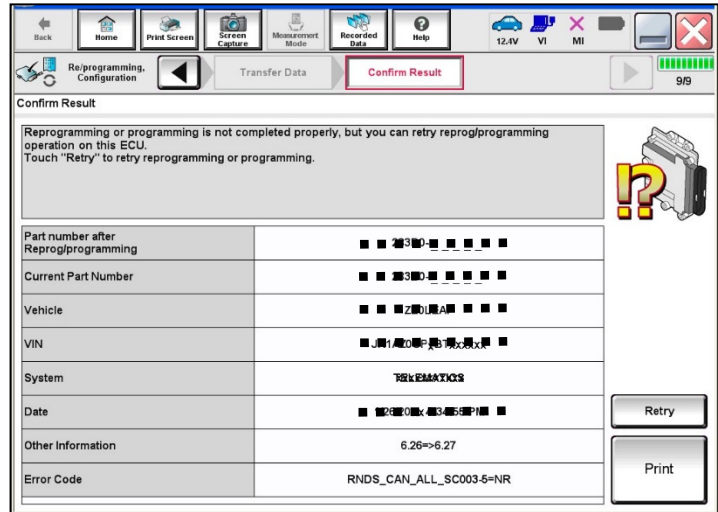
Figure 23

If reprogramming does not complete and the "!" symbol displays as shown in Figure 23:

- Check battery voltage (12.0-15.5V).
- Ignition is ON.
- External Bluetooth® devices are OFF.
- All electrical loads are OFF.
- Select **Retry** and follow the on-screen instructions.
 - Retry may not go through on the first attempt and can be selected more than once.
