AT20-008

ITB20-030

2019-2020 QX50; CVT FLUID COOLER HOSE LEAK

APPLIED VEHICLES: 2019-2020 QX50 (J55) with tow package
APPLIED VIN: 2019 All
 2020 Built before 3PCA75M (**) LF121797
APPLIED DATE: Built before July 1, 2020

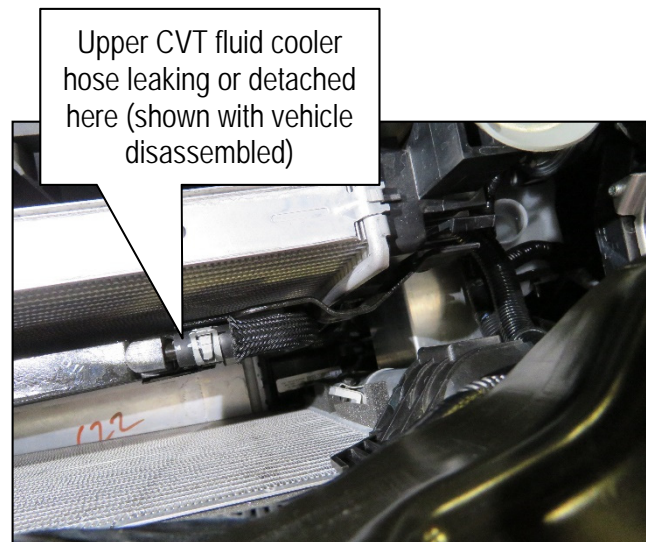
Figure 1

CVT fluid is leaking from the upper CVT fluid cooler hose, at the CVT cooler.

The upper CVT fluid cooler hose has become detached while driving.

Follow the service procedure in this bulletin to replace the upper CVT fluid cooler hose and clamps.
