GROUP	NUMBER	
BODY ELECTRICAL	20-BE-012H	
DATE	MODEL(S)	
DECEMBER, 2020	All Vehicles

BACKUP AND/OR AROUND VIEW CAMERA CARE AND **CIFANING**

This TSB supersedes TSB #17-BE-010 to include more information relating to the camera lens care.

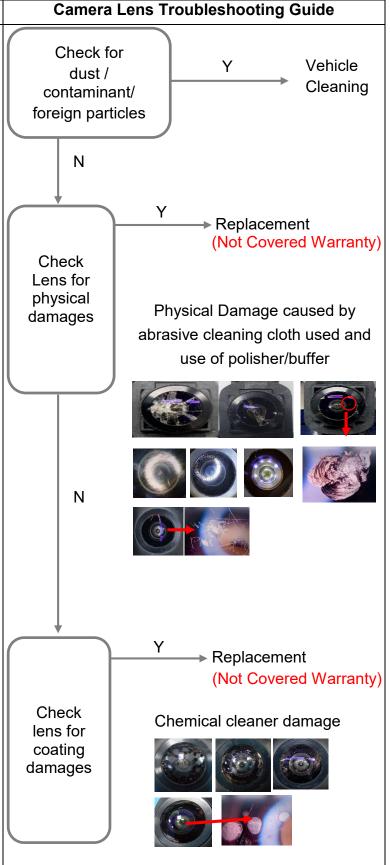
If the camera lens coating is damaged, the camera image will appear blurry.

When the camera lens coating is damaged, the light transmitted to the lens will be out of focus causing a blurry image.

Lens coatings can be damaged by the use of cleaner and fabric.

Usage of chemical cleaner during washing/polishing.

Usage of a cleaning cloth to scrub dirt/stain/dust.

Chemical cleaner should be used sparingly. Instead, water(non-chlorine base) should be used to remove any contamination.
