# Technical Service Bulletin

GROUP	NUMBER			
	Body	20-BD-016H-1			
	DATE	MODEL(S)			
	December, 2020	Santa Fe (TMa) Palisade (LX2)			
Ū

### SECOND ROW SEAT TRACK NOISE REPAIR

**Description:** Certain Santa Fe (TMa) and Palisade (LX2) vehicles may exhibit noise coming from the second row seat track. This bulletin provides information on how to inspect and if necessary repair the condition.

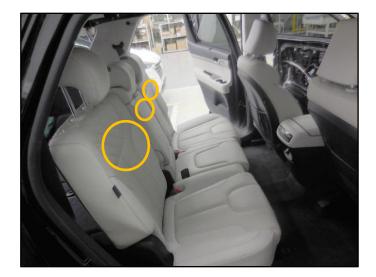
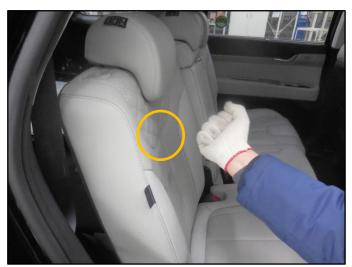
Tap the upper portion of the rear seat back 10+ times to inspect for noise.

Perform this inspection on all rear seat backs.

If noise is heard from a rear seat back, carefully remove the affected rear seat (A) using the applicable vehicle shop manual section below:

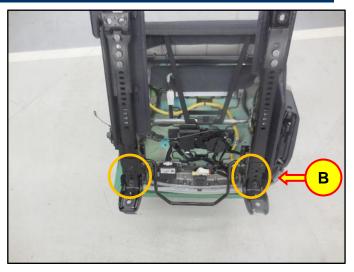
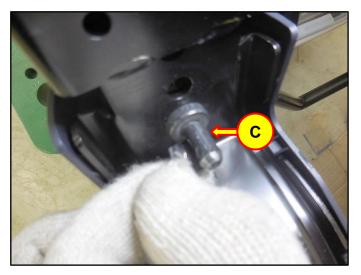
3. Place the rear seat on a workbench, and locate the track location pins (B).

4. Use a utility knife to cut the existing location pin tubes (C).

5. Remove and discard both location pin tubes.
