SERVICE BULLETIN

| Classification: EC20-020 | Reference: NTB20-094 | Date: December 22, 2020 |

2015-2020 ROGUE; MIL ON WITH DTC P0181 AND/OR P0183

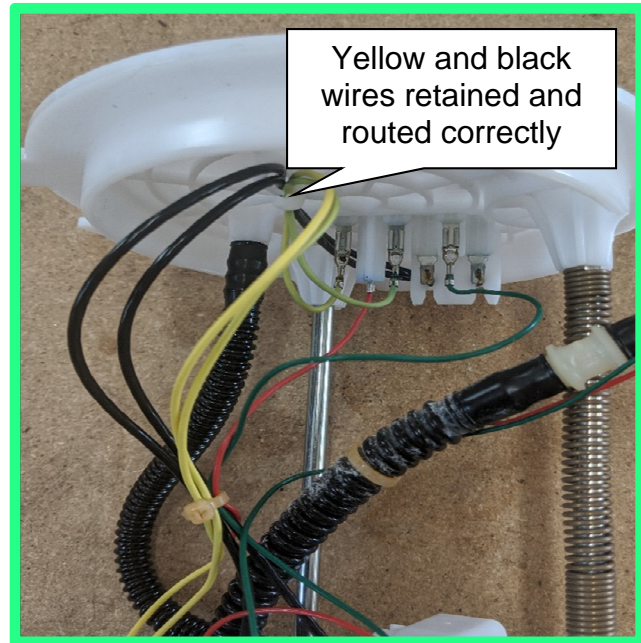
Figure 1

2. Inspect the routing of the yellow wires on the fuel pump assembly. The yellow and black wires should be routed the same way and retained at the top by the plastic wire retainer as shown in Figure 1.
 - If the wires are routed correctly, continue to step 3.
 - If the wires are not routed correctly, as shown in Figure 2, route them as shown in Figure 1.

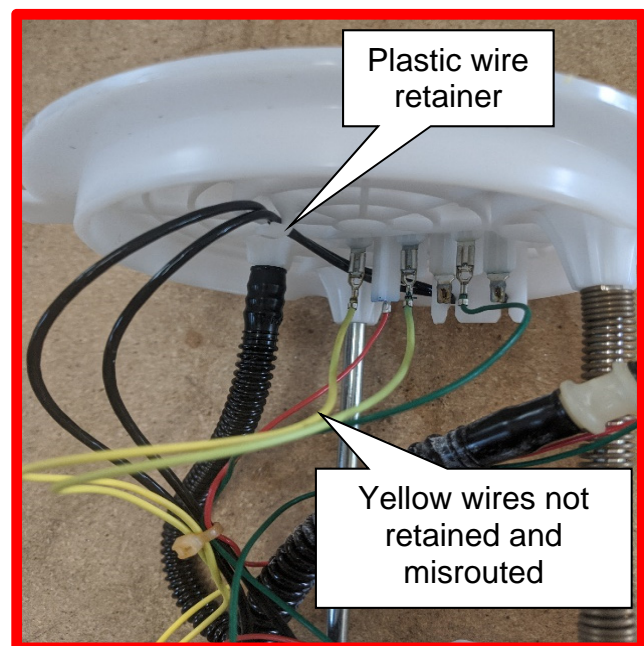
Figure 2

The MIL is ON with DTC P0181 (FTT SENSOR) and/or P0183 (FTT SEN/CIRCUIT) stored in the ECM.

1. Remove the fuel pump assembly.
2. Inspect the fuel pump assembly wiring, and reroute the wiring, if applicable.
3. Reinstall the fuel pump assembly.
