**** TECHNICAL INFORMATION NOTICE ****

RE: Apple CarPlay Touch Pad Inoperative

TIN Number: TIN-20-54A-003

.....
AFFECTED VEHICLES: 2017 - 2020 Eclipse Cross

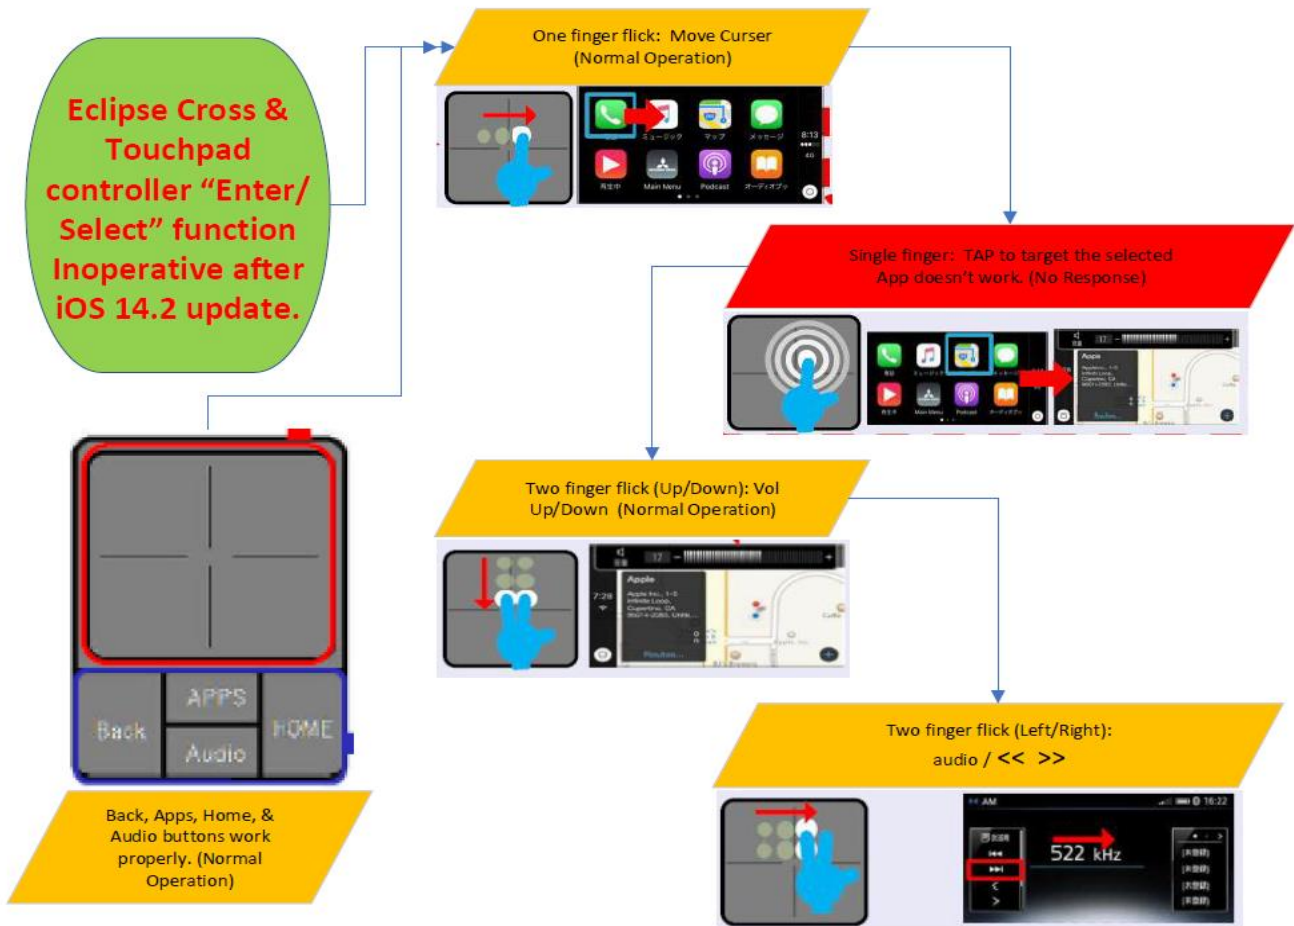
In the latest OS version "iOS 14.2" for iPhone, the "tap to select/enter" function does not respond on the Apple CarPlay screen. This concern may be independent to the iPhone.

Due to the specification changes implemented in iOS 14.2 by Apple, this concern may be caused when the transmission data signal from the vehicle's touch pad is received by the iPhone; but, the transmission from the iPhone is not transmitted back to the Audio unit.

In some situations, the following steps have restored function and should be completed:

- ◆ Update iOS to the latest version (Settings-> General -> Software Update)
- ◆ Disable Apple CarPlay and then restart the iPhone (Settings -> General -> CarPlay)
- ◆ Enable Apple CarPlay (Settings -> General -> CarPlay)
