Technical Service Bulletin

55 Various rear lid malfunctions, rear lid to body gap dimensions are incorrect

55 21 52 2060901/3 January 7, 2021. Supersedes Technical Service Bulletin Group 55 number 20-50 dated October 22, 2020 for reasons listed below.

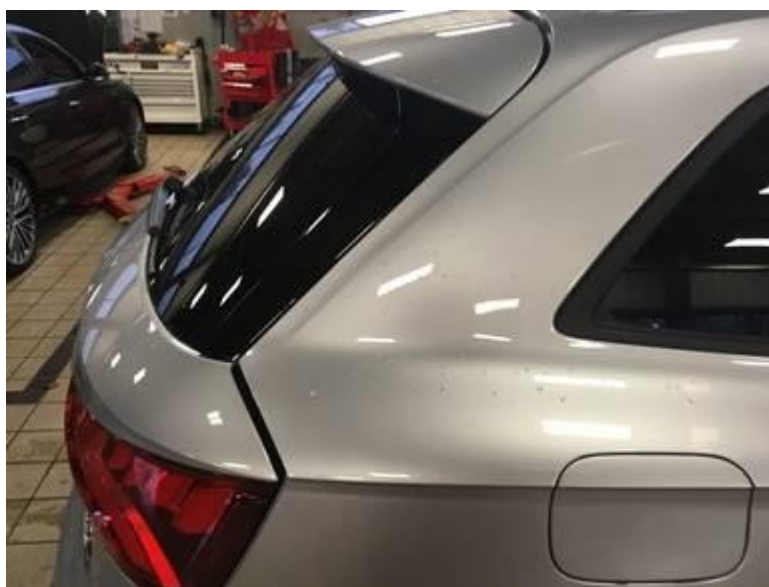
- The rear lid opens or closes with difficulty.
- They also may mention that the rear lid does not appear to be adjusted correctly as the gap at the top of the rear lid to the body is excessive and the clearance between the rear lid and the rear bumper cover appears to be too small (Figures 1 – 2).

Figure 1. An out of alignment rear lid.

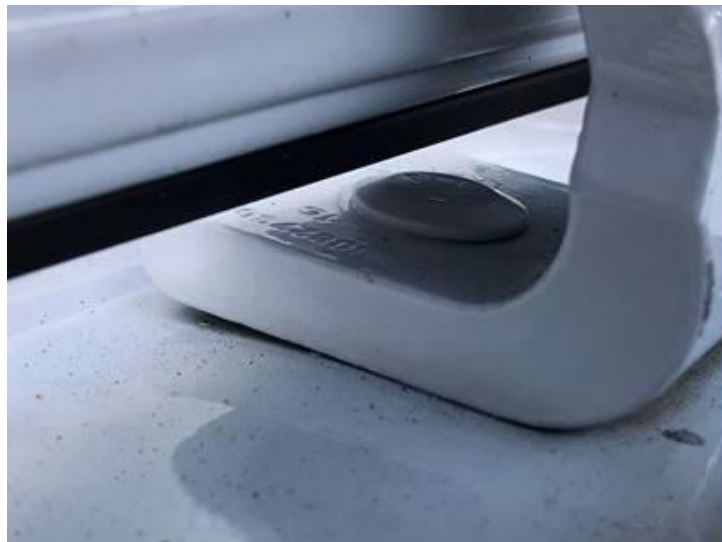
1. Visually inspect the rear lid hinge mount areas. This distortion issue is likely to be apparent viewing the outer area (Figures 4 -5).

Figure 4. Rear lid hinge mount distorted.

3. The vehicle will need to be sent to an Audi authorized collision facility to have the rear lid mounting area straightened. Supply the collision facility with the reinforcement plates and nuts. They will need to install them after the rear lid hinge mounting area is repaired.
4. After the rear lid hinge mounting area is restored to normal, install the reinforcement plates and nuts (Figures 7 – 8). Torque the nuts to 35 Nm.

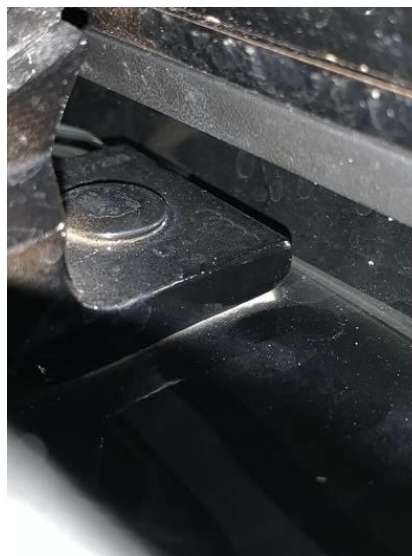
Figure 5. Rear lid hinge mount not flat to the body.
