<b>Subject:</b> <b>EXCESSIVE CONDENSATION OR WATER WITHIN THE HEADLAMP ASSEMBLY</b> <b>- CAUTION</b>	<b>Bulletin No:</b> 09-001/17
	<b>Last Issued:</b> 01/13/2017

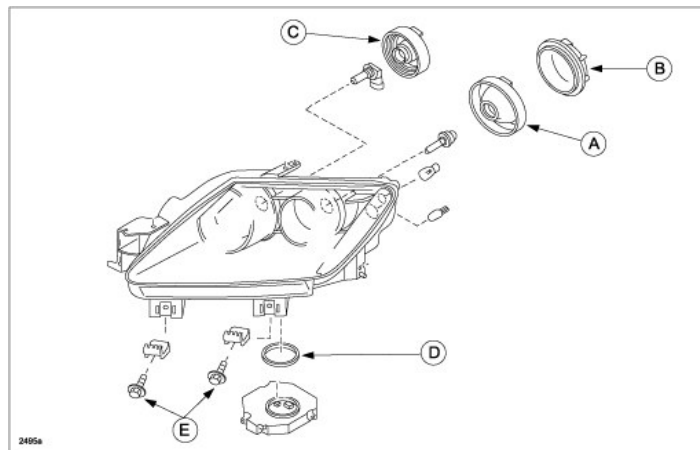
When dealing with customer complaints of excessive condensation and/or water within the headlamp unit, first determine if all the bulb sockets are present and correctly installed. In most cases you will find that the Bulb Seal No. 1 (A) or HID Bulb Seal No. 1 (B) and Bulb Seal No. 2 (C) socket covers have not been correctly installed or are missing due to improper prior repairs (i.e., customer replacing the headlamp bulbs or body shop not transferring them when replacing the headlamp unit(s) due to a collision). Any damage caused by missing socket covers, HID module seal (D), or missing bumper brackets (E) is not covered by warranty policy.

**NOTE:** LED headlamp assembly replacement part include seals. Seal transfer is not required.
