## **Multi-Model (Equipped With MAZDA CONNECT) - DTC U0323/U0423/U3000 Cannot Be Deleted (Update)**

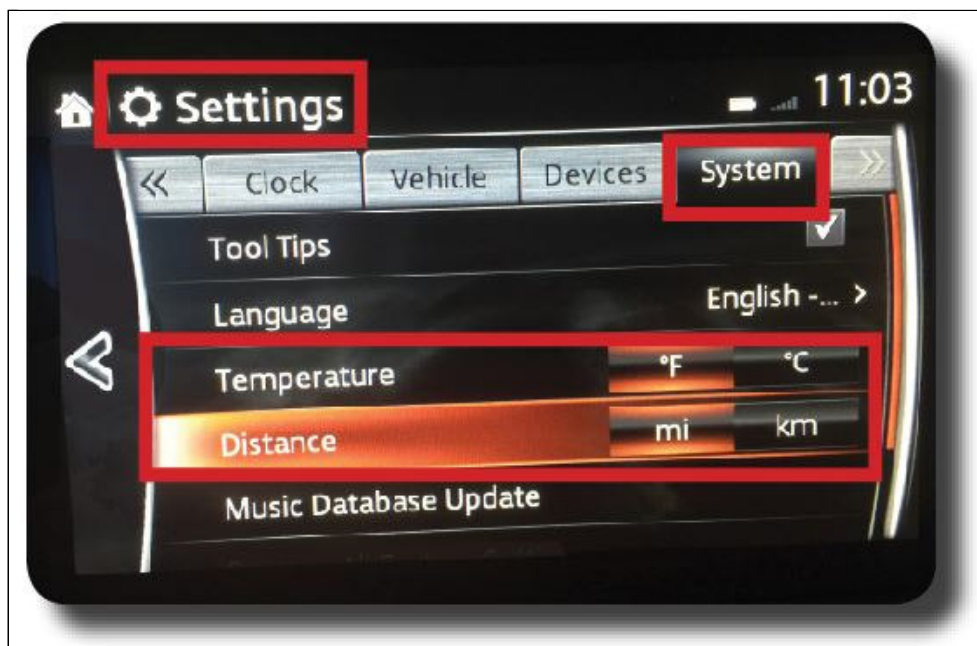
Some vehicles (with MAZDA CONNECT) may exhibit a condition where DTC U0323(PCM) / U0423(ABS) /U3000(IC) CANNOT be deleted when the TPMS warning light flashes and/or the TCS/DSC indicator lights are illuminated. This can happen if the ignition is turned OFF within 20 seconds after the ignition is turned ON in one of the following two situations.

1. The "ROOM" fuse (Engine compartment) is NOT installed when battery level is low.
2. The CMU (Connectivity Master Unit) is NOT connected.

1. Confirm the CMU is connected.
2. Confirm the ROOM fuse is installed properly.
3. Change the Temperature and the Distance setting in MAZDA CONNECT System Settings.
  - Temperature - Fahrenheit to Celsius (or vice versa)
  - Distance - Miles to Kilometers (or vice versa)

4. Turn the ignition OFF.
5. Remove the ROOM fuse.
6. Press and hold the tripmeter reset button more than 5 seconds.
7. Install the ROOM fuse.
8. Turn the ignition ON.
9. Delete the DTC(s) using M-MDS.
10. Return the original unit of Temperature and Distance in MAZDA CONNECT System Settings.
