Multi-Model - Clutch Slippage or Smell after Clutch Disc Replacement

Clutch Disc Spline Grease Application Procedure

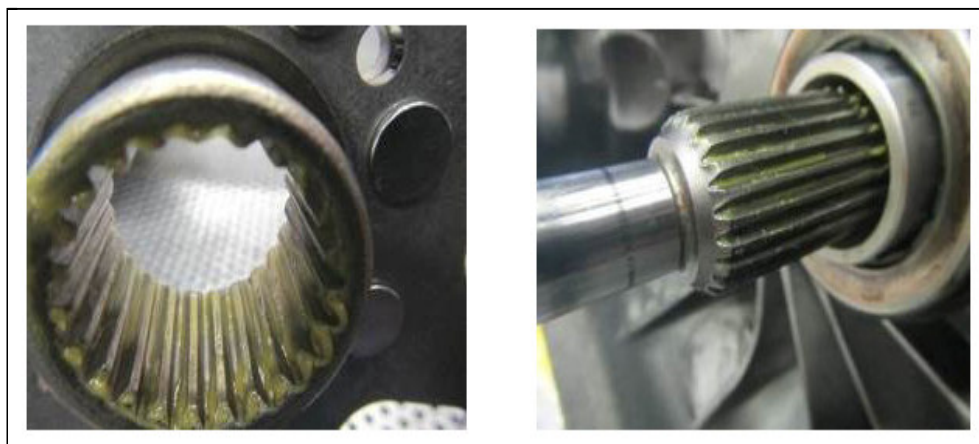
NOTE: Below is an example of a proper thin layer of grease application.
