ROADSTER WARRANTY Bulletin

Campaign no.: 2011-0016
2012-0006

No. **2012-8**

- 1- Updated Throttle Body Actuator Protection**
- 2- ECM and TCM Software Updates**
- 3- Middle Side Panel Grommet Replacement (2011 Models Only)**

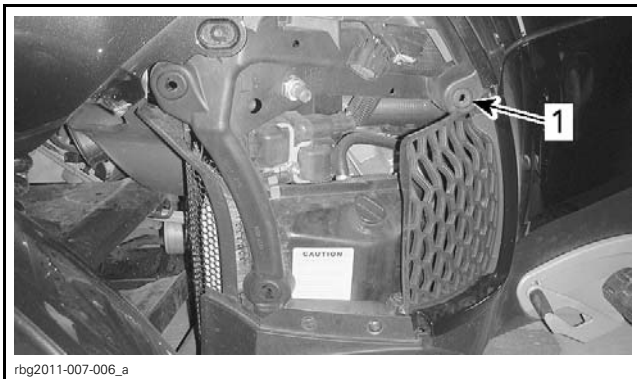
LH SIDE OF VEHICLE SHOWN
1. Check this grommet ONLY

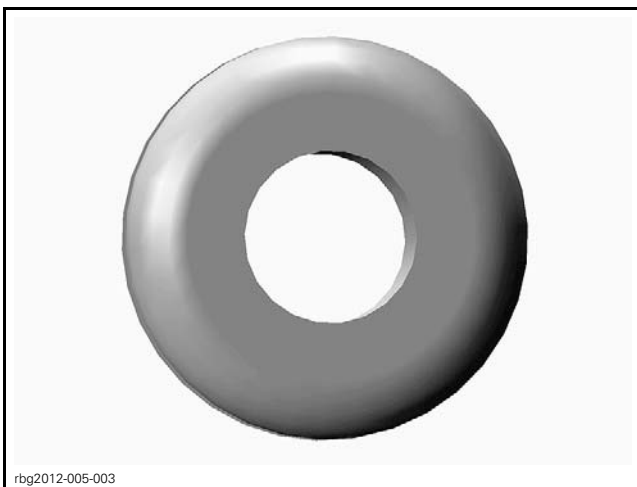
OLD TYPE - SMOOTH OUTER EDGE

GROMMET TYPE	ACTION
Old Grommet type	Replace by (P/N 705 003 264)
New Grommet type	No action required

3. If required, remove the grommet using a flat screwdriver.
4. Scrape off any remaining grommet and glue residue from area where grommet was glued.
5. Install the new grommet.
6. Repeat steps on the other side of the vehicle.

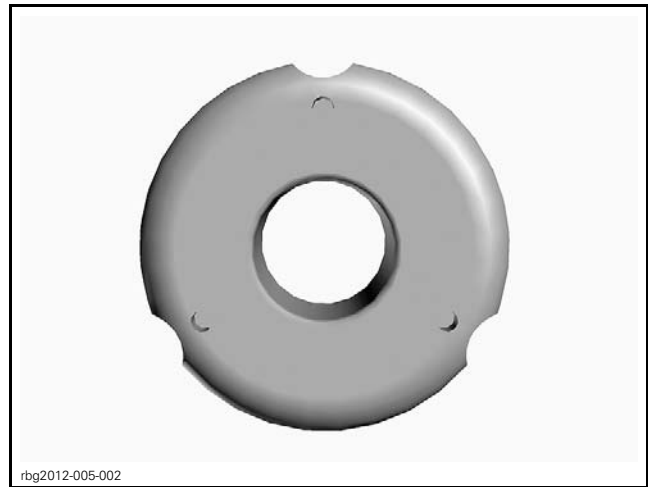
NEW TYPE - NOTCHES ON THE OUTER EDGE AND MOLDED STEEL WASHER
