ROADSTER 2014 Front Fuse Box Covers Replacement, Update ECM Software P1614, Hi Temp, Limp Home (RS, ST)_000071523_TST61Y014S00_en

Campaign no.: **2014-0001**

Publication date: **January 23, 2014**

Subject: **Roadster Spyder™ RS and ST Series**
Subject 1 - Front Fuse Box Covers Replacement
Subject 2 - Update ECM Software (P1614, Hi-Temp Lamps, Limp Home Mode)

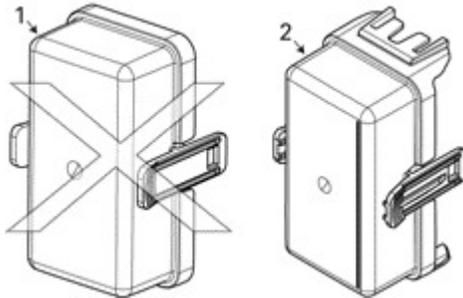
An improved fuse box cover is now used in production. Since this was a running change, a very limited quantity of vehicle were produced having a version of the fuse box cover which no longer meets BRP standards.

1. Old fuse box cover
2. New fuse box cover
3. Install new covers on fuse boxes. Make sure they are properly clipped.

Replace fuse box covers.

1. Remove the cover from both fuse boxes.
2. Transfer fuses to new covers.
