# MULTI-MODEL (EQUIPPED WITH REAR VIEW MONITOR) *REAR VIEW MONITOR DISPLAY IS BLURRY*

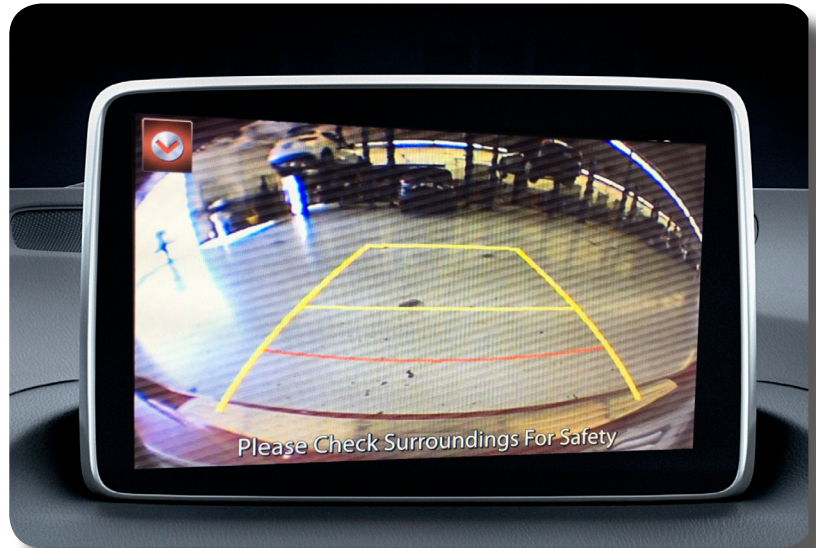
## Blurry Display

With aftermarket cell phone charger connected to 12V outlet

Repairs for this concern are not covered under Mazda's warranty policy. Advise the customer not to use the aftermarket device that is causing the concern.

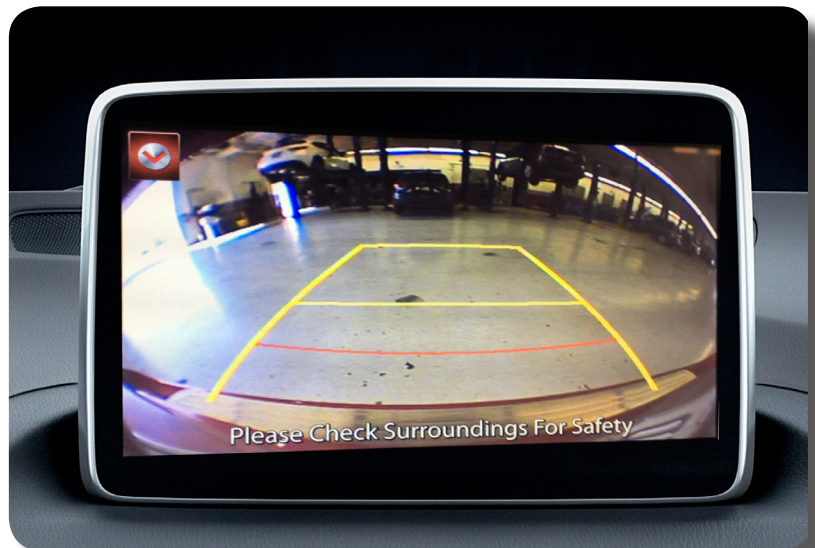
OK

Without aftermarket cell phone charger
