Fuel Tank Fill System – Non or Slow Filling

Bulletin Type:	SRP
Bulletin #(s):	19-021
Job Code(s):	**
Flat Rate(s):	**
<i>** If affected unit has warranty remaining, submit your claim following the normal process.</i>

Publication Date:	January 2021
Make(s):	Jayco Towable
Model(s):	Seismic FW Talon FW
Model Year(s):	2017-2019

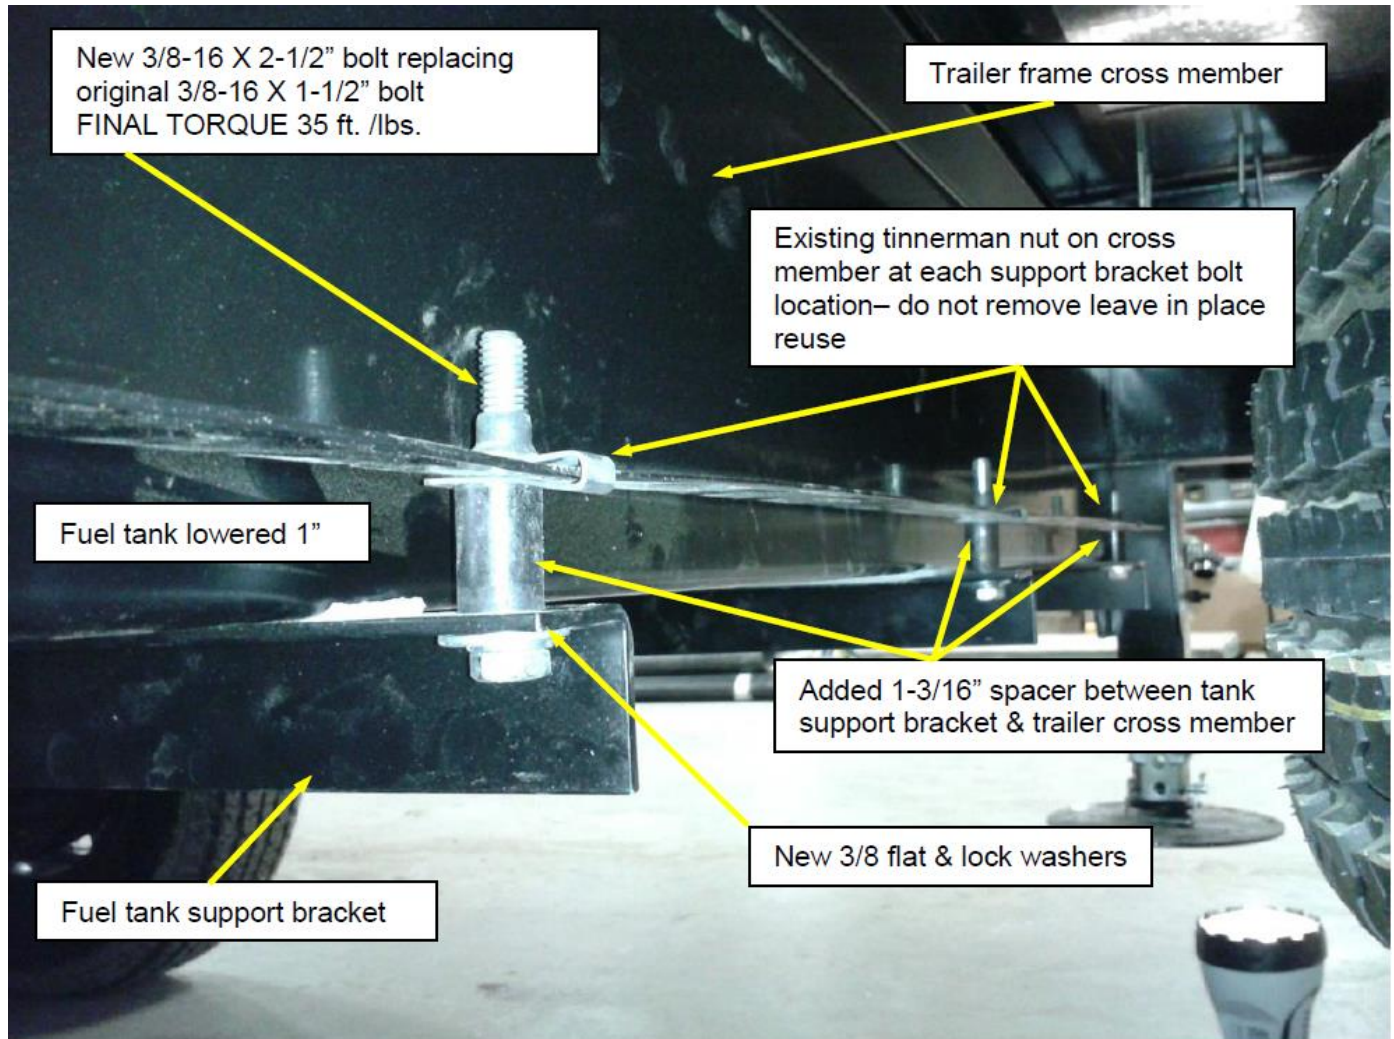
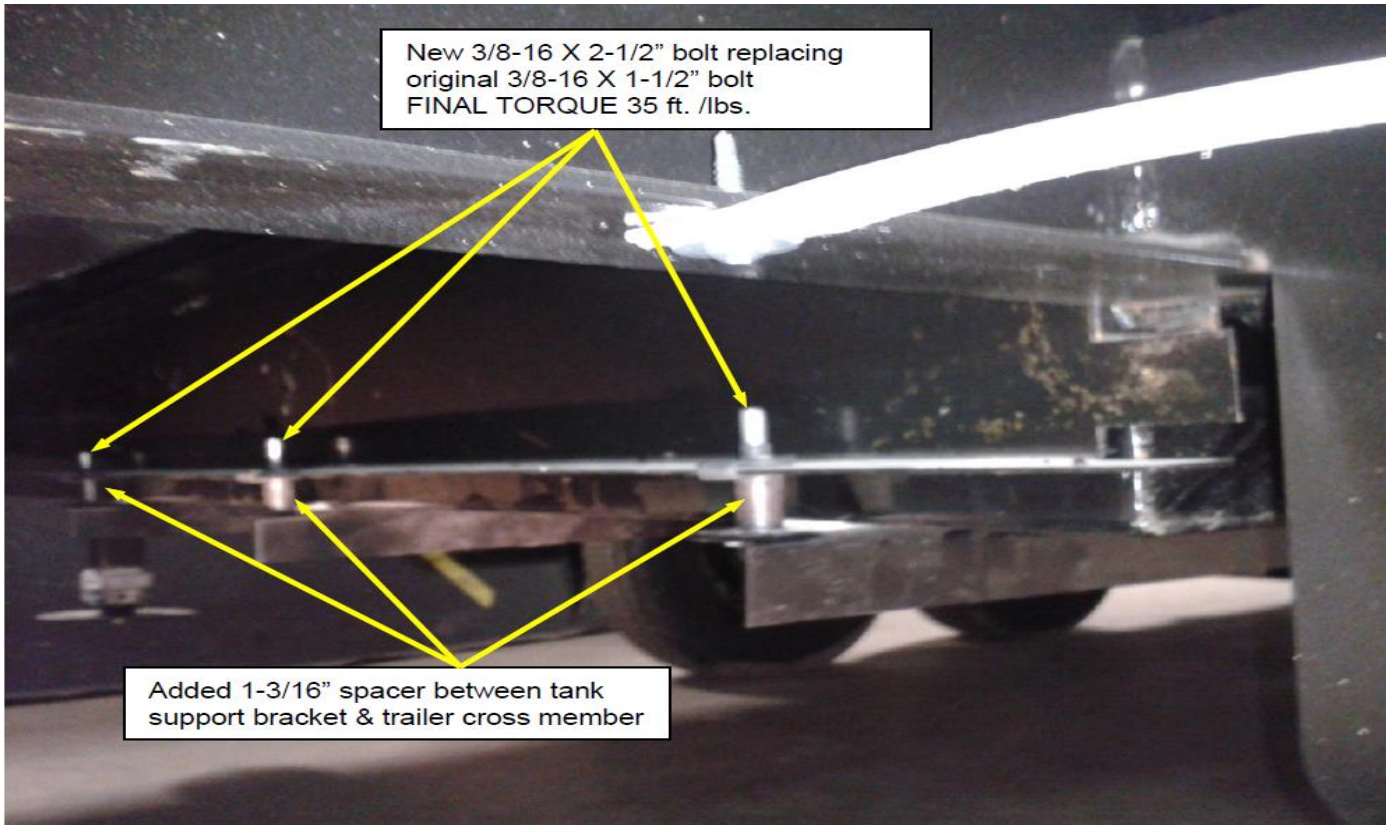
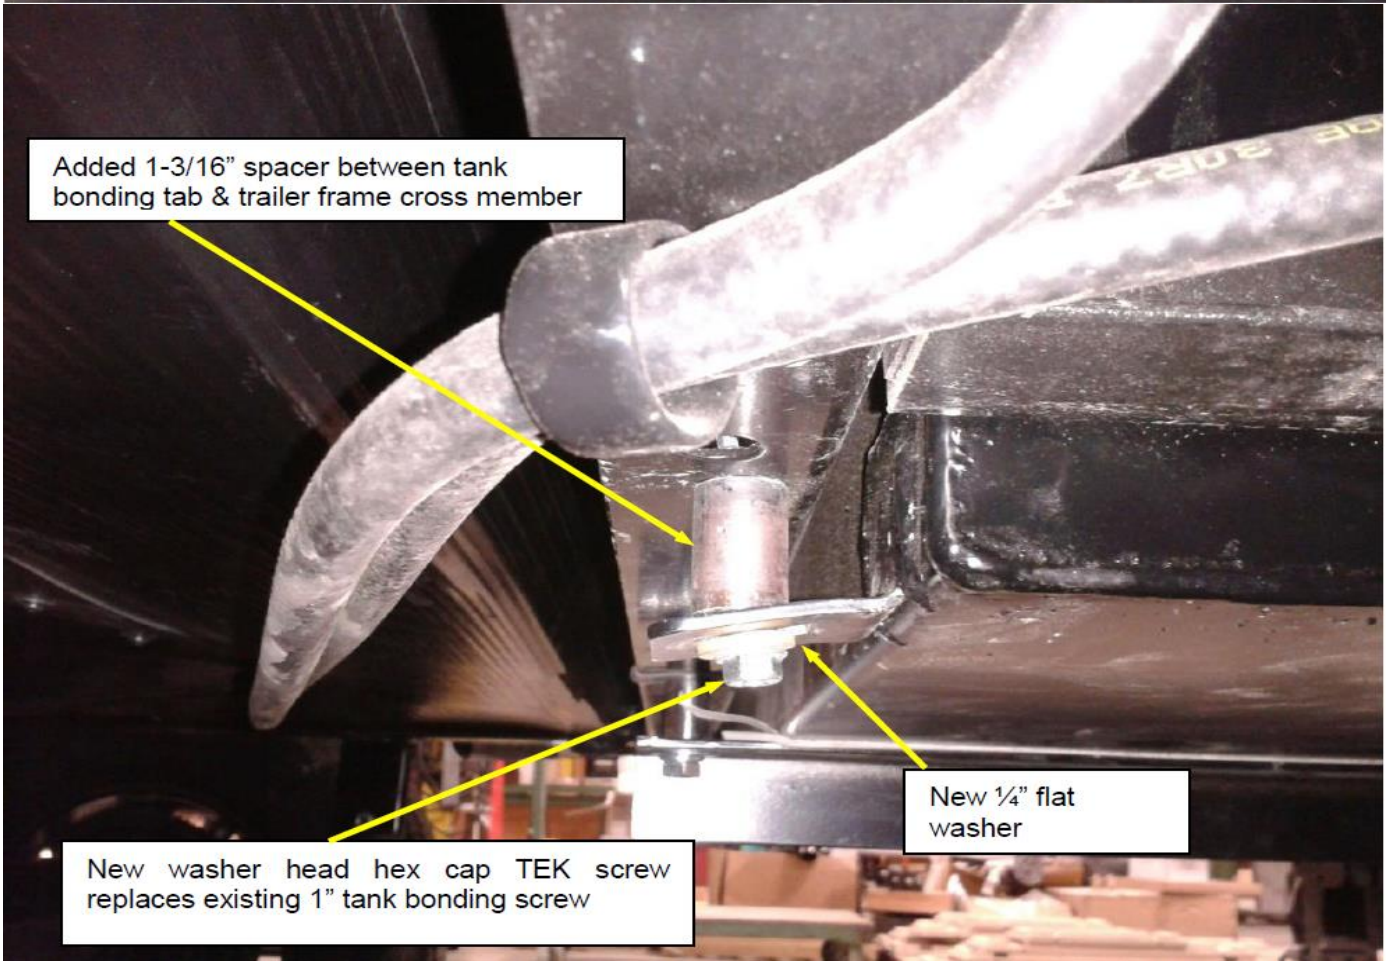
Some fuel tank fill systems of sport utility fifth wheel trailers with 10-inch I-beams have experienced slow filling or not being able to be filled due to inadequate slope of the fill hose from the fill neck outlet to the tank inlet.

Increase the slope of the fill hose(s) from the fill neck outlet to the tank inlet by lowering the fuel tanks.

- c. With the tube in place at the top of the tank and all new bolts, washers, and bottom spacers in place tighten all bolts at the bottom brackets.
 - i. Final torque 35 ft. /lbs.
- 3. The slope of the fuel fill hoses should now be at least 1 to 1-1/4-inch lower at the tank inlet than at the fill neck outlet. This will allow filling at full nozzle delivery pressure.

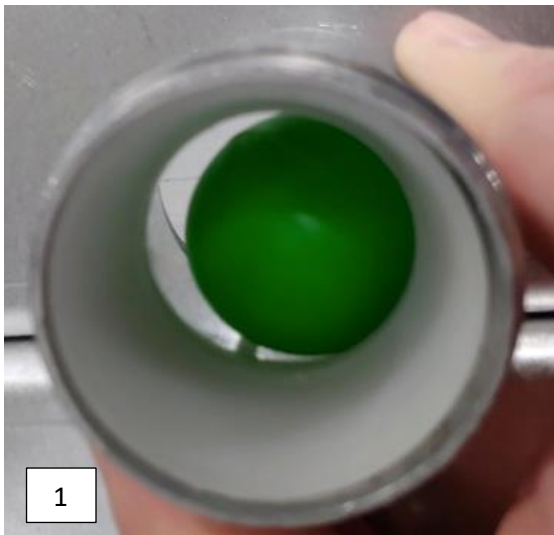
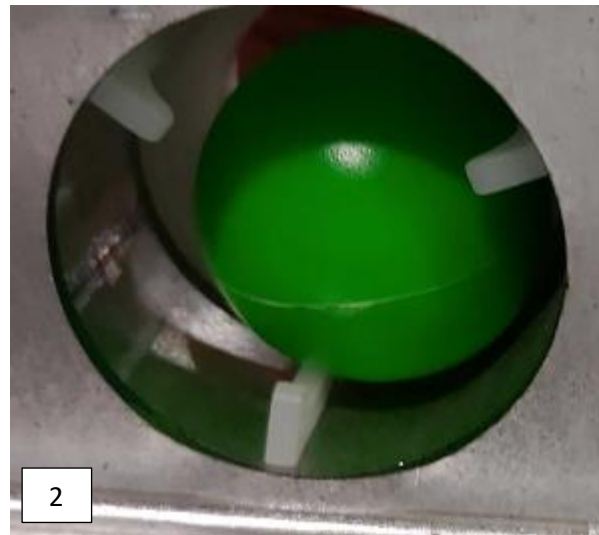
The first 2 photos depict what you would see on a normal tank from inside the tank and also the front of the tank. This is what is considered a good/normal install which will allow fuel to flow with no issues. The check ball should move freely with the confines of the three prongs.

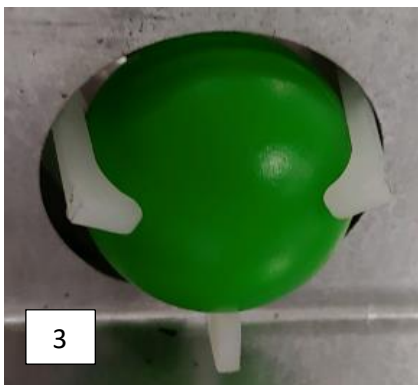
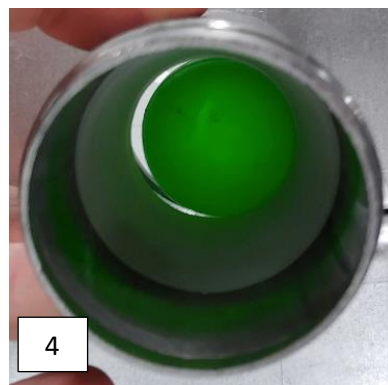
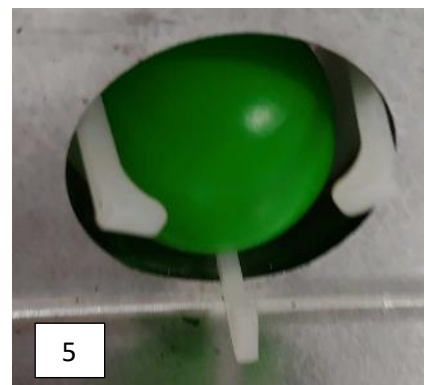
The check ball may have slid into the fill neck, allowing the fingers of the ball check valve to compress and push into the tank opening.

Photos 3-5 show the ball check valve fingers have become compressed and pushed or inserted into the tank opening which is restricting the ball movement and causing the slow fill. The photos depict the worst case scenario, showing the maximum amount the ball valve can be pushed into the tank.

1. Ball check valve retainer is deformed, restricting the ball valve. Replace ball check valve.
2. Ball check valve assembly is incorrectly located in the fill neck. Reset ball check valve in correct location.

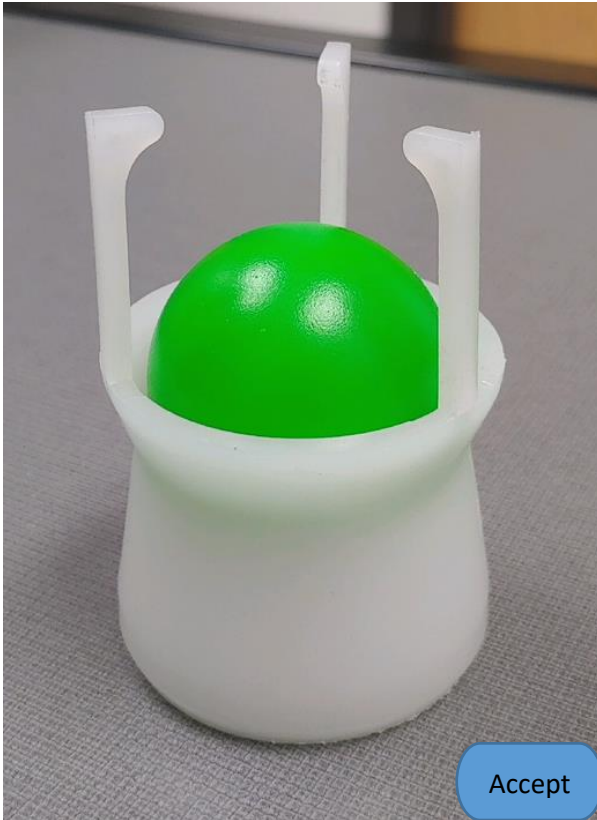
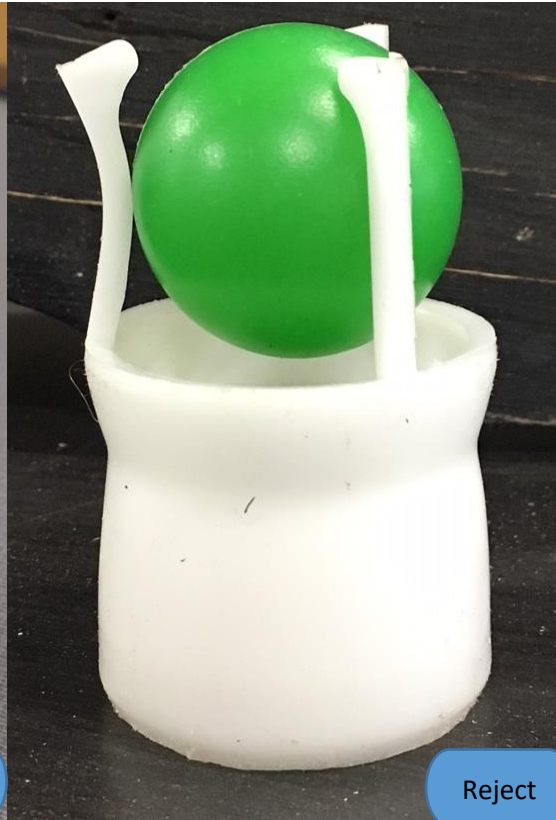
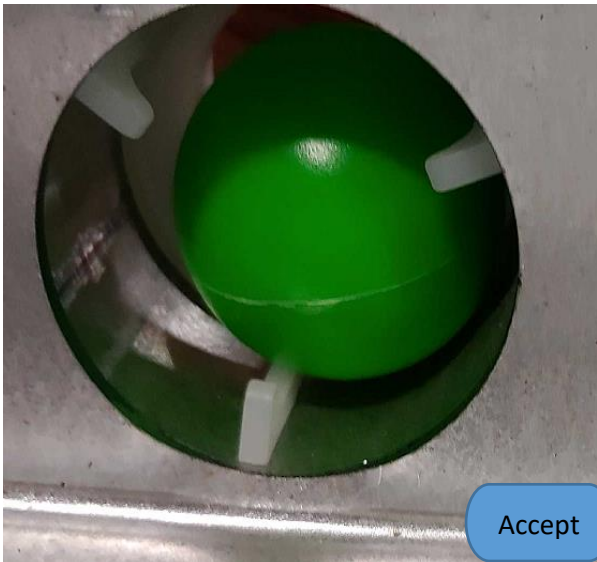
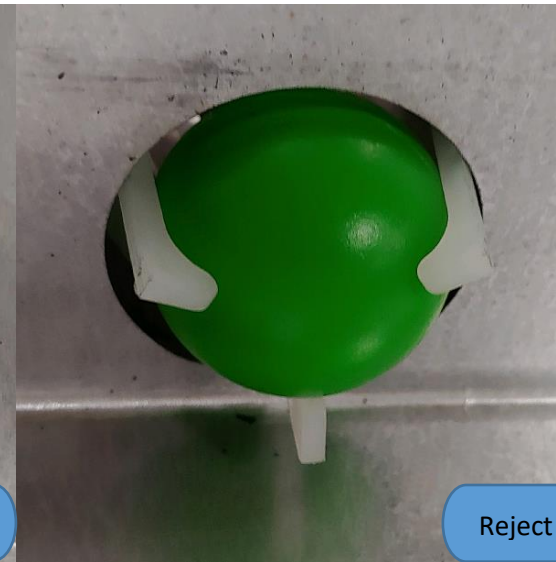
The ball should move freely with the confines of the three prongs.
